ODI Tire Failure Investigation / Rollover
Dynamic Science, Inc. / Case Number: 2007-78-092B
1998 Plymouth Neon
Arizona
July 2007

| 4. Title and Subtitle ODI Tire Failure Investigation | | 5. Report Date February 14, 2008 | |

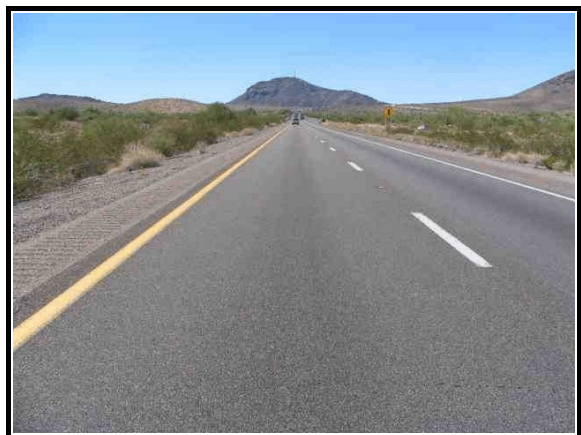
This single vehicle rollover crash occurred in July 2007 at 1140 hours. The crash occurred on a four-lane divided interstate highway (**Figure 2**). At the time of the crash, there were no adverse weather conditions and the asphalt roadway surface was dry. The east/west highway was configured with two lanes in each direction. The westbound lanes were separated by a dashed white center line. The left road edge was separated from the depressed, grassy median by a solid yellow line, a grooved rumble strip, and a gravel shoulder. The right road edge was marked by a solid white line. Beyond the white line was a grooved rumble strip and a gravel shoulder. The crash occurred within an interchange area. To the right (north) of the

Figure 2. Approach to area of tire tread separation (west)

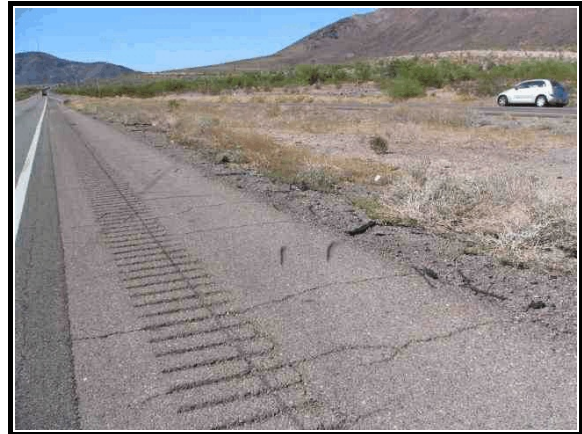
Figure 3. Right side roadway departure

The Plymouth Neon began a clockwise rotation. The vehicle crossed the adjacent westbound lane and traveled approximately 66 m (219 ft) before departing the roadway on the north side (**Figure 3**). The vehicle continued rotating as it traveled approximately 22 m (71 ft) across the grass/dirt area between the roadway and the on-ramp. Just prior to entering the on-ramp, the Neon began a left side leading rollover (Event 1). As the Neon entered the on-ramp, the vehicle struck a delineator post (Event 2). The Neon continued overturning. The NASS investigator reported a total of 10 quarter turns. The Plymouth Neon came to rest north of the on-ramp on its roof facing northeast. During

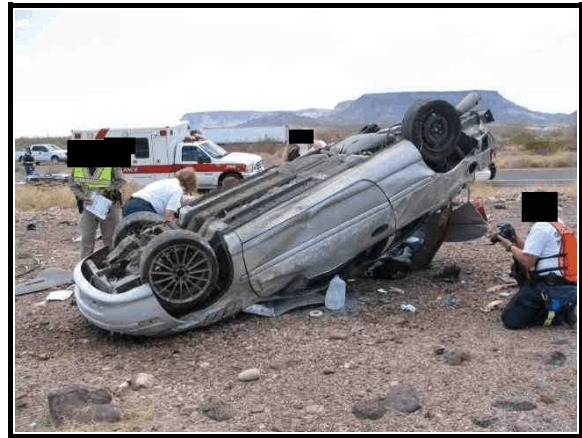
the rollover sequence the front right passenger was completely ejected. He came to rest approximately 5 m (18 ft) north of the Plymouth Neon (**Figure 4**). The driver was also ejected and was found trapped beneath the vehicle.

Figure 4. Vehicle at final rest

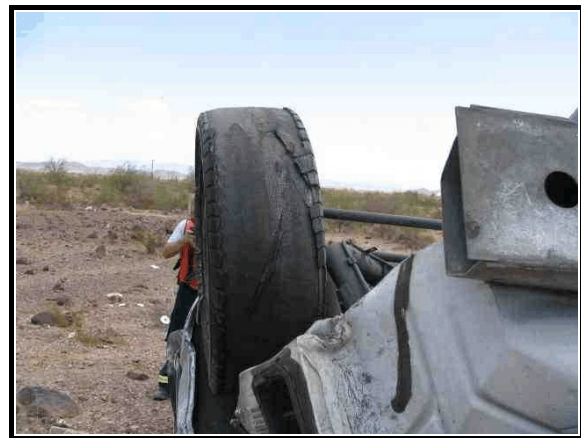
The Plymouth Neon was initially configured with Nexen N3000 205/40R17 tires on 17 inch custom rims. The tire manufacture's maximum pressure was 345 kPa (50 psi). The right rear tire was losing air during the trip. That tire was replaced by a Futura Super Sport P195/60R14 tire on a 14 inch steel rim. The tire manufacture's maximum pressure was 303 kPa (44 psi). The tire had been replaced in Texas. The driver reported that this was one of the tires originally on the vehicle. The Tire Identification Number (TIN) was U9R4 86F249. The build date as printed on the tire (249) was the 24th week of 1999, or June 1999 (**Figure 5**). The tread on the right rear tire separated prior to the rollover (**Figure 6**). The left rear tire/wheel appear to have separated from the vehicle during the rollover event. The specific tire information is as follows:

| Position | Measured Pressure | Measured Tread Depth | Restricted | Damage |
|---|---|---|---|---|
| RR | Flat | Unknown | No | Tire tread separation |

Figure 6. Right rear tire

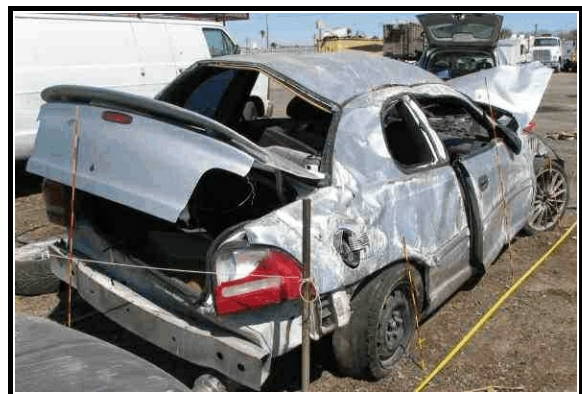
The Plymouth Neon sustained moderate damage to all sides from the rollover event. There was 436.0 cm (171.6 in) of direct damage to the right side of the vehicle (**Figure 7**). The maximum crush was located at the right C pillar and measured 21.0 cm (8.3 in) laterally. The Collision Deformation Classification (CDC) for the rollover was incremented for left shift and was 80RDAO3.

There was an impact with a delineator post, but its location and extent was masked by the rollover damage. Both front doors were jammed shut. The side glass and backlight glass disintegrated during the rollover. The windshield was largely out of place. The left rear tire/rim were separated from the vehicle.

Figure 7. Right side, Plymouth Neon

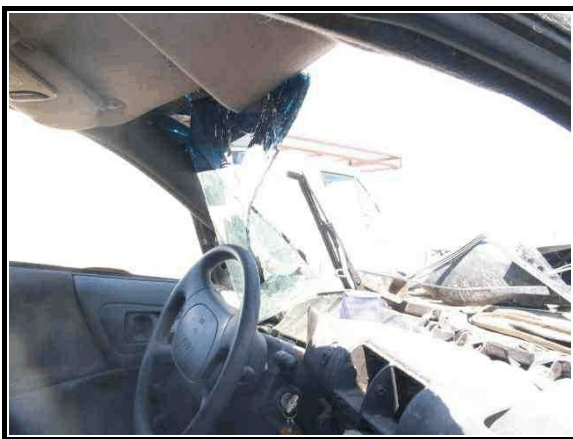
The 1998 Plymouth Neon sustained moderate interior damage as a result of passenger compartment intrusion (**Figure 8**). The right B-C pillars sustained lateral intrusions. The right A pillar, roof and roof side rail sustained vertical intrusions (**Figure 9**). The hood was deformed and intruded into the vehicle through the windshield. The specific passenger compartment intrusions were documented as follows:

Figure 8. Driver's seated position

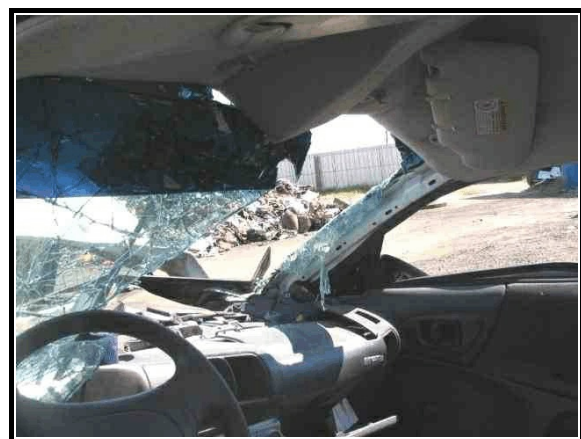
Figure 9. Front right passenger's seated position
