**NOT-IN-TRAFFIC SURVEILLANCE  
CALSPAN ON-SITE BACK OVER FATALITY INVESTIGATION**

**SCI CASE NO: CA07-002**

**VEHICLE: 2006 GMC SIERRA PICKUP TRUCK**

**INCIDENT DATE: DECEMBER, 2006**

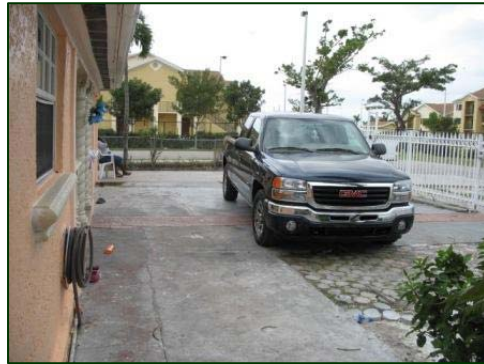
**Figure 1. Overall view of the scene and the trajectory of the child pedestrian.**

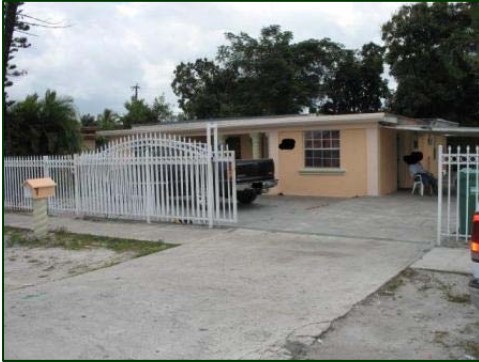
**Figure 2. Overall view of the driveway and the parked position of the GMC.**

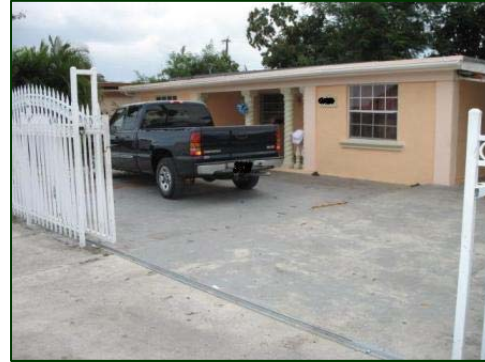
**Figure 3. View of the front yard and the parked position of the GMC Sierra.**

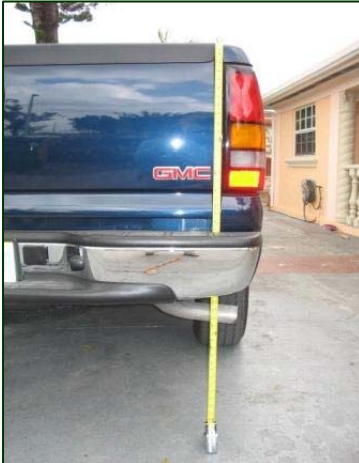
<b>Component</b>	<b>Vertical Clearance Height</b>
Beltline at mid front door	118 cm (46.5”)
Top of tailgate	129 cm (50.75”)
Top of rear bumper	71 cm (28”)
Bottom of rear bumper	50 cm (19.75”)
Bottom of trailer hitch	36 cm (14”) to safety chain bracket, 37 cm (14.5”) to bottom of receiver
<b>Undercarriage</b>	
Bottom of axle tube	31 cm (12.4”)
Bottom of differential	21 cm (8.25”)
Bottom of rear shock mount	22 cm (8.6”)
Bottom of tailpipe (lowest point)	31 cm (12.4”)
Spare tire mounted horizontally to undercarriage aft of rear axle	36 cm (14”) forward aspect of sidewall, 35 cm (13.75”) rear edge of sidewall

**Figure 4. Bumper and tailgate height of the GMC Sierra.**

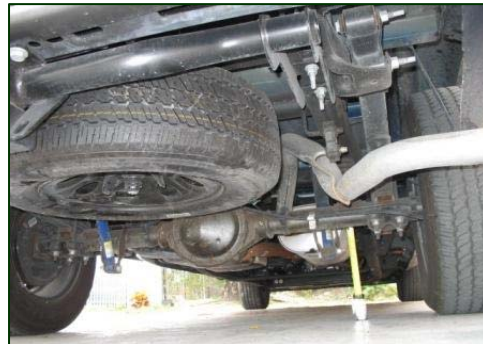
**Figure 5. Undercarriage components of the GMC.**

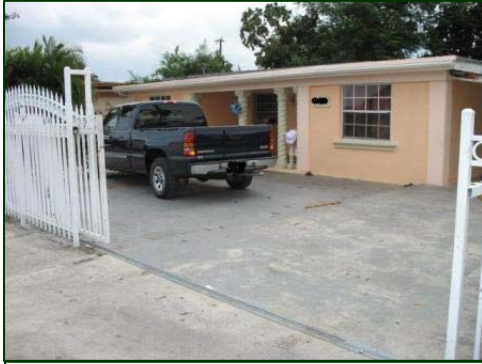
**Figure 6. Backing trajectory of the GMC pickup truck.**

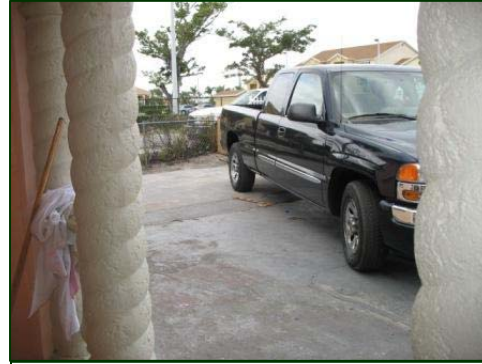
**Figure 7. Trajectory of the child non-motorist.**

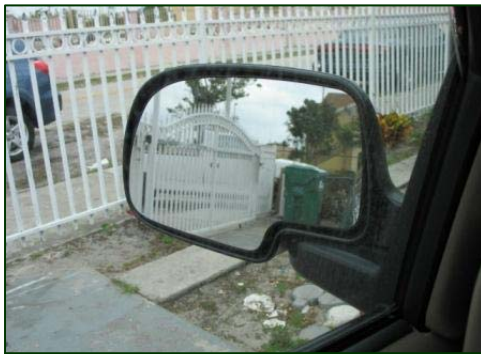
The left outside mirror was adjusted to provide the driver with a line of sight outboard of the bodyline of the vehicle (**Figure 8**). A child immediately adjacent to the left side of

the GMC would not have been visible in this mirror. The right outside mirror did not capture the rear bumper area of the vehicle, or the ground adjacent to the vehicle (**Figures 9 and 10**). The child positioned adjacent to the right rear bumper corner would have been difficult to detect though the use of the mirror.

**Figure 8. Driver's view from the left outside mirror.**

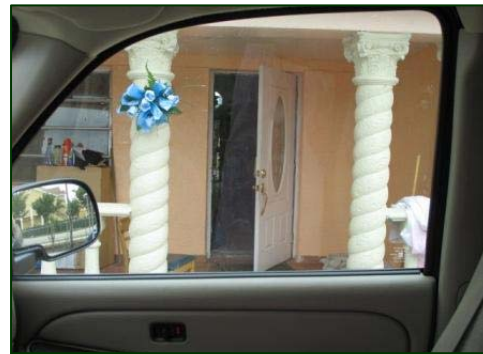
**Figure 9. Driver's view through the right outside mirror and of the front door area.**

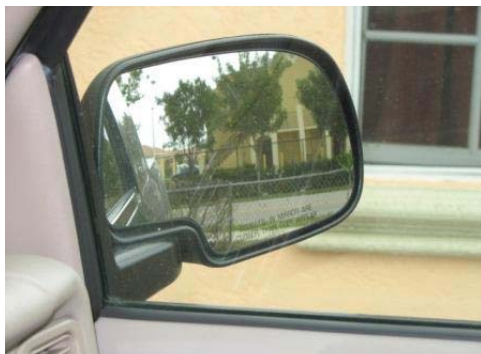
**Figure 10. Close-up view of the driver's line of site from the right outside mirror.**

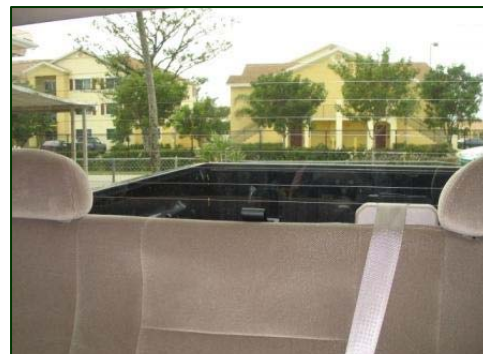
An 8 cm (3") diameter red reflector was placed in a stand and set to a height of 71 cm (28") to the bottom of the reflector. This was placed behind the truck and the driver was instructed to indicate when she could fully detect the reflector. The driver noted full visibility of the reflector through the interior mounted rear view mirror when set to a distance of 7.4 m (24.3') rearward of the vehicle's bumper. It should be noted that the extension of the driver's sight line to the ground was intersected by the 8 cm (3') welded wire fence that bordered the west property line. It was estimated that the driver could first view the ground approximately 18.2 m (60') rearward of the rear bumper. **Figure 11** is a rear view directly through the backlight of the vehicle. An exemplar vehicle was utilized to verify this estimate. Post-inspection measurements of an exemplar GMC Sierra determined the centerline rear visibility was 19.6 m (64.3'). **Figure 12** is a diagram depicting the centerline rear visibility of the subject vehicle.

**Figure 11. Rear view through the backlight of the GMC Sierra.**

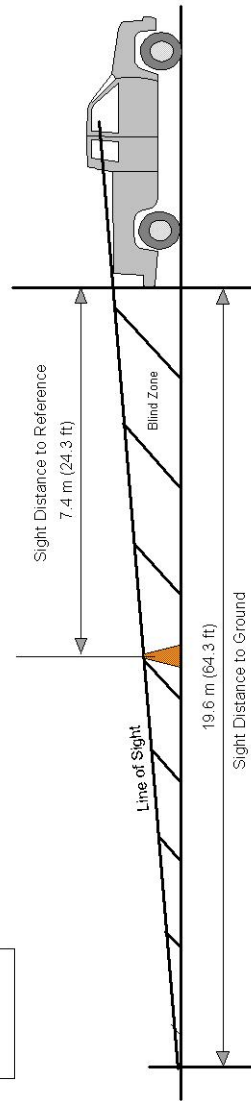
**Figure 12: Visibility Diagram**

Rear Visibility Diagram  
CA07-002  
2006 GMC Sierra  
Driver: 163 cm (64 in) tall  
Eye Height: 138cm (54.25 in) above ground
