ON-SITE NOT-IN-TRAFFIC SURVEILLANCE BACK OVER INVESTIGATION

CASE NUMBER - IN-07-003

LOCATION - NEBRASKA

VEHICLE - 1990 GEO STORM

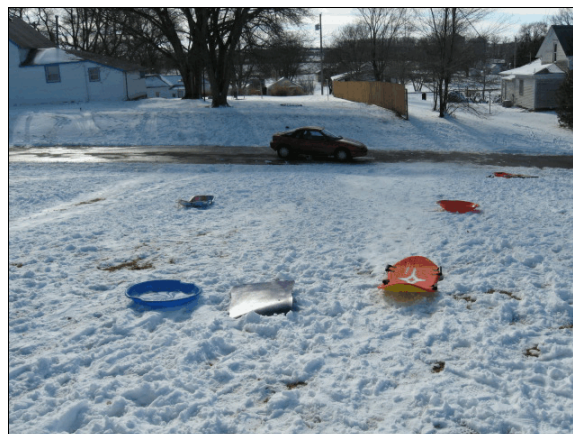
Figure 1: View south to roadway from top of hill showing position of Geo following removal of non-motorist

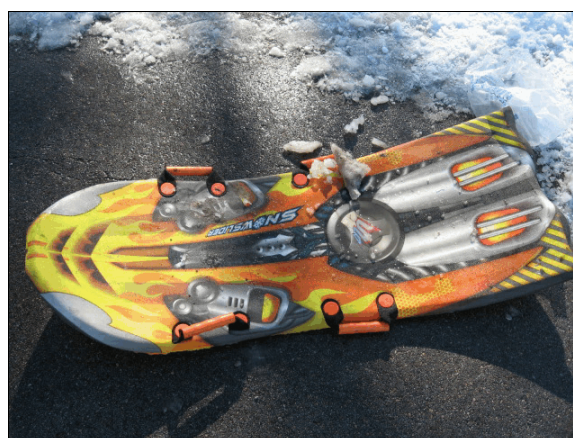
Figure 2: Non-motorist's sled

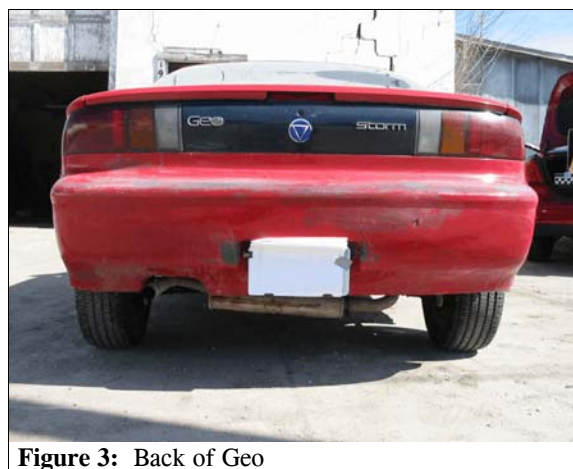
Figure 3: Back of Geo

There was no evidence of non-motorist contact to the Geo's back bumper. However, based on the witness testimony of the plane contacted, a partial Collision Deformation Classification was determined to be: **06-B9LU-1**. The Geo was driven from the scene.

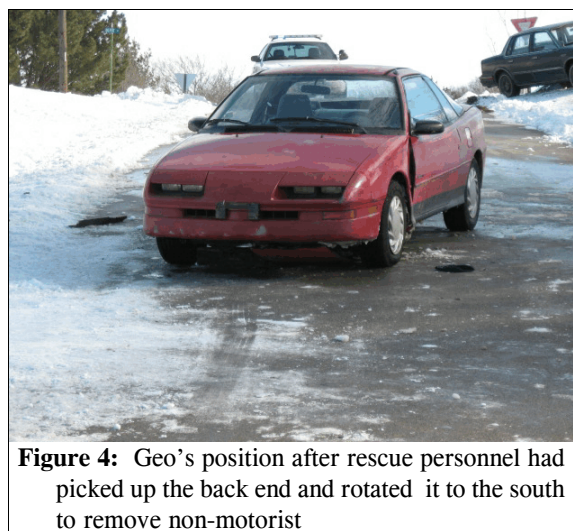
Figure 4: Geo's position after rescue personnel had picked up the back end and rotated it to the south to remove non-motorist

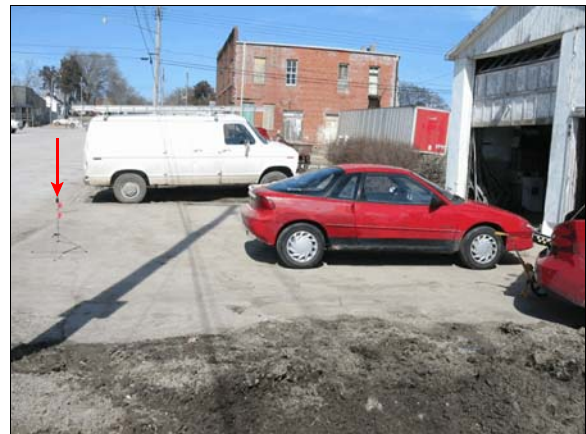
Figure 7: Right side view of Geo and location of target (arrow) where it first came into view with surrogate driver looking over right shoulder

approximately 2.6 meters (8.5 feet) before the top of the target began to come into the surrogate driver's view above the base of the backlight. The lateral extent of the blind zone behind and to the right rear side of the Geo as well as the "C"-pillar blind zone was also determined by moving the target laterally until it went out of view due to the "C"-pillar and then came back into view beyond the right side of the "C"-pillar as the surrogate driver looked through the right rear window. The target was also used to determine the field of view of the rearview mirror (**Figure 9**) and sideview mirrors. See the nominal visibility diagram at the end of this report, which documents all the visibility measurements.

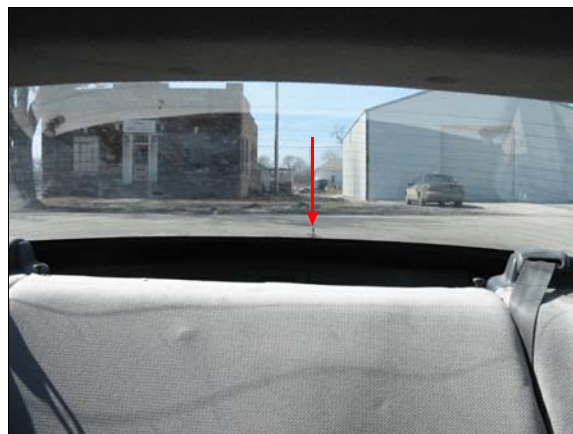
Figure 8: View out backlite from driver's seat, arrow shows top of target

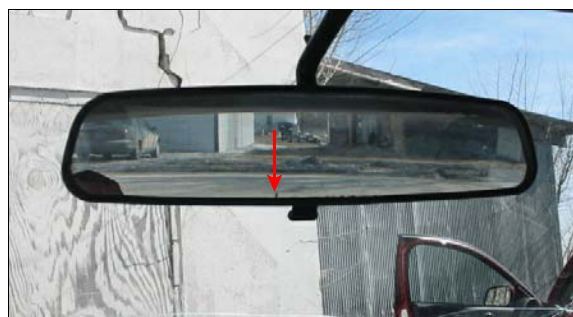
Figure 9: View through rearview mirror, arrow shows top of target

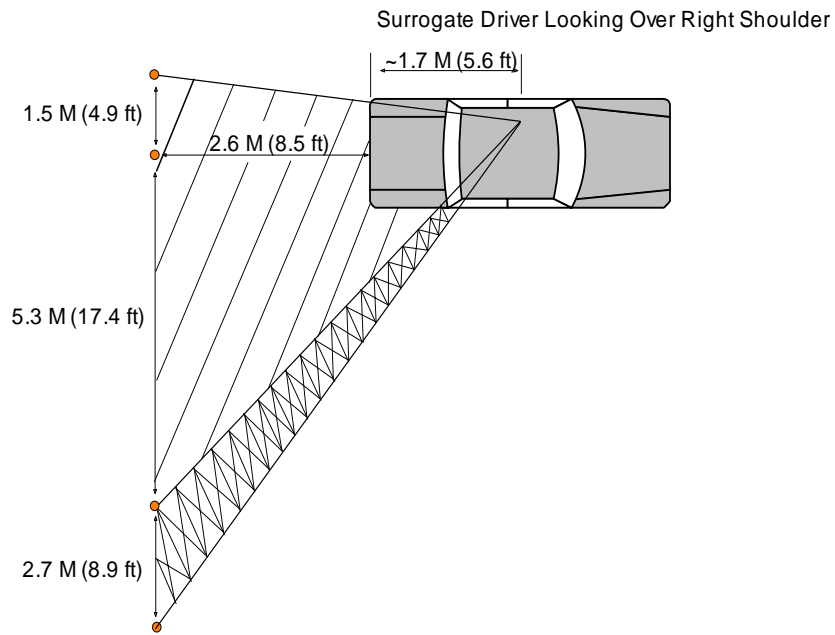
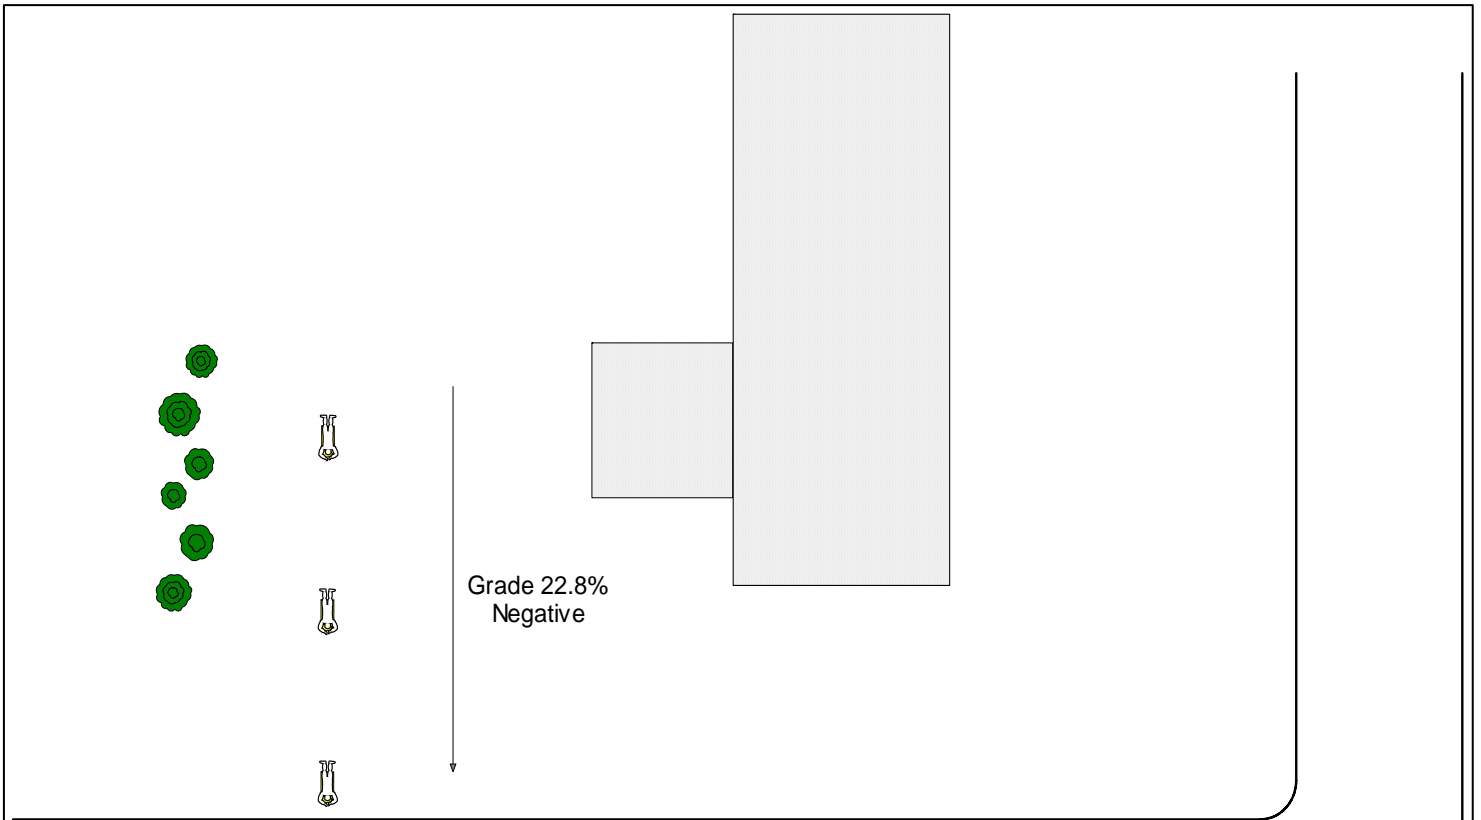
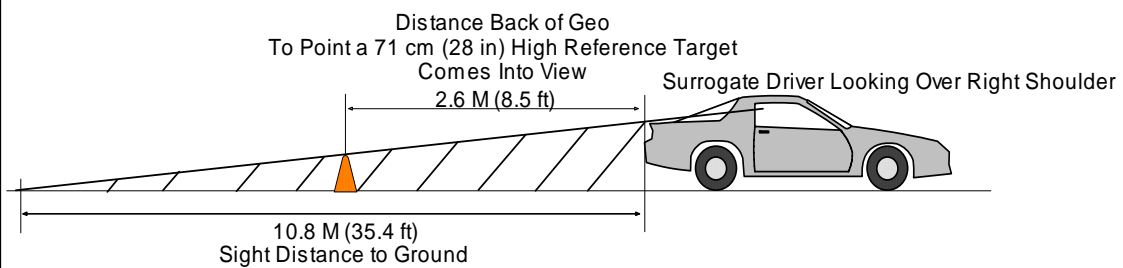
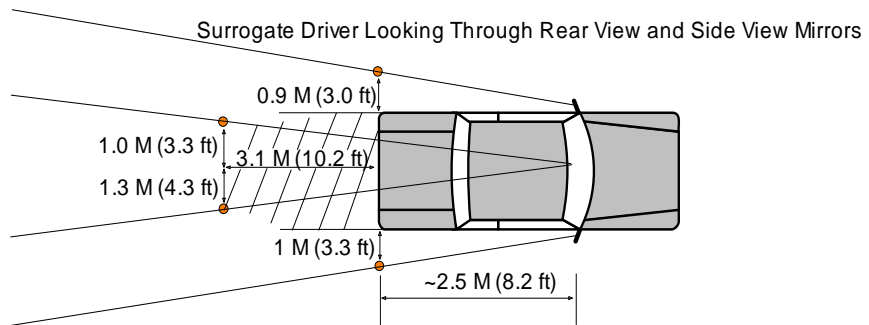
Nominal Visibility Diagram
 Case Vehicle = 1990 Geo Storm 2-Door Hatchback

= Blind Zone Behind and to Rear Passenger Side of Geo
-

= Case Vehicle C-Pillar Bind Zone
-

= Side View and Rear View Mirror Visibility Zone
