ON-SITE VEHICLE ROLLOVER INVESTIGATION

CASE NUMBER - IN-07-005
LOCATION - OKLAHOMA
VEHICLE - 2006 CHEVROLET C3500 CREW CAB PICKUP TRUCK
CRASH DATE - December 2006

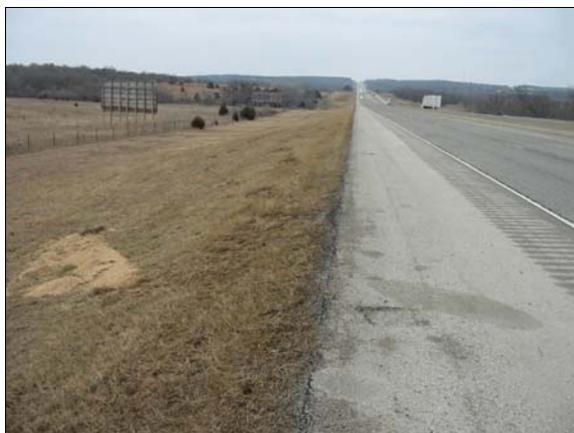
Pre-Crash: The Chevrolet was traveling west-southwest in the outside through lane (**Figure 1**) at a driver reported speed of 113 km.p.h. (70 m.p.h.). The driver intended to continue straight ahead. The driver stated during the interview that he fell asleep. The Chevrolet drifted to the right, departed the north roadside, crossed the shoulder and traveled onto the grassy roadside and down and across an embankment (**Figures 2 and 3**). The Chevrolet's driver steered left in an attempt to reenter the roadway. As a result, the Chevrolet began to rotate counterclockwise and the trailer began to jackknife. The Chevrolet's EDR data indicated that the driver was applying the brakes prior to the rollover. The rollover occurred on the grass embankment on the north side of the road as the Chevrolet was ascending the embankment while attempting to reenter the roadway (**Figure 4**).

Figure 1: View opposite approach of Chevrolet from the area of final rest

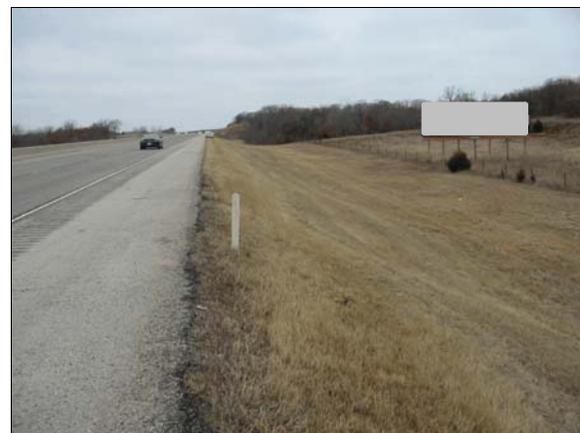
Figure 2: View of area where the Chevrolet departed the north shoulder

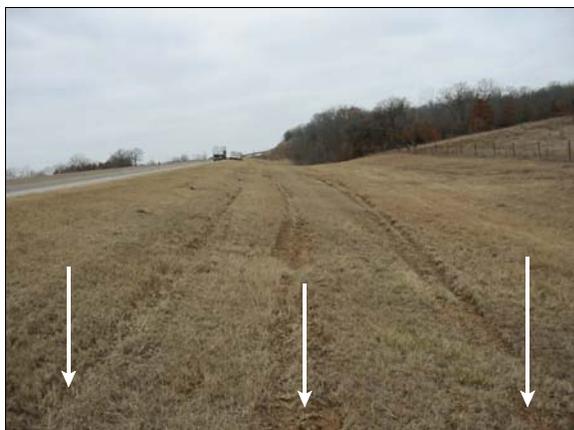
Figure 3: Chevrolet's tire marks (left and center arrows) and trailer tire marks (right arrow) in grass approaching rollover location

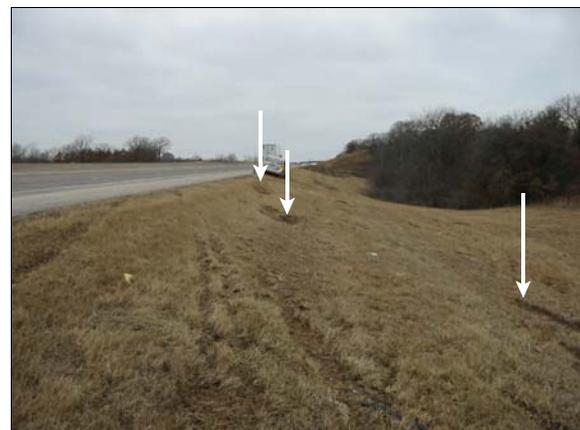
Figure 4: Chevrolet's approach to rollover, divots in ground (arrows) show contact of trailer during rollover

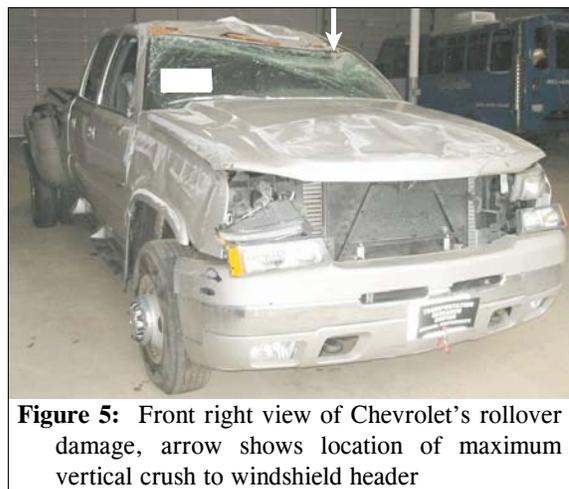
The Collision Deformation Classification (CDC) for the Chevrolet's rollover event was determined to be: **00-TYDO-3**. The maximum vertical crush occurred at the windshield header approximately 6 centimeters (2.4 inches) right of the right A-pillar. There was no measurable lateral crush to the roof structure. Rollovers are out-of-scope for the WinSMASH reconstruction program. However, based on the extent of the roof crush, the severity was determined to be moderate. The Chevrolet was towed due to damage.

Figure 5: Front right view of Chevrolet's rollover damage, arrow shows location of maximum vertical crush to windshield header

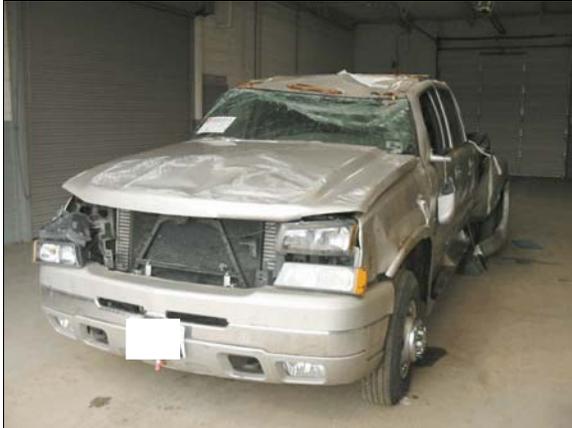
Figure 6: Front left view of Chevrolet's rollover damage

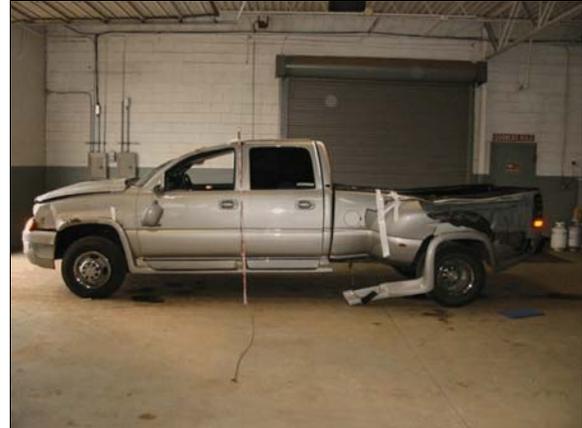
The direct contact damage involved the top and right side of the Chevrolet. Pavement grinding marks were observed on the hood, roof, right A-pillar and right fender. Dirt and damage folds were present on the left fender, and the left side view mirror was broken off the vehicle. This damage was most likely due to vehicle removal as the vehicle was rolled back over onto its wheels. The maximum vertical crush was located at the windshield header, approximately 6 centimeters (2.4 inches) right of the right A-pillar (**Figure 5** and **Figure 6** below), and measured 8 centimeters (3 inches) in depth. There was no lateral crush to the roof structure. Induced damaged involved the truck bed, which interacted with the trailer during the rollover (**Figures 7** and **8** below), and the roof. The Chevrolet's wheelbase was unchanged due to the crash.

Figure 7: Left side view of Chevrolet's rollover damage, damage to truck bed due to interaction with trailer during rollover

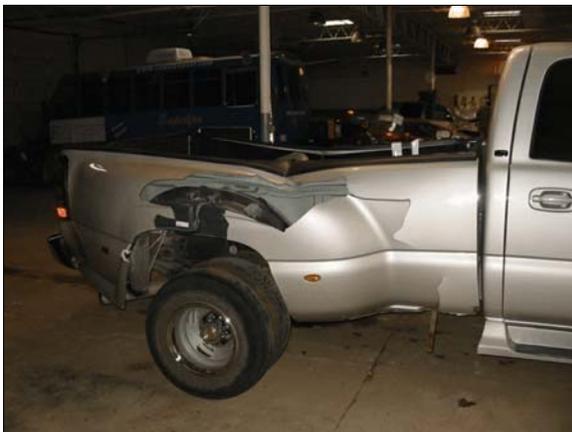
Figure 8: Damage to right side of truck bed due to interaction with the trailer during the rollover

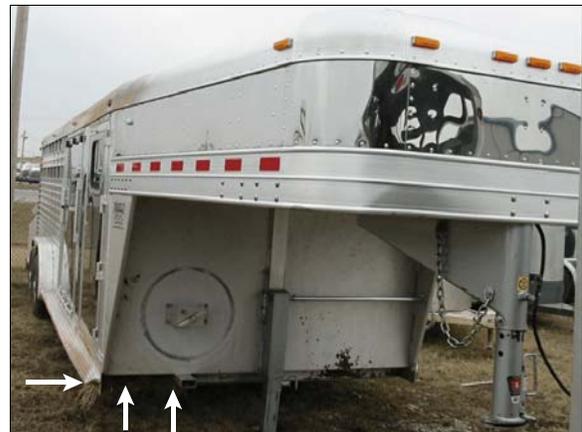
Figure 9: Front right view of trailer, arrows show grass jammed in running board and front frame

Damage to the trailer involved the right side and top. Grass was embedded in the right front running board and front frame rail (**Figure 9**), and the front left corner of the top was dented (**Figure 10**). In addition, there were dirt deposits across the top of the trailer.

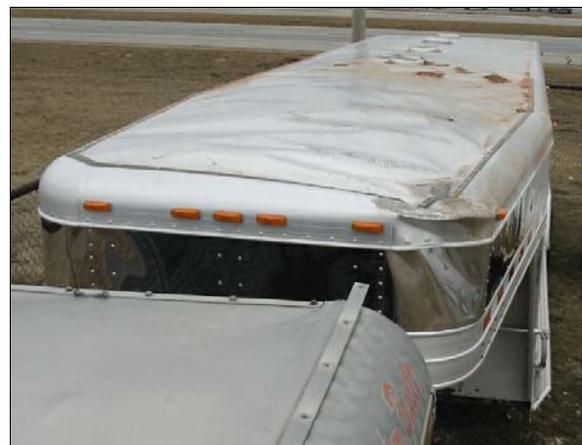
Figure 10: Rollover damage to top of trailer

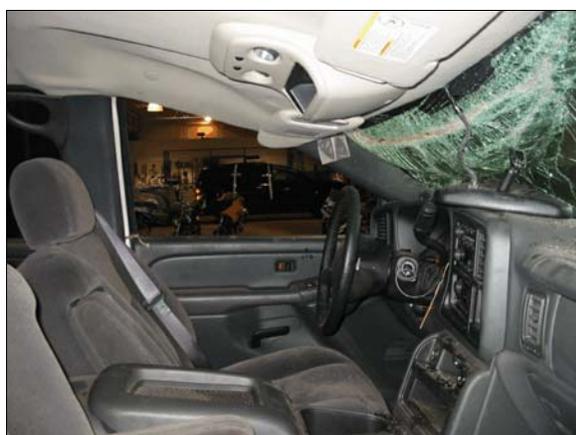
Vehicle Interior: The inspection of the Chevrolet’s interior (**Figures 11 and 12**) revealed a possible occupant contact on the right roof side rail just behind the right A-pillar. No other evidence of occupant contact was observed on any of the interior surfaces or components. The Chevrolet’s passenger compartment sustained several intrusions during the rollover. The three most severe intrusions involved the interior roof structure, which intruded vertically into the front left, middle and right seating positions. The intrusions from left to right were respectively: 16 centimeters (6.3 inches), 17 centimeters (7 inches) and 12 centimeters (4.7 inches). There was no evidence of compression of the energy absorbing steering column or deformation of the steering wheel rim.

Figure 11: View of Chevrolet driver’s seat position, roof intrusion and windshield header intrusion

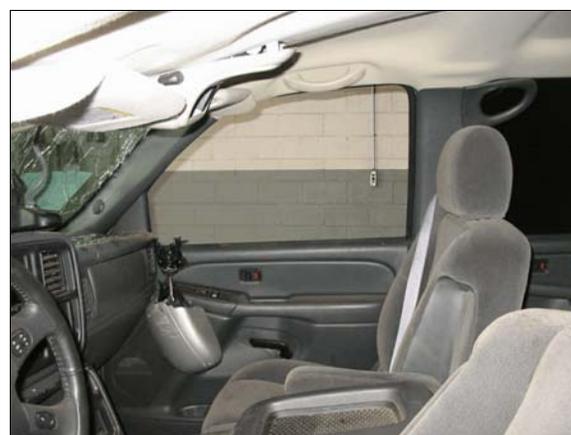
Figure 12: View of Chevrolet’s front right passenger seating area

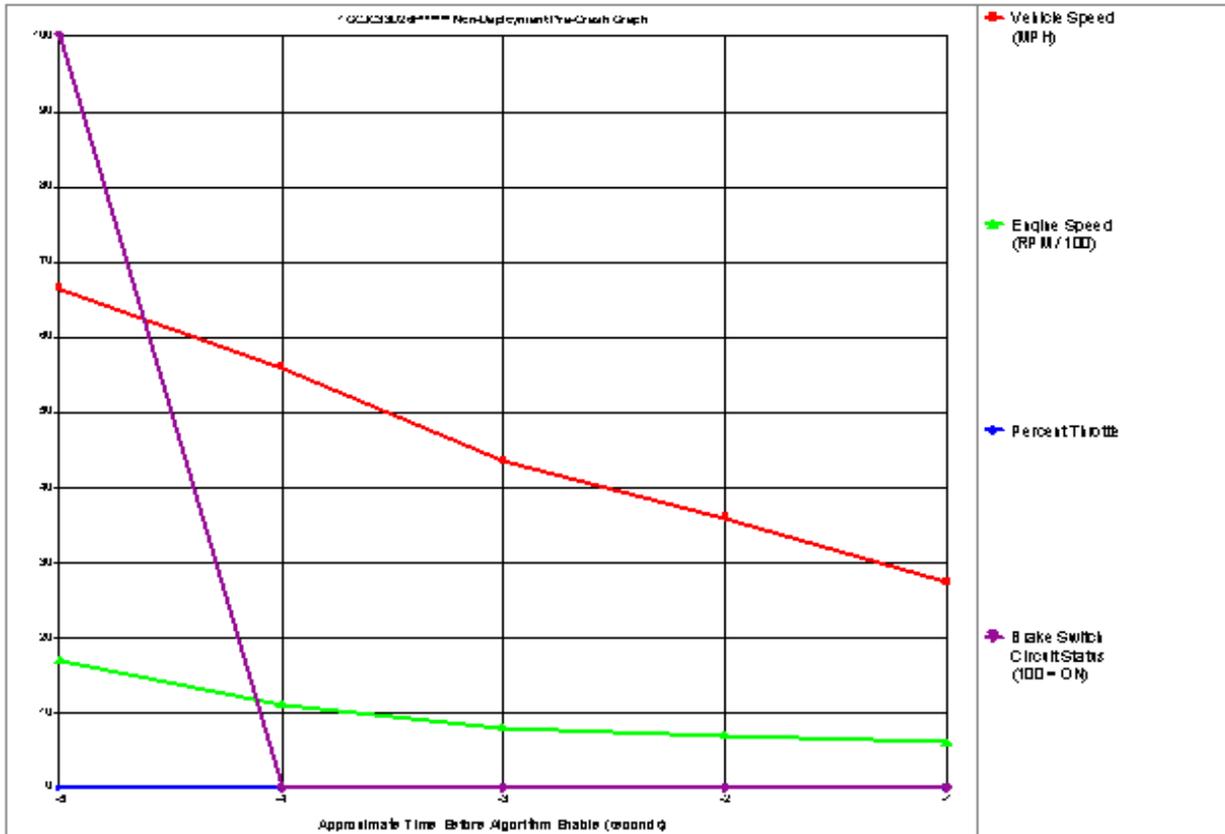
Chevrolet's System Status at Non-Deployment report and pre-crash data

SIR Warning Lamp Status	OFF
Driver's Belt Switch Circuit Status	BUCKLED
Ignition Cycles At Non-Deployment	1645
Ignition Cycles At Investigation	1650
Maximum SDM Recorded Velocity Change (MPH)	-3.51
Algorithm Enable to Maximum SDM Recorded Velocity Change (msec)	127.5
Crash Record Locked	No
Event Recording Complete	Yes
Multiple Events Associated With This Record	Yes
One Or More Associated Events Not Recorded	Yes

Seconds Before AE	Vehicle Speed (MPH)	Engine Speed (RPM)	Percent Throttle	Brake Switch Circuit Status
-5	67	1664	0	ON
-4	56	1088	0	OFF
-3	44	768	0	OFF
-2	36	704	0	OFF
-1	27	576	0	OFF

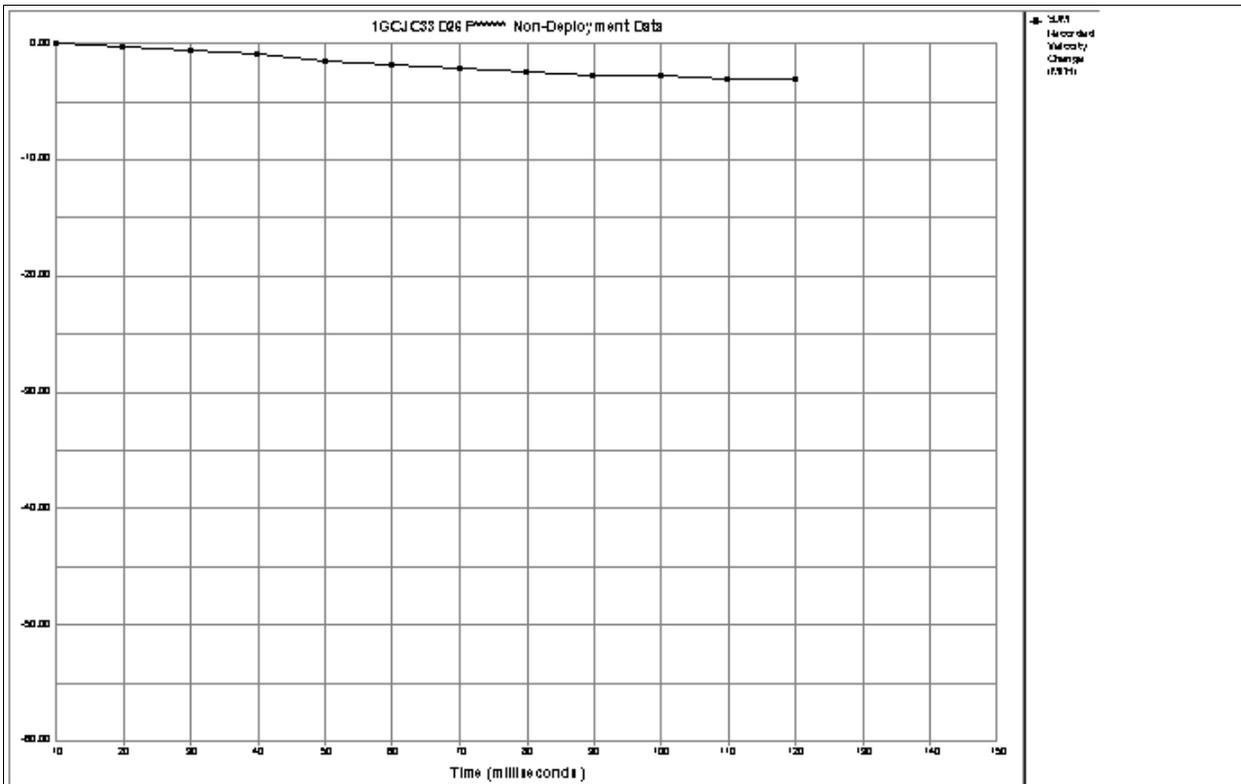
Chevrolet's Non-Deployment velocity change graph

Time (milliseconds)	10	20	30	40	50	60	70	80	90	100	110	120	130	140	150
Recorded Velocity Change (MPH)	0.00	-0.31	-0.62	-0.93	-1.55	-1.86	-2.17	-2.48	-2.79	-2.79	-3.10	-3.10	N/A	N/A	N/A
