**CALSPAN ON-SITE CHILD AIR BAG RELATED FATALITY
INVESTIGATION**

SCI CASE NO.: CA07-005

VEHICLE: 1998 PONTIAC TRANS SPORT MONTANA

CRASH DATE: SEPTEMBER 2006

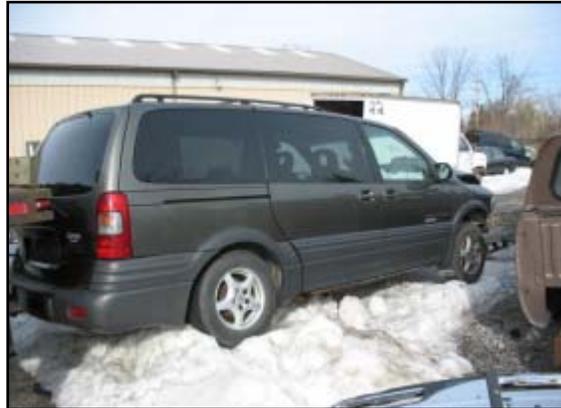
Figure 1. Subject vehicle 1998 Pontiac Trans Sport Montana.

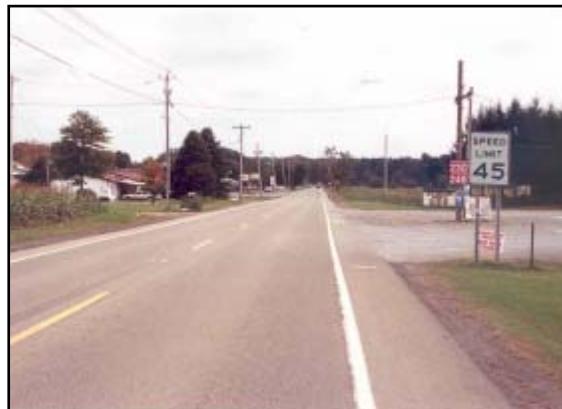
The driver of the Pontiac was unable to stop the vehicle as the front of the Pontiac impacted the rear of the Ford in the eastbound travel lane (**Figure 2**). The front-to-rear impact configuration was slightly off-set, right for the Pontiac and left for the Ford. Initial contact involved the front bumper of the Pontiac against the rear bumper of the Ford; however, as the bumpers crushed the front of the Pontiac underrode the rear of the Ford. This was apparent by the deformation to the Pontiac’s upper radiator support. The resultant directions of force were 12

Figure 2. Area of impact.

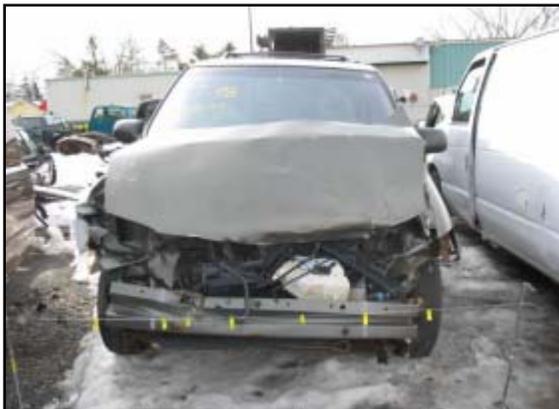
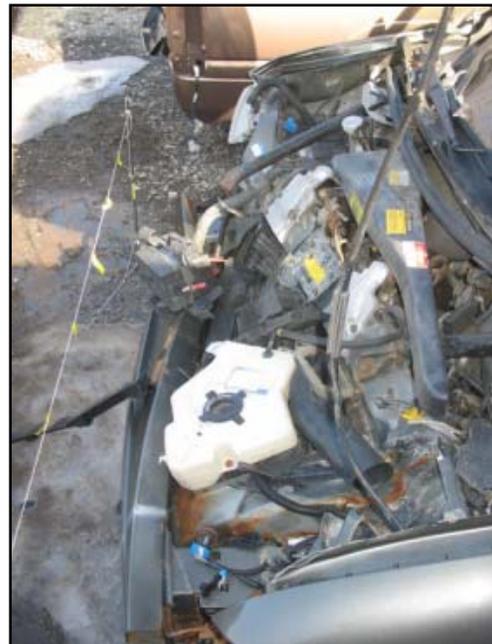
The 1998 Pontiac Trans Sport Montana sustained moderate severity frontal damage as result of the crash with the Ford (**Figures 3 and 4**). The impact damage included the bumper fascia which separated bumper beam, fenders, hood, and the upper radiator support. Within the engine compartment, damage was noted to the cooling system, main wire harness, and the fuse box. In addition to the damage, the wire harness and fuse box wires were cut by the fire department.

The front of the vehicle underrode the rear of the Ford; therefore, the direct contact damage and crush profiles were documented at the level of the bumper beam and the upper radiator support. The direct contact damage on the bumper fascia measured 122 cm (48") which began at the front left corner and extended to the right, terminating 31 cm (12") inboard of the right corner. The maximum crush at the bumper level was 38 cm

Figure 3. Frontal damage to the Pontiac.

Figure 4. Left lateral view of the crush to upper radiator support.

(15”) and was located 29 cm (11.5”) right of the centerline. The crush profile at the bumper beam was follows: C1 = 0 cm, C2 = 1 cm (0.4”), C3 = 4 cm (1.6”), C4 = 7 cm (2.8”), C5 = 7 cm (2.8”), C6 = 1 cm (0.4”).

At the upper radiator support, the direct contact damage measured 145 cm (57”) and began at the left end of the radiator support and extended onto the forward aspect of the right fender. The maximum crush at the upper radiator support was 40 cm (15.7”) and was located 27 cm (10.8”) inboard of the left end of the radiator support. The residual crush at the upper radiator support was follows: C1 = 19 cm (7.5”), C2 = 40 cm (15.7”), C3 = 31 cm (12.2”), C4 = 22 cm (8.7”), C5 = 13 cm (5.1”), C6 = 0 cm. The Collision Deformation Classification (CDC) for this impact 12-FDEW-3.

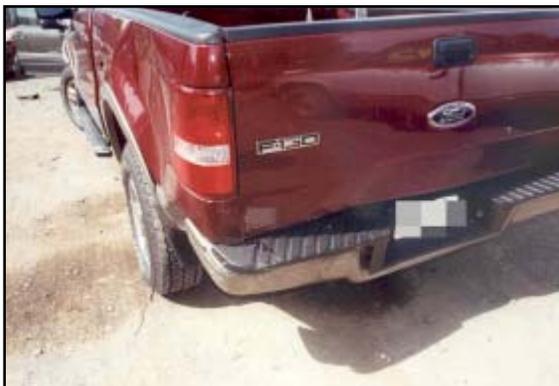
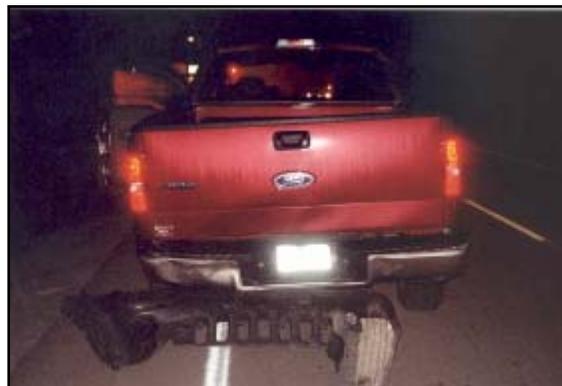
The 2005 Ford F-150 sustained moderate damage as result of the impact with the Pontiac (**Figures 5 and 6**). This vehicle was not inspected during this on-site investigation. The damage information was based on the police provided images of the Ford. Direct contact damage was apparent on the rear plane with induced deformation to the left side of the cargo box. In addition, there was cab-to-bed contact from the forward displaced cargo bed. The direct contact damage began at the rear left bumper corner and extended right approximately three-quarters of the bumper width. The maximum crush occurred at the rear left bumper corner and was approximately 10 cm (4”). The CDC for this impact was 06-BDEW-1.

Figure 5. Rear plane damage to the Ford.

Figure 6. On-scene image of the resultant damage to the Ford.

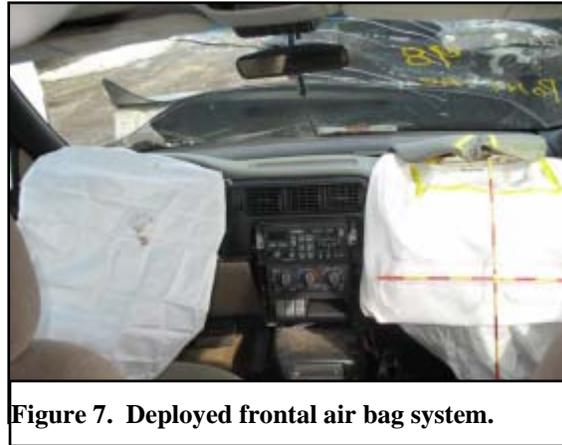
The Pontiac was equipped with redesigned frontal air bags for the driver and front right occupant positions. The history of the safety system was unknown. The system deployed as a result of the impact sequence with the Ford (**Figure 7**).

Figure 7. Deployed frontal air bag system.

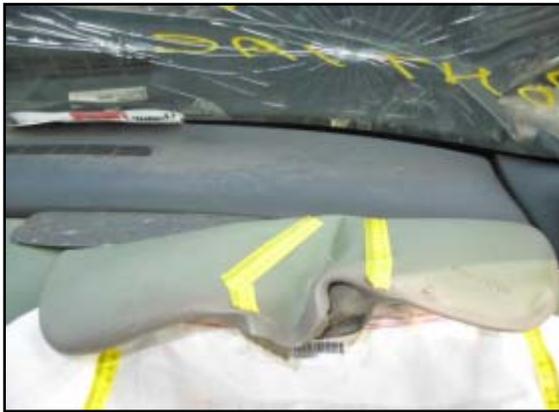
The front right passenger air bag was a top-mount design, incorporated into the right instrument panel. A single cover flap concealed the front air bag. The cover flap measured 36 cm (14") in width and 19 cm (7.5") in depth. The cover flap was constructed of a vinyl top with a steel backer panel. Prior to the impact, the driver applied a level of braking which resulted in the forward displacement of the front right passenger. At impact, the frontal air bag system deployed which resulted in interaction between the front right passenger and the deploying front right air bag. This interaction was evidenced by a tissue transfer on the cover flap and deformation of the vinyl top and steel backer panel (**Figure 8 and 9**). The transferred tissue measured 5 cm (2") in height and 0.3 cm (0.125") in width. The transfer was located right of the centerline from 5-10 cm (2-4") forward of the leading edge. The deformation of the vinyl top and steel backer panel was a V-shaped crease that was 6 cm (2.5") in width and extended from the leading edge to the rear edge. Additionally, the forward edge of the flap contained fragments of tissue. The cover flap rotated the child's head up and rearward as it continued to open, hyper-extending the child's neck.

Figure 8. Deformed front right air bag module cover flap.

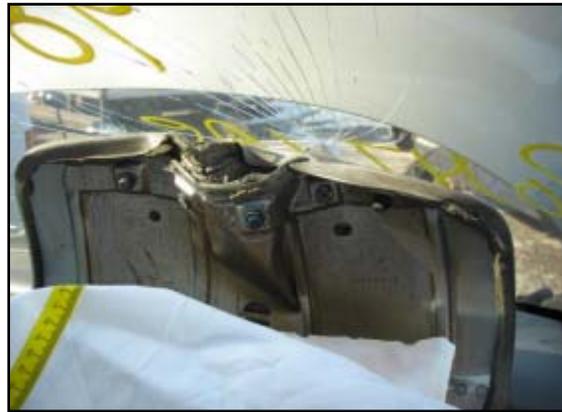
Figure 9. Steel backer panel deformation.

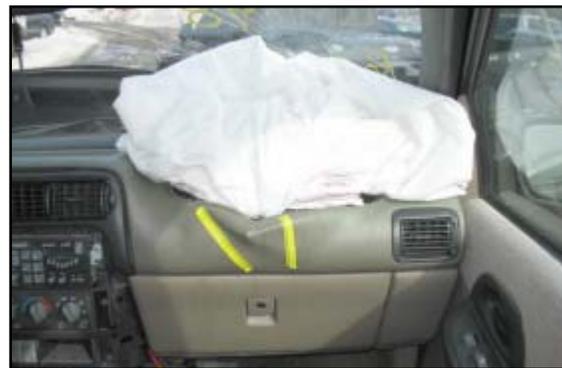
As a result of the forward position of the child against the cover flap, the deployment of the air bag was impeded. This impeded deployment was evidenced by rearward displacement (outward bowing) of the mid-instrument panel (**Figure 10**). The rearward deformation was 10 cm (3.75") at the greatest point and was located 32-43 cm (12.5-17")

Figure 10. Damage to the instrument panel from the impeded deployment.

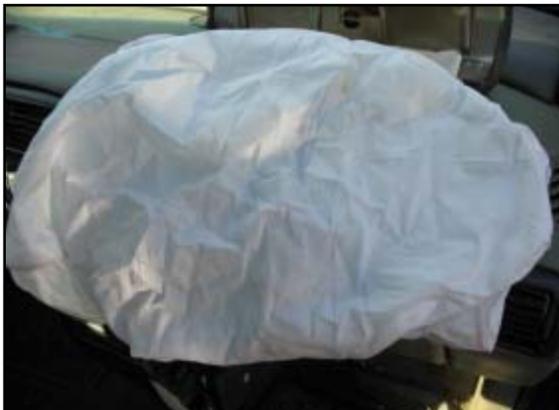
As the air bag continued to expand, the bottom and right side panels of the membrane contacted the child passenger. This contact was evidenced by blue fabric transfers on the air bag membrane. The blue fabric transfers on the bottom panel were numerous and vertically oriented (**Figure 11**). The total of area of the transfers measured 27 cm (10.5”) in width and 36 cm (14”) in height. A blue fabric transfer that was 4 cm (1.75”) in width and 25 cm (10”) in height was present on the right side panel (**Figure 12**).

Figure 11. Vertically oriented blue fabric transfers on the bottom panel.

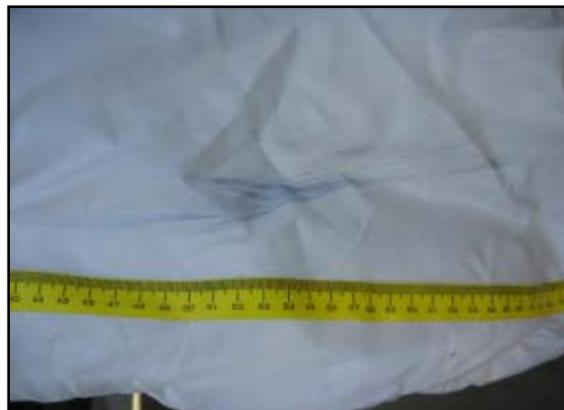
Figure 12. Blue fabric transfer on the right side pane.
