Rollover/Child Safety Seat Investigation / Vehicle To Object  
Dynamic Science, Inc. / Case Number: DS07007  
2004 Chevrolet Tahoe  
California  
January 2007

1. Report No. DS07007	2. Government Accession No.		3. Recipient Catalog No.	
4. Title and Subtitle Rollover/Child Safety Seat Investigation		5. Report Date February 22, 2008

**Dynamic Science, Inc.**  
**Crash Investigation**  
**Case Number: DS07007**

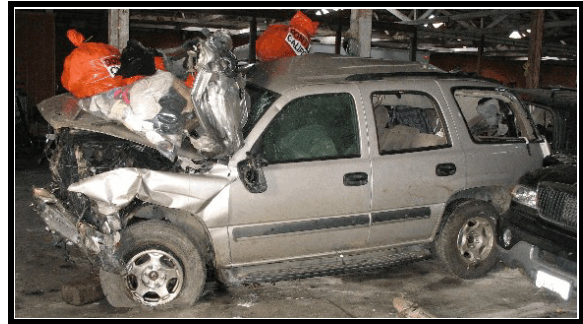
This on site investigation focused on three child safety seats that were installed in the rear seats of a 2004 Chevrolet Tahoe (**Figure 1**). The case vehicle was being driven by a 25-year-old female. There were a total of nine additional occupants in the vehicle. Seven of the vehicle's occupants were children, ranging in age from one to fifteen years old.

**Figure 1.** Case vehicle, 2004 Chevrolet Tahoe

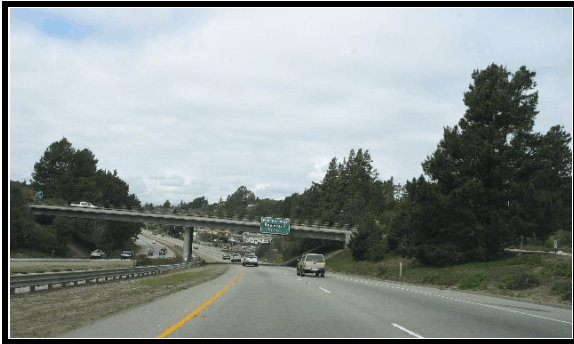
southbound roadways. The northbound roadway curved to the left and had negative grade (**Figure 2**). The speed limit was 105 km/h (65 mph).

**Figure 2.** Approach to area of road departure (north)

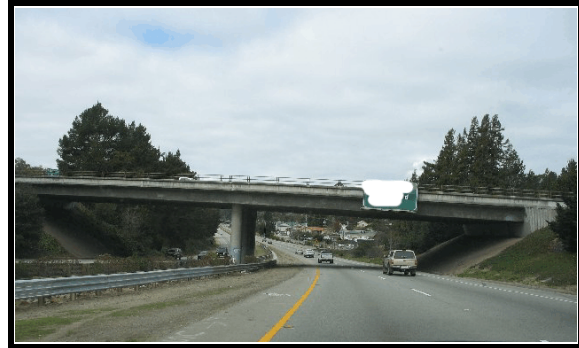
The Chevrolet Tahoe was traveling northbound on the state highway at an unknown speed. There were a total of 10 occupants in the vehicle. The vehicle was designed to accommodate nine passengers. An overview of seating positions, restraint usage, and injuries is shown in Table 1. The case vehicle was initially in the outboard lane. The driver lost control and the vehicle veered to the left (**Figure 3**).

**Figure 3.** Area of road departure and impact with center guardrail (north)

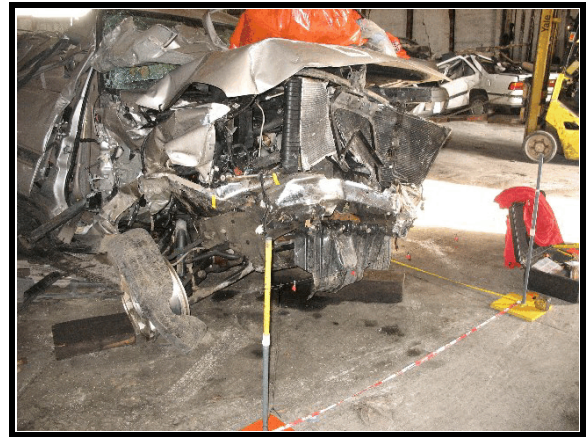
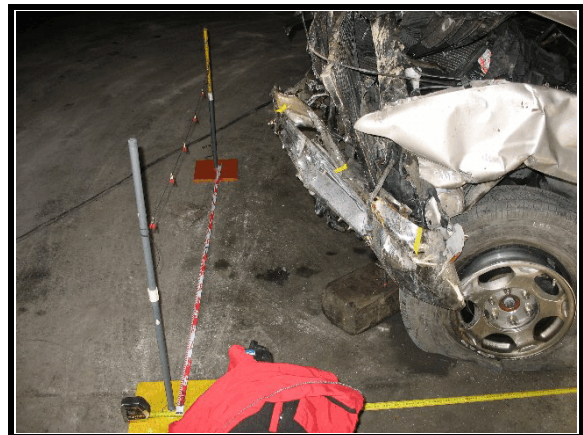
The 2004 Chevrolet Tahoe sustained severe front end damage as a result of the impact with the guardrail (**Figures 4-5**). The direct damage began at the left front bumper corner and extended 176 cm (68.9) laterally across the entire front end. The direct damage extended up to the hood and into the radiator area.

Six crush measurements were documented at the bumper level as follows: C1 = 36 cm (14.2 in), C2 = 29 cm (11.4 in), C3 = 15 cm (5.9 in), C4 = 32 cm (12.6 in), C5 = 36 cm (14.2 in), C6 = 36 cm (14.2 in).

The Collision Deformation Classification (CDC) for the impact with the guardrail was 01FDEW2.

**Figure 4.** Front right, 2004 Chevrolet Tahoe

**Figure 5.** Left side view showing depth of crush at bumper level

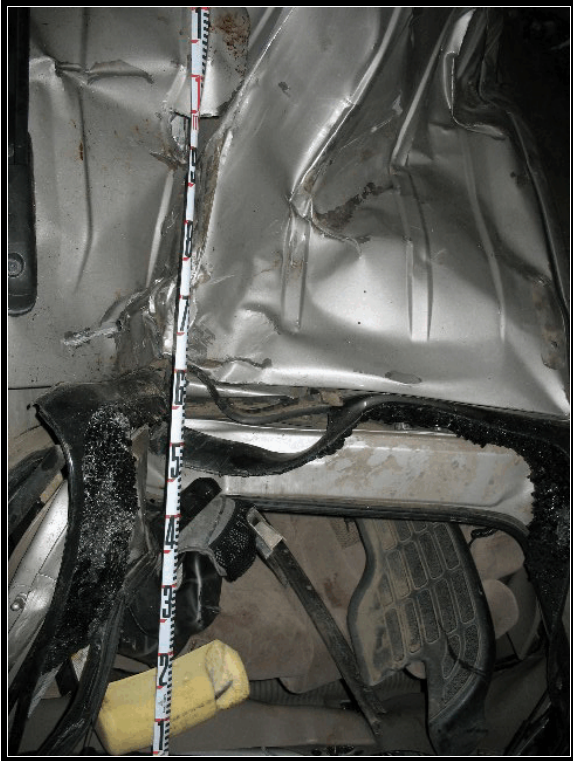
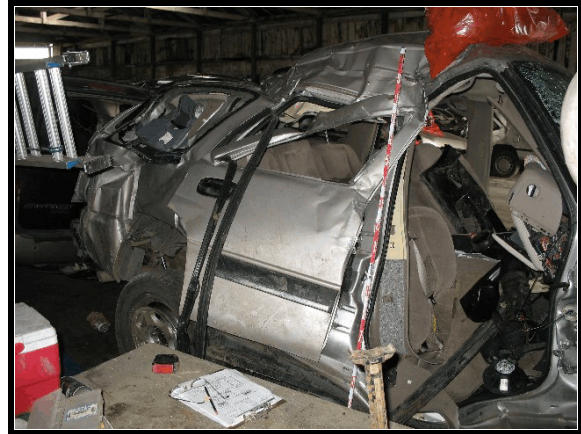
The Tahoe sustained severe roof damage as a result of the rollover (**Figures 6-7**). The direct damage began at the rear hatch. It was approximately 110 cm (43.3 in) wide and extended 102 cm (40.2 in) forward. The roof skin was torn in several locations and bloodstains were present. The maximum vertical crush was located on the roof between the C and D pillars and measured 41 cm (16.1). There was also vertical crush to the B-C-D pillars. There was lateral crush to the C-D pillars. The maximum lateral crush was at the D pillar and measured 36 cm (14.2). The CDC for the rollover was 00TDDO4. There was contact damage to the roof from the guardrail.

**Figure 6.** Top view of case vehicle (front of vehicle towards top of image)

**Figure 7.** Right side, Chevrolet Tahoe

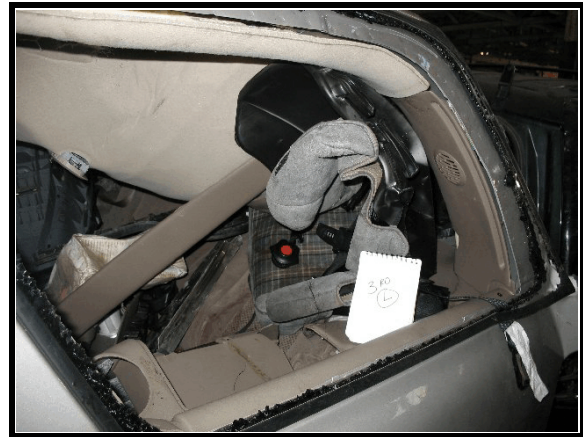
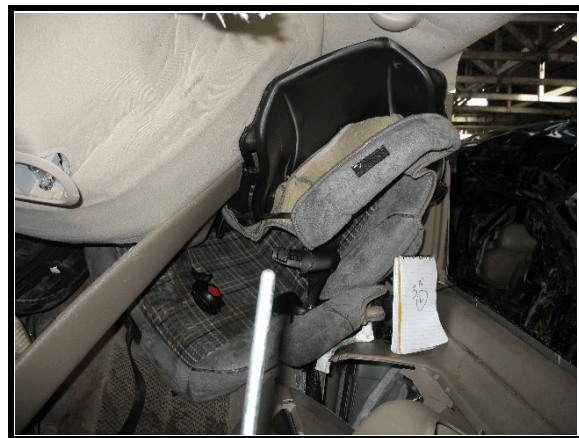
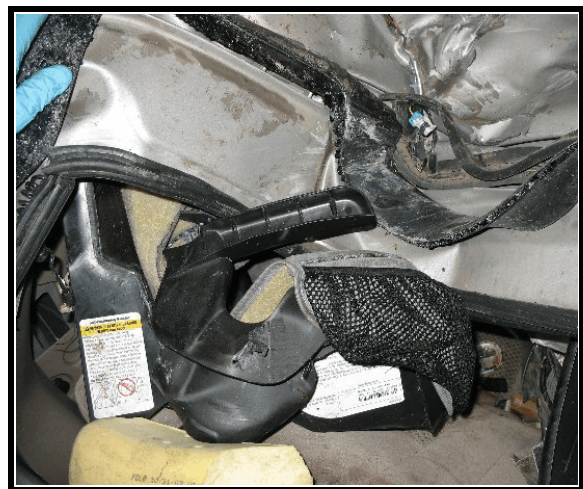
A Cosco/Dorel High Back Booster Seat was positioned in the third row left seat of the Chevrolet Tahoe (Figures 8-10). The model number was 22858 and the date of manufacture was January 17, 2006. The seat was configured with a five-point harness. The booster seat was rated for children who weigh between 10 and 36 kg (22-80 lbs) and whose height is between 74 and 132 cm (29 and 52 in). The 4-year-old child in this seating position was within the recommended height and weight limits for the child seat.

The booster seat was not secured to the vehicle and the child occupant was not wearing the safety harness. During the crash sequence, the seat pivoted within the confines of the passenger compartment. As the Tahoe landed on its roof, the booster seat became entrapped between the left side roof/roof rail and the plastic side panel. Efforts to remove the seat from the vehicle were unsuccessful. The seat was restricted within the vehicle and was totally immobile approximately 25 cm (10 in) above the vehicle seat bottom. The seat was rotated approximately 20 degrees in the clockwise direction. The plastic seat back was deformed forward, slightly downward and was twisted in a counterclockwise direction approximately 90 degrees. Long black hair transfers were found on the left arm rest of the CSS.

**Figure 8.** Booster seat as seen from outside left side of vehicle

**Figure 9.** Booster seat as seen looking toward the rear of the vehicle

**Figure 10.** Booster seat as view from the rear hatch window

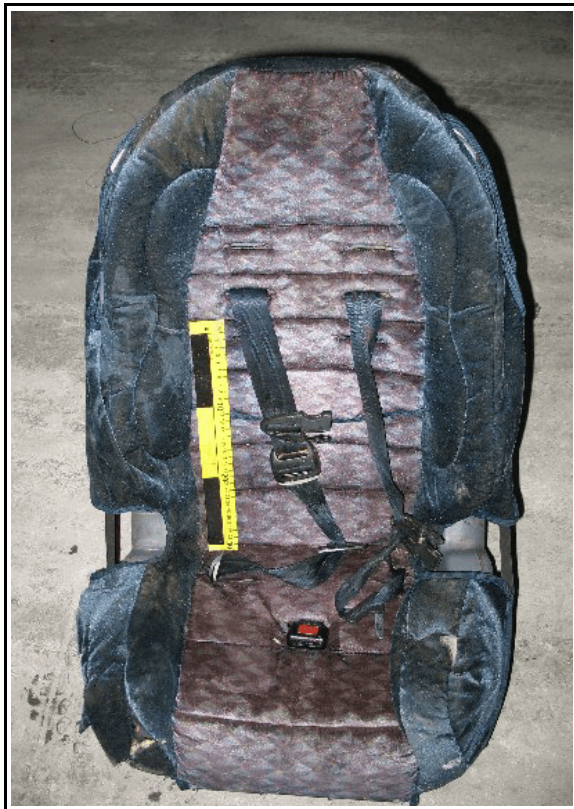
An Evenflo Express Booster seat was positioned in the third row right position of the Chevrolet Tahoe (**Figure 11**). The model number was 2481198 and the date of manufacture was May 8, 2002. The seat was configured with a five-point harness and a two piece, locking retainer clip.

**Figure 11.** Evenflo booster seat

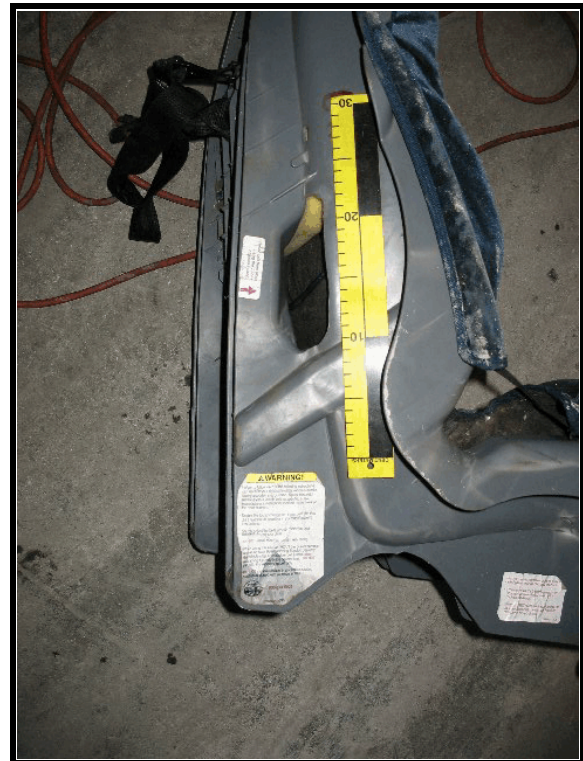
**Figure 12.** Load marks to booster seat anchor point on right

At the time of the inspection, the harness straps were routed through the middle set of harness slots. The harness retainer clip was positioned 20.0 cm (7.9 in) below the harness slot. The seat was generally old and the fabric was worn in several places. There were light fluid stains on the right side of the seat back and dark stains on the right towards the top of the seat back. The booster seat was installed forward facing using the vehicle lap and shoulder belt. The lap and shoulder belt was routed through the proper slot. There were indications of loading to the booster seat and the seat belt slot locations (**Figure 12**).

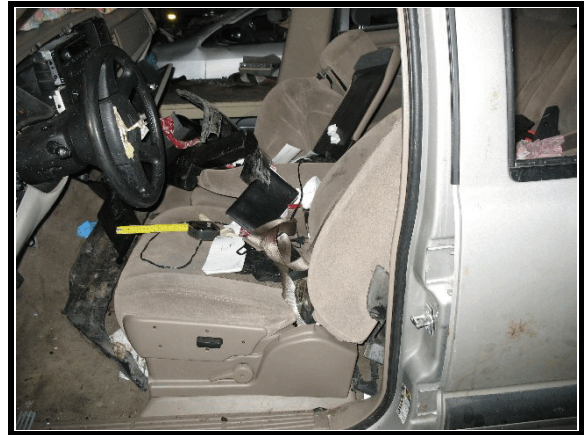
The 24-year-old female driver was seated in an upright posture and was restrained by the 3-point lap and shoulder belt (**Figure 13**). The seat track was positioned to the mid track position. Prior to impact, the driver had lost control of the vehicle and it was beginning a counterclockwise rotation. The driver was likely steering back to the right to regain control of the vehicle. Roadway evidence suggested that the driver was braking. At impact with the guardrail, the frontal air bag deployed and the belt pretensioner actuated. The driver initiated a forward and slightly right trajectory in response to the 1 o'clock direction of force. She loaded the safety belt and contacted the deployed air bag. As the vehicle began to overturn to the right, she was displaced sharply in that direction, but did remain in her seat position. The vehicle overturned three quarter turns and came to rest on the driver's side. The driver was found in her original seating position after the crash. She was reportedly holding one of the other occupants in her arms when found.

**Figure 13.** Driver's seated position

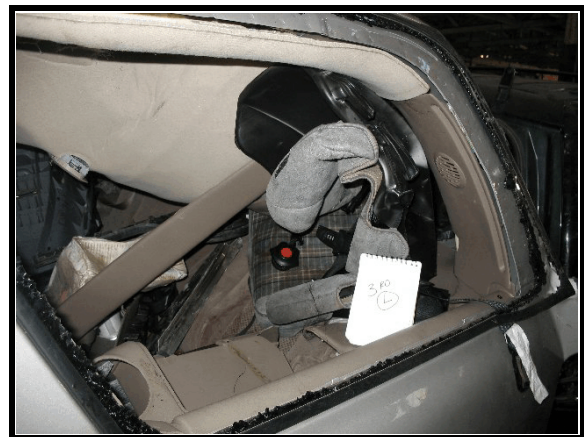
The 4-year-old female child was seated in a Cosco/Dorel High Back Booster seat (**Figure 14**). The seat was not secured to the vehicle and the child was not using the seat's internal harness. At impact, she initiated a forward and slightly right trajectory and likely came into contact with the second row seat back. During the rollover sequence, the CSS pivoted within the passenger compartment. As the Tahoe landed on its roof, the booster seat became entrapped between the left side roof/roof siderail and the plastic side panel. The seat was being held in place and was totally immobile above the vehicle seat bottom. The seat was rotated approximately 20 degrees in the clockwise direction. The plastic seat back was deformed forward, slightly downward and was

**Figure 14.** Booster seat as seen from outside left side of vehicle

twisted in a counterclockwise direction approximate 90 degrees. According to one investigating officer, the child was partially ejected from the vehicle. Her head and torso were completely outside of the vehicle and she was being held in place a component in the vehicle that was trapping her leg or foot. She sustained a visible head injury and was fatally injured.
