ON-SITE CHILD SAFETY SEAT INVESTIGATION

CASE NUMBER - IN07007

VEHICLE - 2006 LINCOLN TOWN CAR

CRASH DATE - December 2006

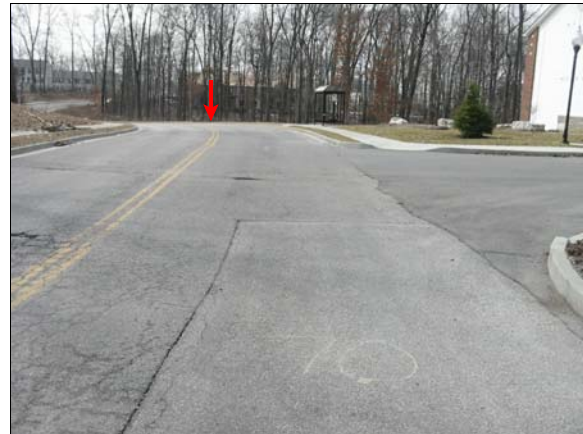
Pre-Crash: The Lincoln was traveling south in the southbound lane in a left curve (**Figure 1** below). The driver was intending to continue through the left curve. The front right passenger (9-year-old, female) stated to the investigating police officer that the driver fell asleep just prior to the crash. As a result, the vehicle departed the right side of the roadway (**Figure 2**) where the crash occurred. The vehicle's driver took no actions to avoid the crash. The police reported toxicology results indicated that the driver tested positive for marijuana. In addition, the driver stated to the investigating police officer that she had taken Ambien (sleeping aid) at 4:00 a.m and Lortab (pain reliever) at an unspecified time the morning of the crash.

Figure 1: Approach of Lincoln southbound to road departure (arrow), number on pavement indicates meters to fire hydrant impact

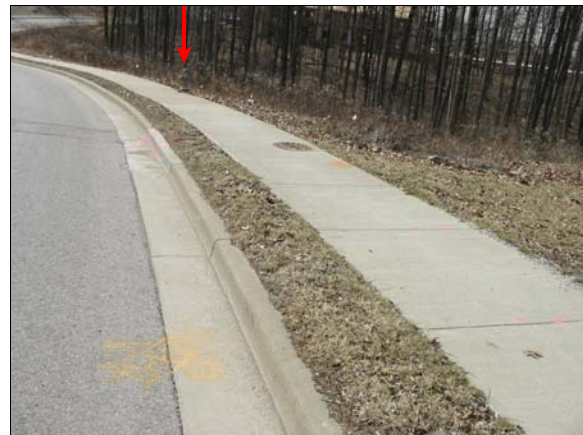
Figure 2: Area of Lincoln roadway departure, arrow shows impacted fire hydrant (repaired)

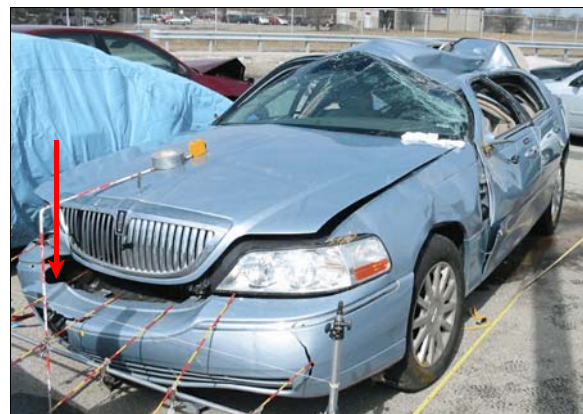
Figure 3: Overview of damage to front of Lincoln from fire hydrant impact (arrow) and rollover damage to roof

Exterior Damage: The Lincoln's initial impacts to the curb involved the right front and right rear wheels (events 1 and 2). The impacts de-beaded both tires and slightly dented the right rear rim. The vehicle's impact to the fire hydrant (event 3) involved the right portion of the front bumper. The front bumper fascia, energy absorbing plastic and grille were broken; the right headlamp/turn signal assembly was displaced and missing, and the underlying bumper bar was crushed. The direct damage began 23 centimeters (9.1 inches) left of the right front bumper corner and extended

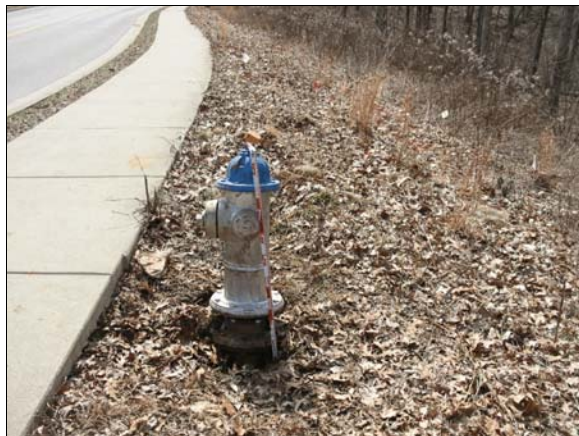
Figure 4: Location of impacted fire hydrant (repaired)

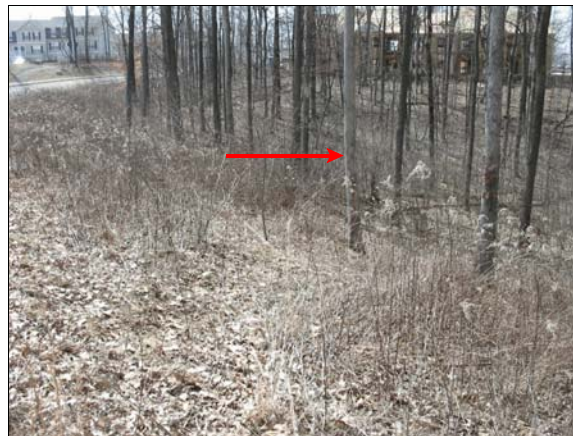
Crash: As the Lincoln departed the right side of the roadway, the vehicle's front right wheel impacted the curb (event 1) and deflated, followed by the right rear wheel, which also deflated due to the curb impact (event 2). The vehicle crossed a sidewalk and the front (**Figure 3**) impacted a fire hydrant (event 3, **Figure 4**), which was located 3.4 meters (11.2 feet) west of the roadway. At this point, the roadside began to slope downward (38% negative grade, **Figure 5**) and the vehicle began to roll onto its right side (event 4). The vehicle rolled five quarter turns down the embankment traversing a distance of approximately 18 meters (59 feet) at which point the top (**Figure 6**) impacted a medium sized tree (event 5, **Figure 5**) located 12.7 meters (41.7 feet) west of the roadway. The vehicle then rotated clockwise off the tree and rolled back to its left and onto its wheels. The total rollover distance was approximately 21 meters (68.9 feet).

Figure 5: Lincoln rolled down embankment, impacted tree indicated by arrow, and came to final rest on its wheels on left side of tree

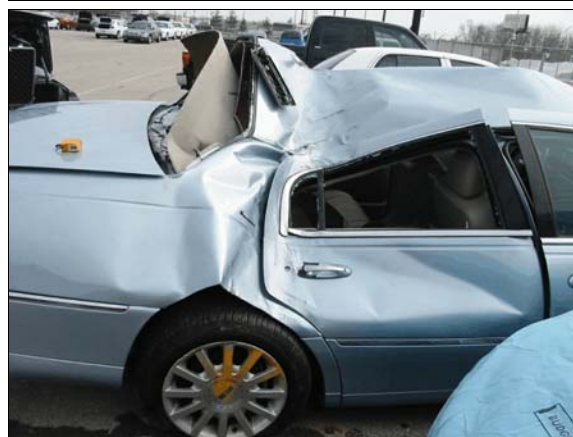
Figure 6: Damage to roof and right rear door due to impact with tree during rollover

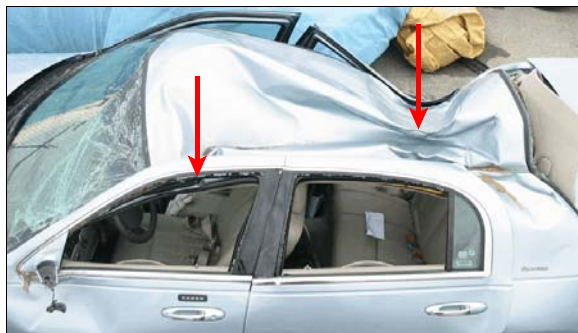
The rollover damage involved both sides and the top (event 4). The impact with the tree (event 5), which occurred during the rollover, involved the top, right roof side rail, right rear door and the right quarter panel. The crush pocket caused by the tree impact was angled approximately 45 degrees to the left of the Lincoln's vertical axis. The maximum vertical and lateral crush (Figures 7, 8 and 9) to the top plane due to the rollover were 36 centimeters (14.2 inches) and 34 centimeters (13.4 inches), respectively. The maximum crush to the top plane from the tree impact was 33 centimeters (13 inches) and occurred near the back corner of the right rear door (Figures 7 and 9).

Figure 7: Left arrow shows location of maximum vertical and lateral crush due to the rollover; right arrow shows roof crush due to tree impact that occurred during rollover

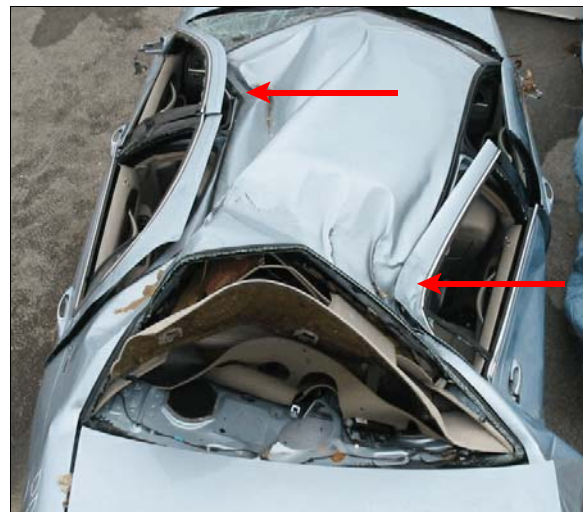
Figure 9: Left arrow shows location of maximum lateral crush to the roof due to rollover; right arrow shows crush from tree impact that occurred during rollover

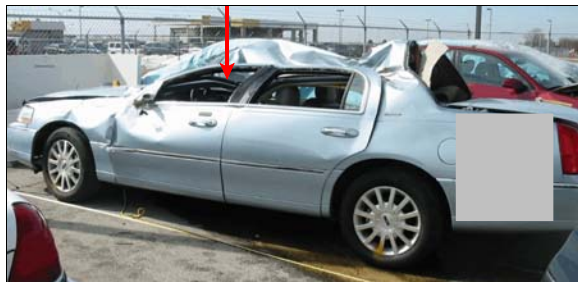
Figure 8: Left rear view of left roof side rail crush (arrow)

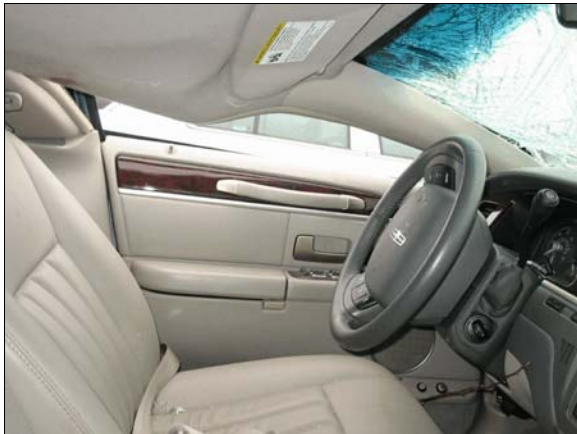
Vehicle Interior: Inspection of the vehicle's interior (**Figures 10-13**) revealed hair transfers on the roof over the driver's seat and scuffs in the nap of the roof over the back right seat position. Possible occupant contact scuffs were also observed on the back left arm rest. No other evidence of occupant contact was observed. Inspection of the safety belt assemblies revealed that the driver's safety belt and the back right passenger's safety belt had been cut by rescue personnel. The passenger compartment sustained severe intrusions due to the rollover and subsequent impact with a tree during the rollover. Intruding components included the roof, roof side rail and all the pillars. The most severe intrusion involved the roof structure at the back right seat position, which intruded approximately 37 centimeters (14.6 inches). There was no evidence of deformation to the steering wheel or compression of the energy absorbing steering column.

Figure 10: Overview of Lincoln driver's seat position and roof intrusion

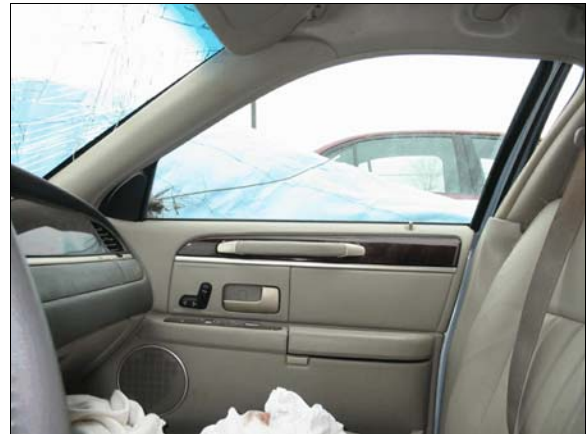
Figure 11: Overview of Lincoln's front right seat position

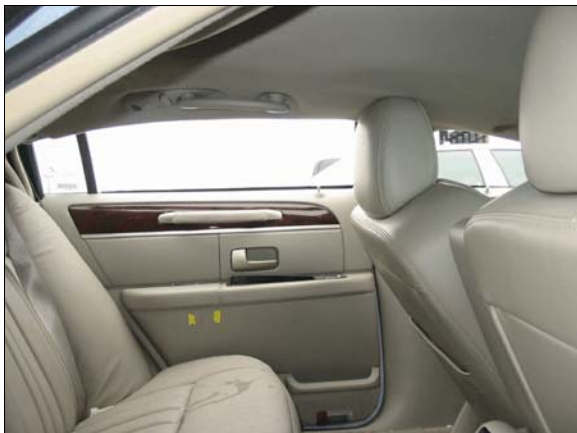
Figure 12: Overview of Lincoln's back left seat position and roof intrusion

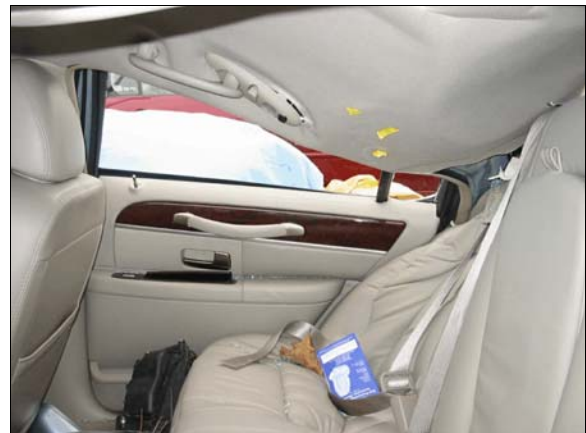
Figure 13: Overview of Lincoln's back right seat position and roof intrusion

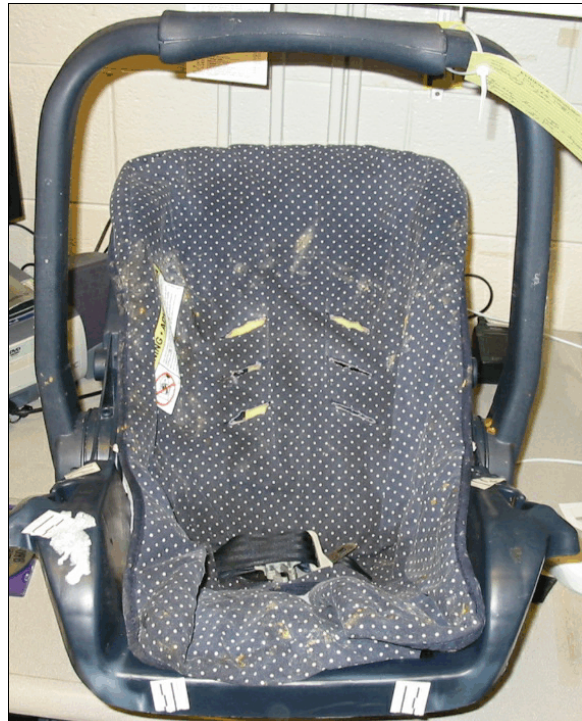
Figure 14: Front view of Lincoln's back center infant seat

Inspection of the infant seat revealed a few stress marks on the plastic shell. There was no other evidence of crash related damage to the infant seat. The inspection also revealed that the shoulder harness straps had been routed through the same slots in the cloth pad as the upper thigh straps (**Figure 15**). In addition, the harness retainer clip was positioned just above the latch plates (**Figure 15**). The improper routing of the harness straps was also reported on the supplement to the police crash report.

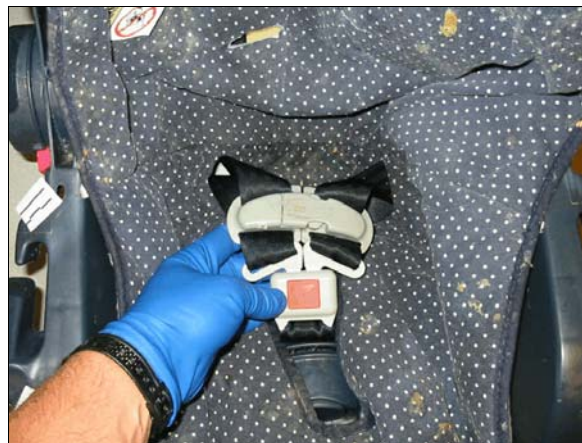
Figure 15: Shoulder harness straps routed through same slots in padded cover as lap belt straps, harness retainer clip positioned just above latch plates.

Based on an interview with the investigating police officer and the supplement to the police crash report, the back center passenger was not restrained in the infant seat. The child had been placed in the infant seat and was not restrained by the available five-point harness. Inspection of the infant seat revealed that the harness straps were routed through the top slot in the back of the infant seat. However, when the harness straps were routed through the padded infant seat cover, they were routed through the same slots as the upper thigh belt. In addition, the harness retainer clip was positioned just above the latch plates. The infant seat had been secured in the vehicle with the lap-and-shoulder belt. The driver indicated she had buckled the belt around the seat. The belt was equipped with a light weight locking latch plate.

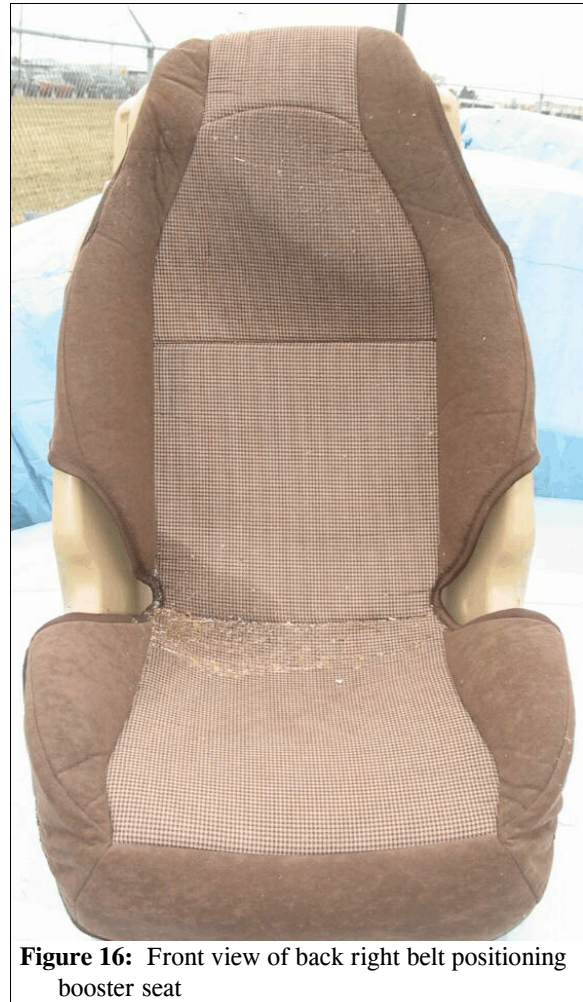
Figure 16: Front view of back right belt positioning booster seat

Inspection of the child safety seat revealed some scuffs on the top of the seat back. The plastic on the top left side of the shell also showed signs of stress. It appeared that this damage may have been due to contact with the intruding back right roof structure (**Figure 13**), which occurred during the roof impact to a tree as the vehicle rolled over. In addition, several areas of scuffing were observed at the right front corner of the seat cushion. Otherwise, the child safety seat was intact and unremarkable.

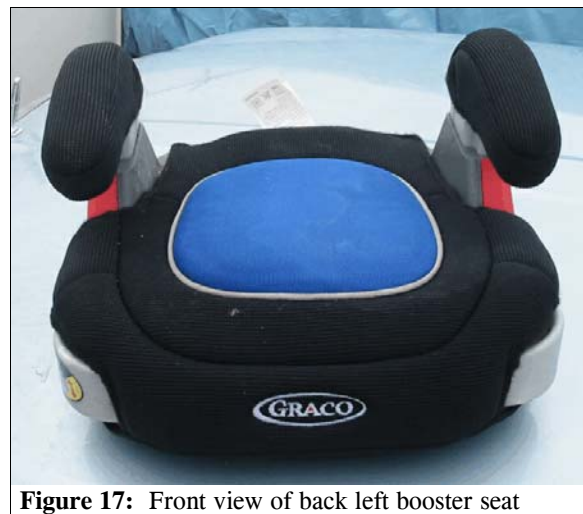
Figure 17: Front view of back left booster seat

The back left passenger (6-year-old, male) was seated in a Graco TurboBooster booster seat (**Figure 17**). The booster seat was manufactured by Graco Children's Products on April 4, 2005. The model number was 8491RGB and the serial number was JJ0414050806376. The booster seat was constructed of a one-piece plastic shell with padded arm rests and a padded seat cushion. There were brackets on the back of the seat to accommodate installation of a back support. The booster seat was being used without the back support. The manufacturer's information label indicated that the booster seat should be used with the back support installed for children who were 3-10 years of age, weighed 13.6 to 45.4 kilograms (30 to 100 pounds) and were 96.5 to 144.8 centimeters (38 to 57 inches) tall. The booster seat could be used without the back support installed for children who were 4-10 years of age, weighed 18.1 to 45.4 kilograms (40 to 100 pounds) and were 101.6 to 144.8 centimeters (40 to 57 inches) tall. Inspection of the booster seat was unremarkable.

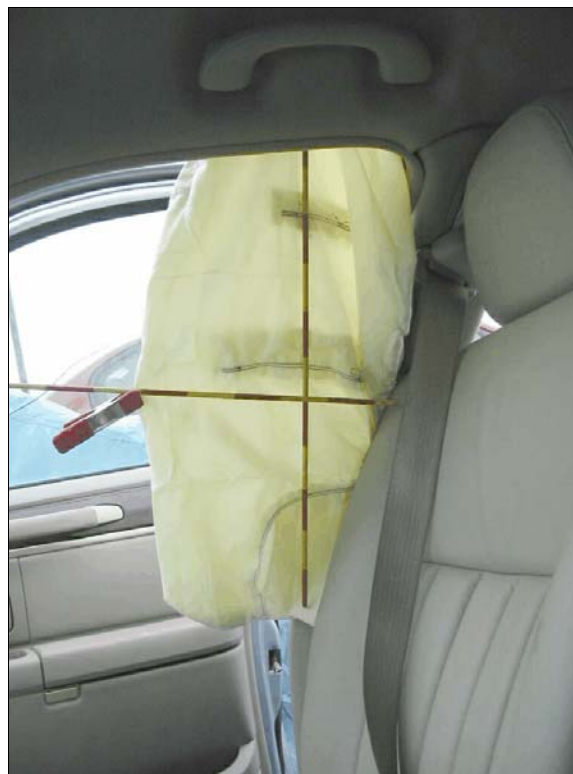
Figure 18: Lincoln’s front right passenger seat back-mounted side impact air bag, each increment on rods is 5 cm (2 in)

principles, when the vehicle impacted the tree, she loaded the deployed seat back-mounted side impact air bag (**Figure 18**). The passenger remained restrained in her seat and was removed from the Lincoln by rescue personnel.
