ON-SITE NOT-IN-TRAFFIC SURVEILLANCE BACK OVER INVESTIGATION

CASE NUMBER - IN-07-011

LOCATION - WISCONSIN

VEHICLE - 2002 KIA SEDONA

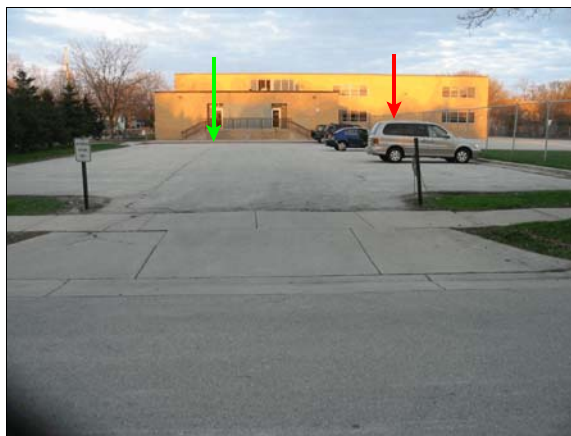
Figure 1: Overview of grade school parking lot where incident occurred, red arrow shows Kia Sedona in parking space driver initially pulled into, green arrow shows area driver was intending to back up to

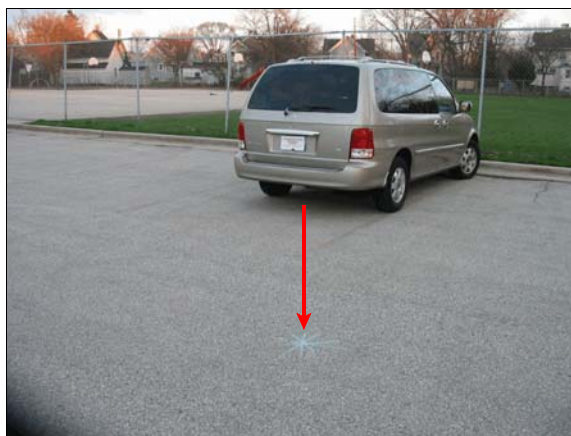
Figure 2: Overview of Kia Sedona in parking space, Kia's driver stated he only pulled partially into the parking space at an angle on day of incident, red arrow shows driver's reported area of impact

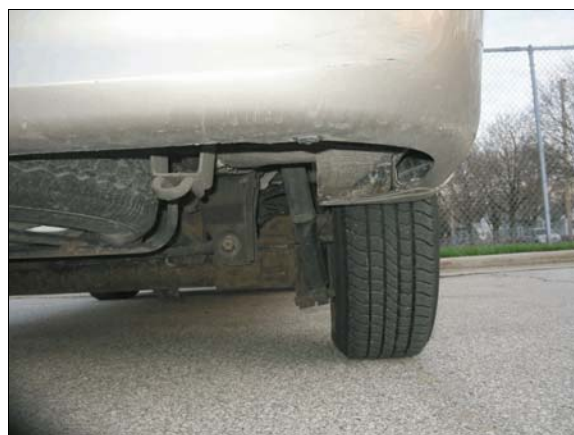
There was no evidence of pedestrian contact to the Kia Sedona's back bumper. There was also no evidence of contact to any of the Kia's rear undercarriage components. Based on the available information indicating the pedestrian was struck by the back bumper, a Collision Deformation Classification was estimated to be: **06-BRLU-1 (180 degrees)**. The Kia was driven from the scene.

Figure 5: Kia Sedona's right rear wheel and undercarriage

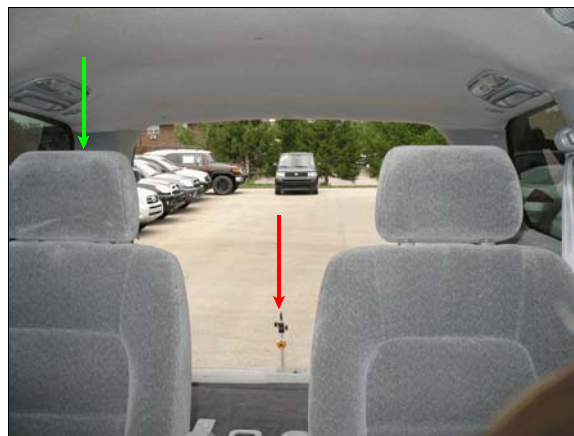
A visibility study was conducted during the Kia Sedona inspection. The study was conducted in the driveway of the driver's residence, which was approximately level. The purpose of the study was to determine the nominal blind zone behind the Kia. In addition, the visibility zones of the side view mirrors were also determined. The Kia's driver assisted the SCI investigator in making the visibility observations. The driver's eye height was 141 centimeters (55.5 inches) above the ground as he sat in the driver's seat. Since the Kia's back hatch was open at the time of the incident and the driver could directly see the standard 71 centimeters (28 inches) high target directly behind the back bumper with the back hatch open, it was decided to set the height of the target to 53 centimeters (21 inches). This placed the top of the target just below the top of the back bumper [back bumper height was 54 centimeters (21.3 inches)] and out of the driver's field of view. The target had to be moved 55 centimeters (21.7 inches) rearward, as well as 8 centimeters (3.1 inches) to the right of the Kia's centerline before the driver could see it (**Figures 7 and 8**). The driver's view out of the back left portion of the open hatch, when he was turned to the right and looking rearward as he did at the time of the incident, was blocked by the seat back of the second row left bucket seat (**Figure 7**). The target was then moved 70 centimeters (27.6 inches) to the right of the approximate centerline where it went out of the driver's view due to the second row right bucket seat (**Figure 7**).

Figure 7: View from driver's seat of exemplar Kia out of open hatch, red arrow shows target in position Kia's driver said he could first see it as it was moved rearward from back bumper, pedestrian was seated behind second row right bucket seat (green arrow)

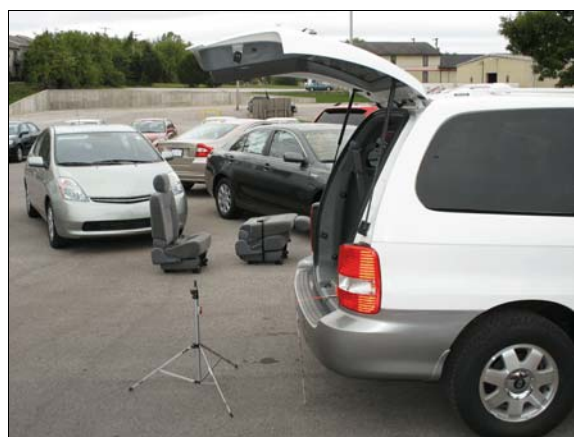
Figure 8: View of target set at location behind exemplar Kia where driver indicated he could first see it [55 centimeters (22 inches) back bumper to target] while looking over his right shoulder out of the open back hatch

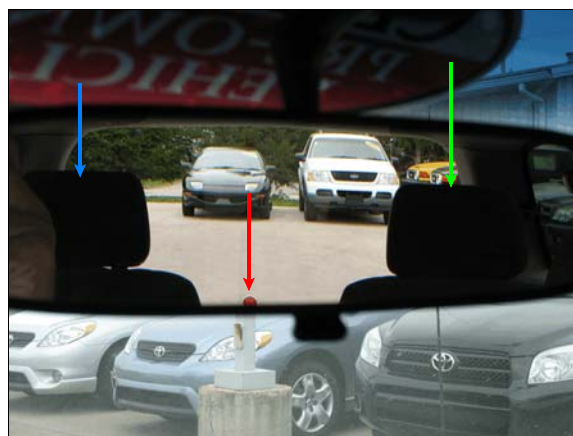
(28 inches) high target was used for the observations. The target had to be moved rearward 2.8 meters (9.2 feet) from the back of the exemplar Kia before the surrogate driver could see it in the rear view mirror (**Figure 9**). When the target was moved 0.5 meters (1.6 feet) to the right of the exemplar Kia’s approximate centerline, it became obstructed by the seat back of the second row right bucket seat (**Figure 9**). When the target was moved 0.4 meters to the left of the approximate centerline, it became obstructed by the seat back of the second row left bucket seat (**Figure 9**). The observations through the rearview mirror indicated that the driver’s view of the pedestrian was most likely blocked by the seat back of the second row right bucket seat.

Figure 9: Close view through rearview mirror from driver’s seat of exemplar Kia, red arrow shows target where it first came into surrogate driver’s view, green arrow shows seat back of second row right bucket seat, blue arrow shows seat back of second row left bucket seat

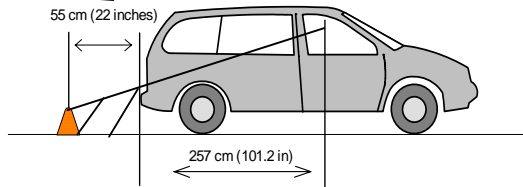
1. Distance Back of Kia
To Point a 53 cm (21 in) High Reference Target
Comes Into Driver's View as He Looks Over Right Shoulder with Rear Hatch Open

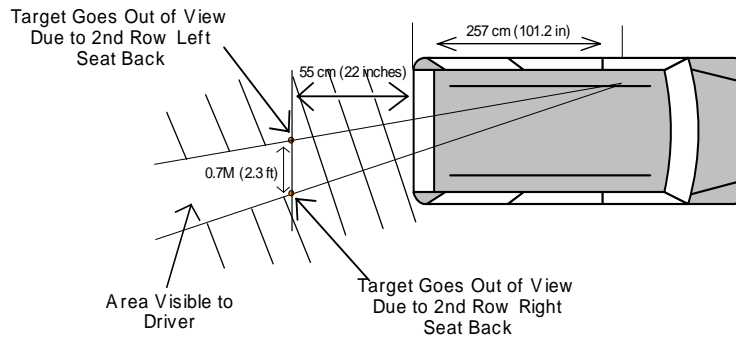
2. Kia's Driver Looking Over Right Shoulder, 2nd Row
Seat Backs Block View Out of Open Rear Hatch

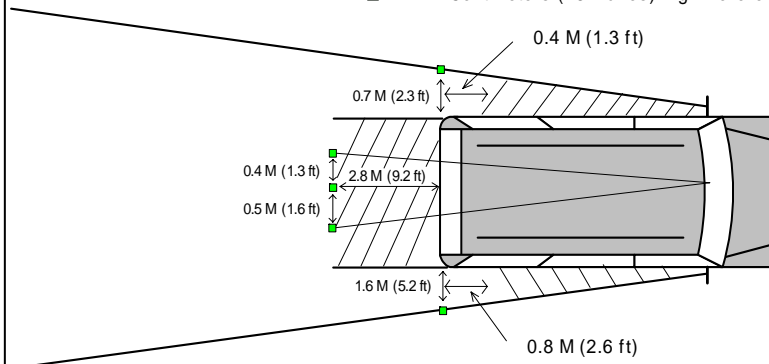
3. Side View Mirrors Visibility Zones and Rearview Mirror Blind Zone Using Standard 71 Centimeters (28 inches) High Target [rearview mirror blind zone and beginning of side view mirrors visibility zones assessed on exemplar 2003 Kia Sedona, surrogate driver's eye height 148 cm (58.3 in)]

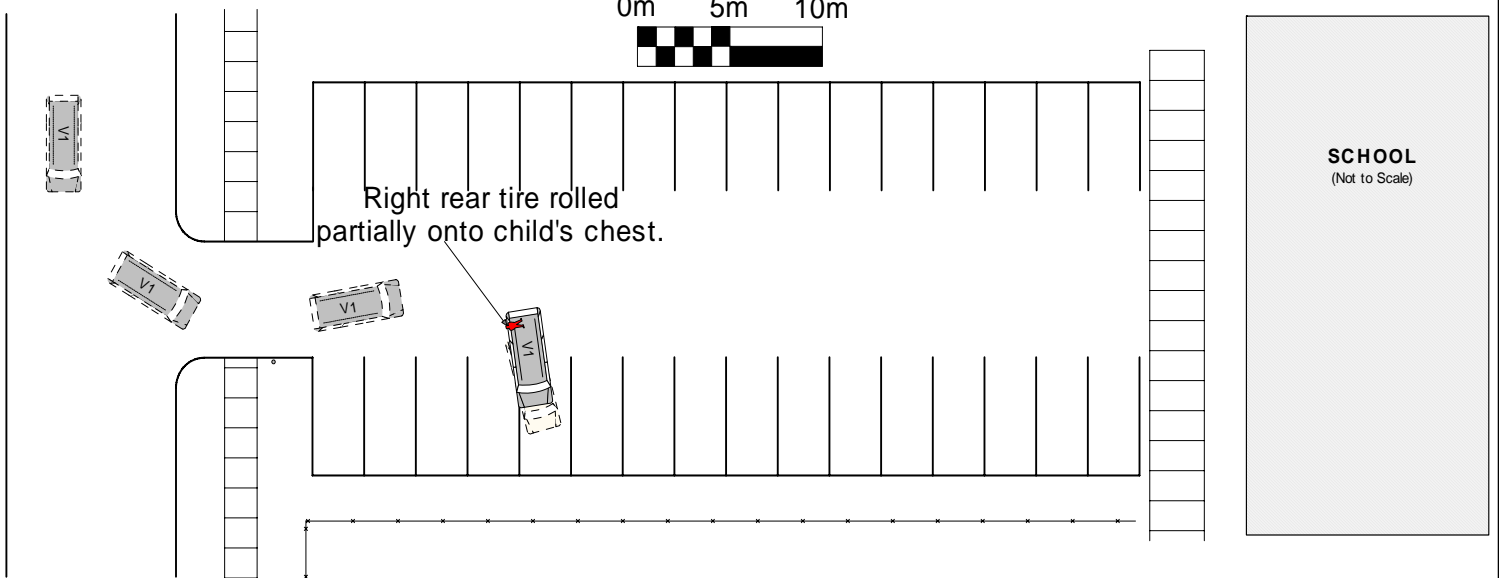
Kia's driver pulls into parking space. Child riding in back right with rear hatch open jumps out. Driver immediately starts to back up and backs over child.
