Rollover Investigation / Vehicle v. Object
Dynamic Science, Inc. / Case Number: DS07015
2006 Honda Civic
California
February 2007

| 4. Title and Subtitle Rollover Investigation | | 5. Report Date November 8, 2007 | |
| 16. Abstract This on site investigation focused on a 2006 Honda Civic that was involved in a rollover crash. This single vehicle crash occurred in February 2007 at 0050 hours. The crash occurred on a five-lane divided state highway. The speed limit at this location is 105 km/h (65 mph). The case vehicle is a 2006 Honda Civic that was being driven by a restrained 24-year-old male. The Honda Civic was traveling westbound at a police reported speed of 129 km/h (80 mph) in the fourth lane from the right. According to the driver of the Honda Civic, the crash was caused by a non-contact vehicle braking in front of the Civic. The investigating police agency did not find any evidence of any other involved parties. The driver of the Civic lost control of his vehicle. The Civic veered across the adjacent lanes to the right. The Civic departed the roadway and struck a dirt/shrub covered embankment. The driver's frontal air bag deployed at this point. The Civic was redirected b

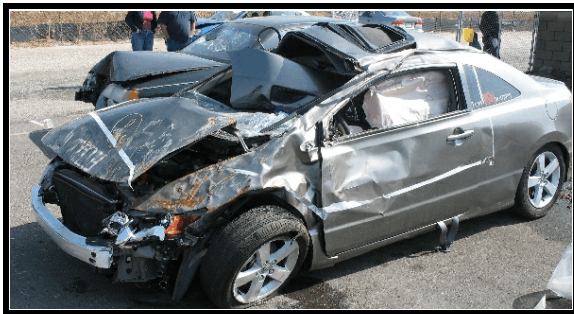
This on site investigation focused on a 2006 Honda Civic that was involved in a rollover crash (**Figures 1-2**). This single vehicle crash occurred in February at 0050 hours. The crash occurred on a five-lane divided state highway. The speed limit at this location is 105 km/h (65 mph). The case vehicle is a 2006 Honda Civic that was being driven by a restrained 24-year-old male. The Honda Civic was traveling westbound at a police reported speed of 129 km/h (80 mph) in the fourth lane from the right. According to the driver of the Honda Civic, the crash was caused by a non-contact vehicle braking in front of the Civic. The investigating police agency did not find any evidence of any other involved parties. The driver of the Civic lost control of his vehicle. The Civic veered across the adjacent lanes to the right. The Civic departed the roadway and struck and dirt/shrub covered embankment. The driver's frontal air bag deployed at this point. The Civic was redirected back onto the roadway shoulder where it rolled onto its roof. The left and right side air curtains and the driver's side air bag deployed during the rollover. The driver of the Civic sustained a neck strain and minor hand abrasions. He was transported to a local hospital for treatment. The Honda Civic was towed from the scene due to damage. It was later declared to be a total loss by the insurance company.

Figure 1. Case vehicle, 2006 Honda Civic

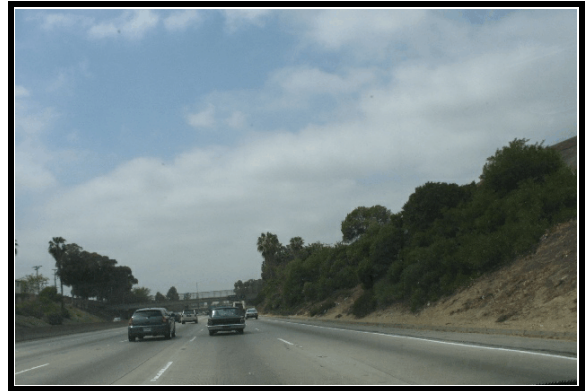
This single vehicle crash occurred on the roadside of a state highway in February 2007 at 0050 hours. At the time of the crash, there were no adverse weather conditions and the concrete roadway surface was dry. The state highway was configured with five lanes for westbound traffic (**Figure 3**). Each lane was delineated by broken painted white lines. The traffic lanes were bordered on the south by a solid painted yellow line, an asphalt shoulder and a concrete median barrier. The traffic lanes were bordered on the north by a solid painted white line, an asphalt shoulder and an ascending dirt/shrub covered embankment. It was dark at the time of the crash and there were no streetlights present. The speed limit at this location is 105 km/h (65 mph).

Figure 3. Approach to area of impact/rollover (west)

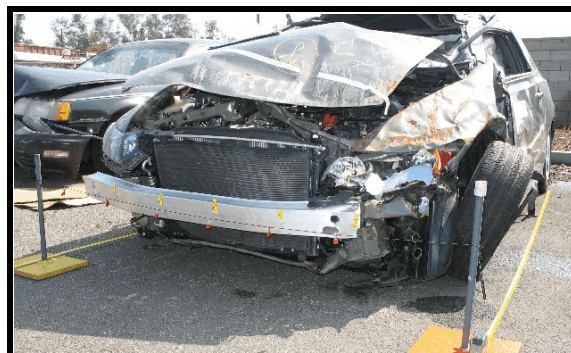
The 2006 Honda Civic sustained moderate front end damage as a result of the impact with the embankment (**Figure 4**). The direct damage began on the left front bumper corner and extended 68 cm (26.8 in) laterally across the bumper face. The bumper fascia was knocked off during the crash (**Figure 5**). The bumper was shifted laterally 12 cm (4.7 in) to the right (**Figure 6**). Six crush

Figure 4. Front end damage, Honda Civic

measurements were documented at the bumper level as follows: C1 = 10 cm (3.9 in), C2 = 3 cm (1.2 in), C3 = 1 cm (0.4 in), C4 = 0.5 cm (0.2 in), C5 = 0 cm, C6 = 0 cm. The Collision Deformation Classification (CDC) for the impact with the embankment was 11FYEW1.

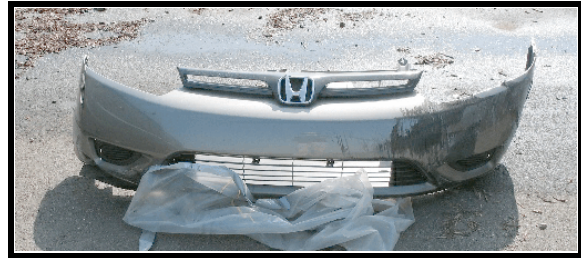
Figure 5. Front bumper fascia

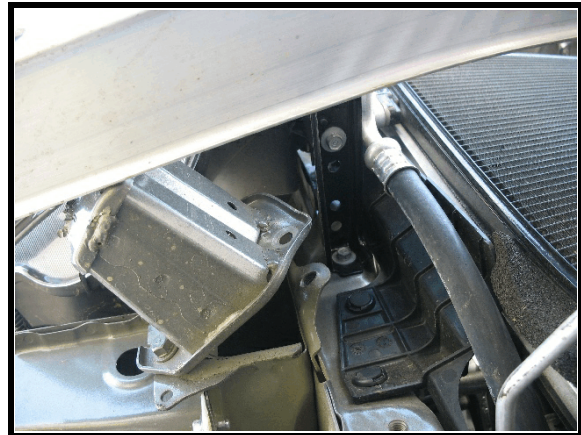
Figure 6. Movement of the right bumper mount

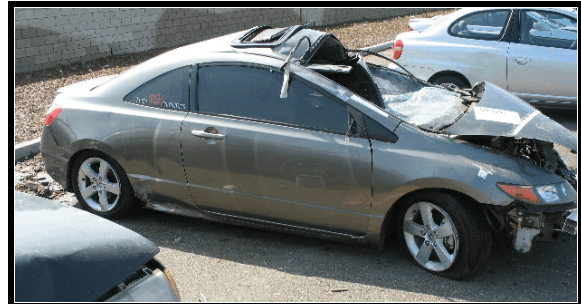
There was direct damage to the right lower frame rail area that measured 78 cm (30.7 in). There was also damage to the lower A pillar area on the right side. The right front tire was flattened. It appears that this damage occurred as the vehicle went up the embankment and struck some low terrain object(s). The CDC assigned for this impact was 99RDLW1 (**Figure 7**).

Figure 7. Right side damage (forward of rear tire)

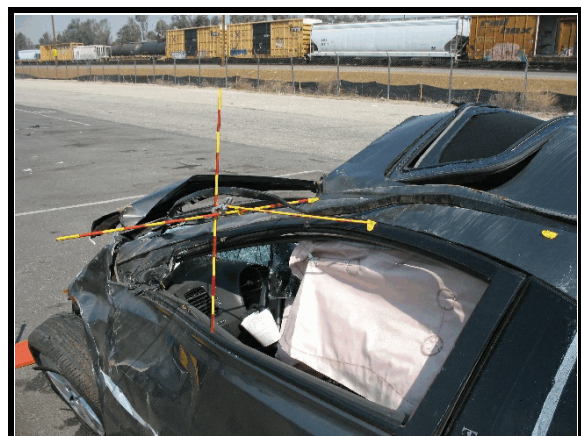
The Honda Civic sustained moderate roof damage as a result of the left side leading rollover (**Figure 8**). The direct damage began at the hood edge and extended rearward past the windshield header. The maximum lateral and vertical crush was located at the left A pillar and measured 16 cm (6.3 in) and 6 cm (2.4 in), respectively. The CDC for the rollover was 00TYDO2.

Figure 8. Roof crush

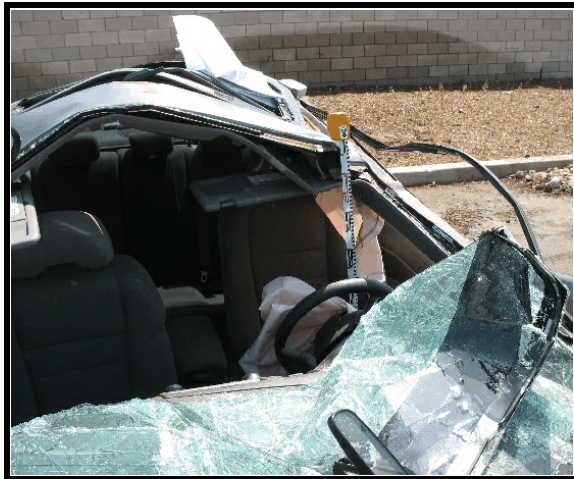
The 2006 Honda Civic sustained moderate interior damage as a result of passenger compartment intrusion. The left A pillar and left side rail intruded laterally (**Figure 9-10**). The roof, left A pillar, roof and windshield header intruded vertically. There was occupant contact damage to the left interior door and door handle.

Figure 9. Exterior view of left side intrusion

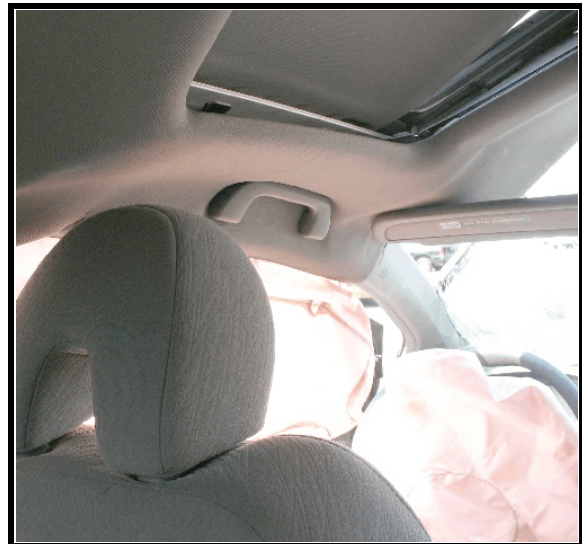
Figure 10. Interior view of left side intrusion

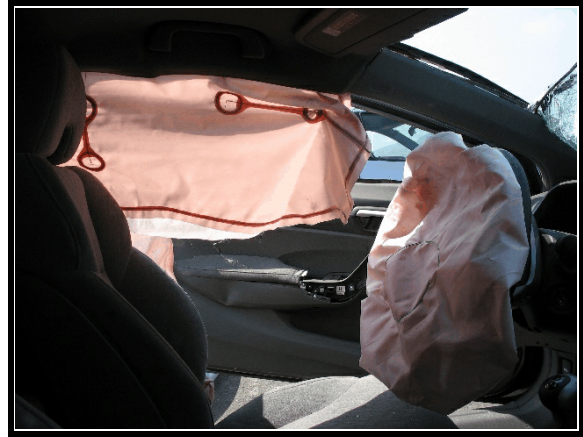
The driver's air bag deployed from the center of the steering wheel hub through asymmetrical H-configuration cover flaps (**Figure 11**). The top flap measured 13 cm (5.1 in) in width and 3.5 cm (1.4 in) in height. The bottom flap measured 13 cm (5.1 in) in width and 8 cm (3.1 in) in height. The deployed air bag measured 50 cm (19.7 in) in its deflated state. The air bag was tethered by a single internal strap. Two circular vent ports were located at the 11 and 1 o'clock aspects on the rear of the air bag. There were no indications of occupant contact or any damage to the air bag.

Figure 11. Interior view, left curtain and driver's air bag

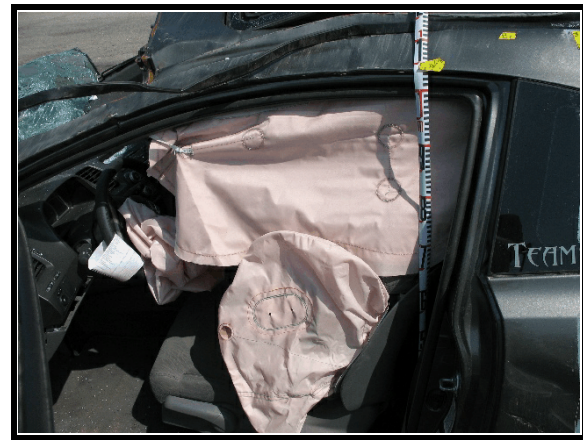
The driver's side air bag deployed from the left side seat back (**Figure 12**). The deployed air bag measured 50 cm (19.7 in) in height and 31 cm (12.2 in) in width. There were three small vent ports on both sides of the air bag. There were no indications of occupant contact or any damage to the air bag.

Figure 12. Exterior view, left side curtain and left side air bag

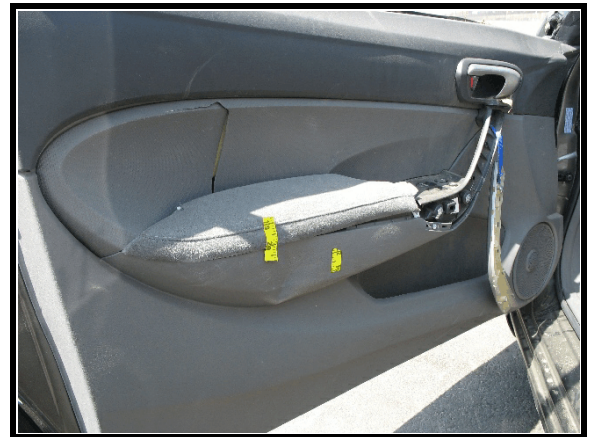
The 24-year-old male driver was seated in an upright posture and was restrained by the 3-point lap and shoulder belt. The seat was positioned at the mid track position. The driver's seat back was at an 18 degree angle from the vertical; the seat cushion was at a 13 degree angle from the horizontal. The driver was actively steering and braking. The case vehicle appears to have been in a slightly clockwise yaw prior to impact. At impact with the embankment, the driver's frontal air bag deployed. The driver initiated a forward and slightly left lateral trajectory. He loaded the safety belt. As the vehicle engaged the embankment it began a sharper clockwise rotation. The vehicle tripped and began a left side leading rollover. The driver engaged the left door with the left side of his torso and abdomen (**Figure 13**). The door and handle were damaged, but there were no related injuries.

Figure 13. Occupant contact damage to door
