TRANSPORTATION RESEARCH CENTER

ON-SITE CHILD SAFETY SEAT INVESTIGATION

CASE NUMBER - IN07015
LOCATION - WISCONSIN
VEHICLE - 1995 JEEP CHEROKEE SPORT 4x4
CRASH DATE - May 2007

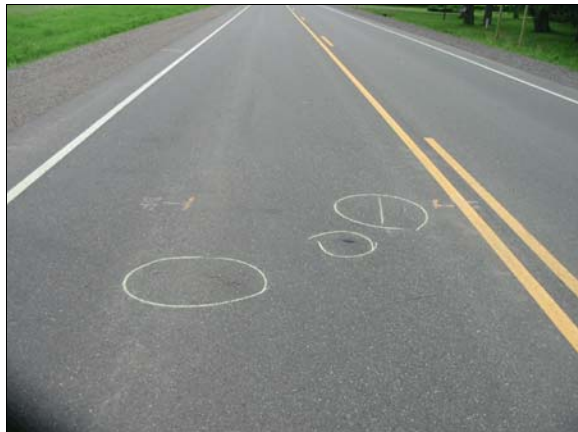
Figure 3: View north to impact gouges in southbound lane

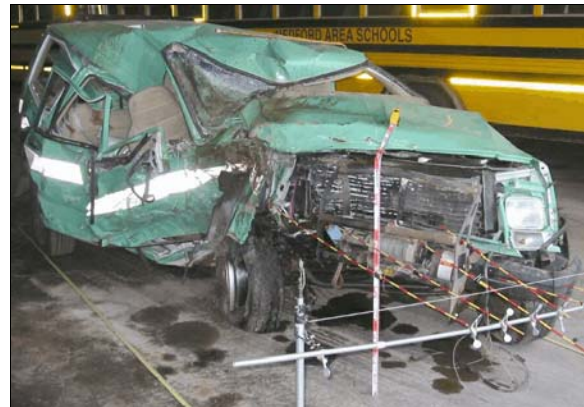
Crash: As the Jeep entered the southbound lane, its front right (**Figure 4**) impacted the front right of the Chevrolet (**Figure 5**). The impact caused the Jeep's driver air bag to deploy. The Chevrolet's driver and front right passenger air bags also deployed. Following the impact, the

Figure 4: Damage to Jeep from impact with front of the Chevrolet; vertical scale in tenths of meter, each increment on measurement rods in 5 cm (2 in)

Exterior Damage: The Jeep Cherokee’s impact with the Chevrolet C1500 involved the front end. The front bumper, grille, hood and right fender were directly contacted and crushed rearward. The Jeep was equipped with a winch and brush guard on the front bumper, which was also directly contacted and crushed rearward. The direct damage from the front plane extended down the right side in a sideswipe type configuration. The direct damage to the front end began at the front right bumper corner and extended 76 centimeters (29.9 inches) across the front end. Crush measurements were taken at the bumper level, and the residual maximum crush was measured as 103 centimeters (40.6 inches) occurring at C₆ (**Figure 7**). The rollover damage was minor and involved only surface scratches to the hood and the roof. The majority of the damage to the roof structure (**Figure 8**) was due to induced damage related to the collapse of the passenger compartment from the severe front impact. The table below shows the Jeep’s front crush profile.

The front impact reduced the right side wheelbase 85 centimeters (33.5 inches) and extended the left side wheelbase 12 centimeters (4.7 inches). Induced damage involved the hood, left fender, left and right quarter panels and the roof.

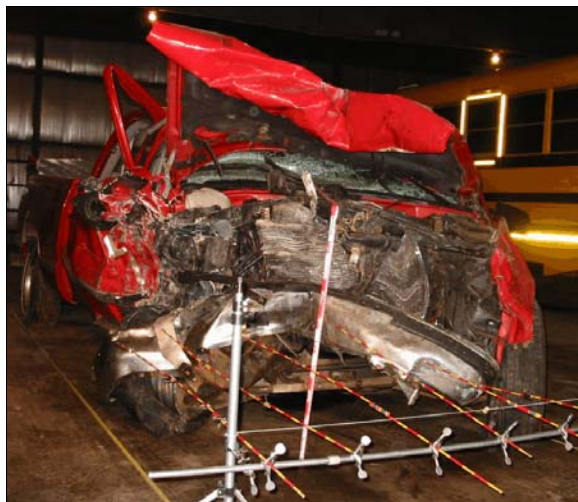
Figure 5: Overview of damage to front of Chevrolet due to impact with front of Jeep

Exterior Damage: The Chevrolet's impact with the Jeep involved its front plane. The front bumper, bumper fascia, hood, grille, radiator, both turn signal and headlamp assemblies, and both fenders were directly damaged and crushed rearward. The direct damage length was determined to be 171 centimeters (67.3 inches). The crush measurements were taken at the bumper level. The residual maximum crush was measured as 144 centimeters (56.7 inches) occurring at C₆ (**Figure 12**). The table below shows the Chevrolet's front crush profile.

The Chevrolet's right side wheelbase was reduced 73 centimeters (28.7 inches) while the left side wheelbase was extended 11 centimeters (4.3 inches). Induced damage involved the hood, roof, right front door, right A-pillar, right B-pillar, right side of the cab, left front door and the left fender. In addition, the hood was displaced into the windshield.

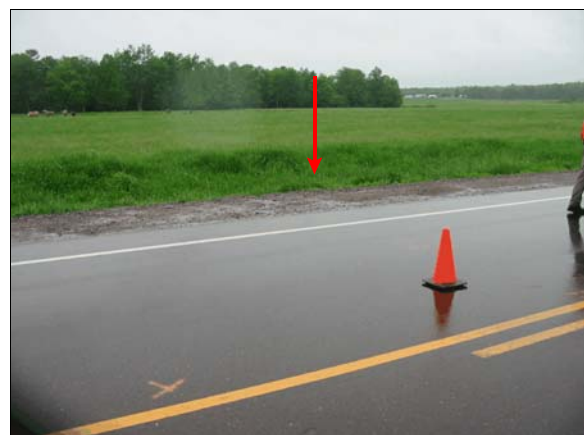
Jeep rotated clockwise, departed the west side of the roadway and rolled over, driver side leading, two quarter turns into a ditch (Figure 6).

Figure 6: View northwest through impact area to area where Jeep rolled over into ditch (arrow)

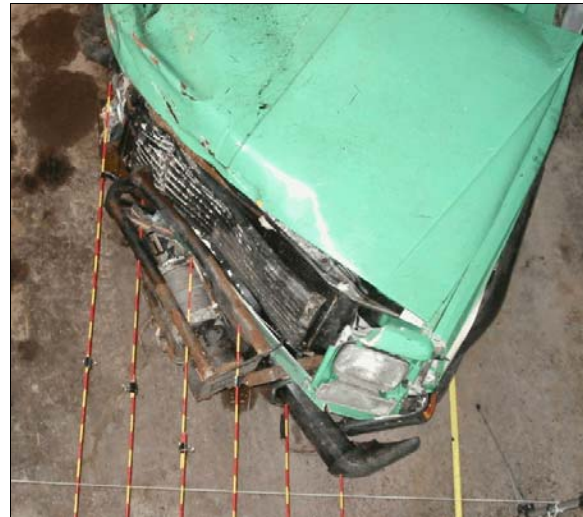
Figure 7: Top view of crush to front of Jeep

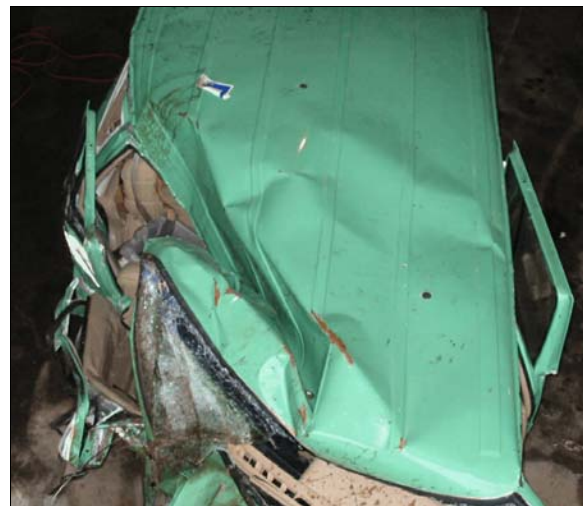
Figure 8: Induced damage folds to roof structure of Jeep due to front impact with the Chevrolet

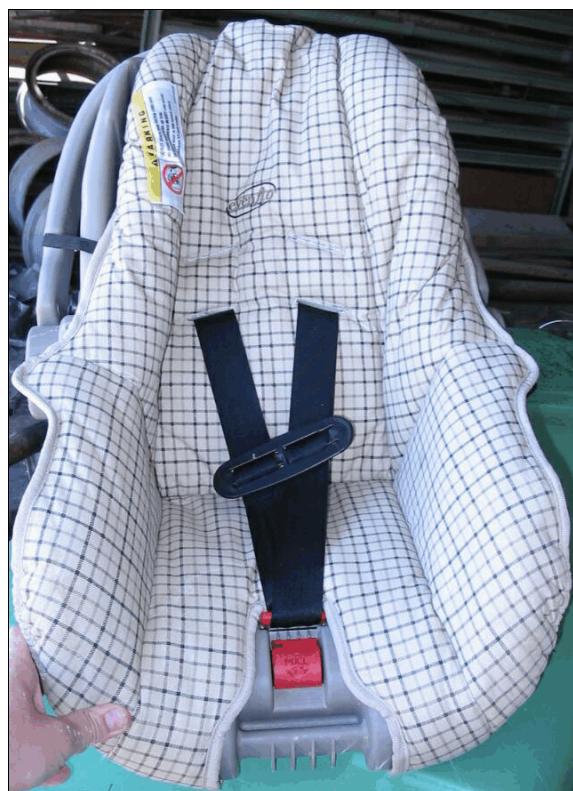
The Jeep's back center passenger was restrained in an Evenflo Discovery rear-facing infant seat with a base (**Figures 9 and 10**). The infant seat was manufactured by Evenflo on December 22, 2006. The model number was 3911698L2. The infant seat was designed with a three-point harness, which buckled into a recessed buckle located between the infant's legs. There were two sets of slots on the back of the infant seat to thread the harness straps through, depending on the size of the infant. The harness straps were threaded through the bottom set of slots. A harness retainer clip was found attached to the harness straps at a level that would probably

Figure 9: Jeep's back center infant seat

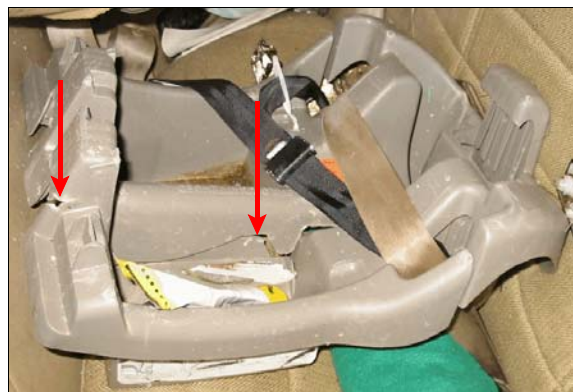
Inspection of the infant seat and base revealed evidence that they had been heavily loaded during the crash. The back and bottom of the plastic shell were broken (**Figure 11**) and the base was fractured in several places (**Figure 10**).

In addition, there were signs of stress to the plastic in the form of light colored striations throughout the infant seat and the base. The base was twisted to the right and bent forward slightly. The damaged condition of the infant seat and base indicated that they were heavily loaded, probably as the infant seat and base were compressed between the front right passenger's seat back and the rear seat back as the front right passenger seat was displaced rearward during the front impact (**Figures 10, 12 and 13**). In addition, the Jeep's back center lap belt and the infant seat had loaded against the base. It is also possible that the unrestrained back left passenger had impacted the infant seat during the crash. Lastly, the back center passenger had loaded the harness straps and back of the infant seat. As a result of the loading, both the infant seat and base

Figure 10: Infant seat base as found in Jeep's back center seat position, arrows show fractures in plastic

had been severely flexed, deformed and cracked in this high severity crash. Based on information from the investigating sheriff's deputy, the infant seat was found still attached to the base following the crash.

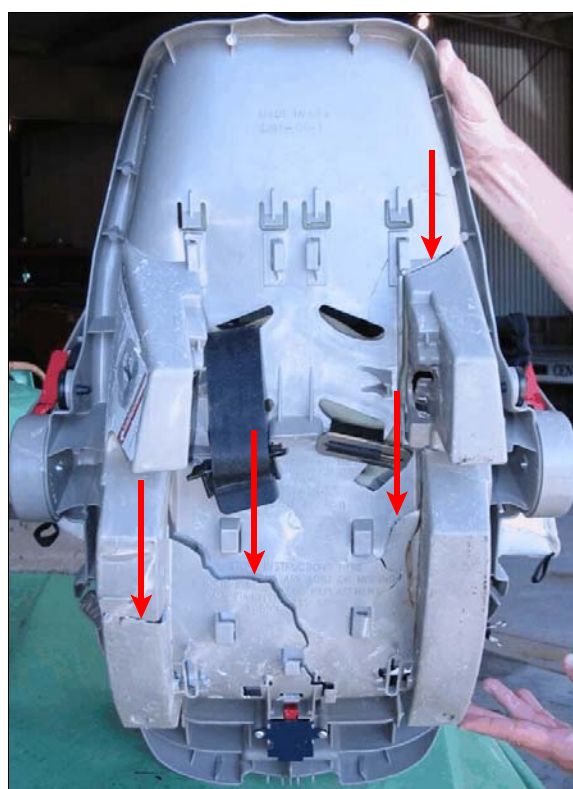
Figure 11: Overview of back of infant seat, arrows show cracks in plastic shell

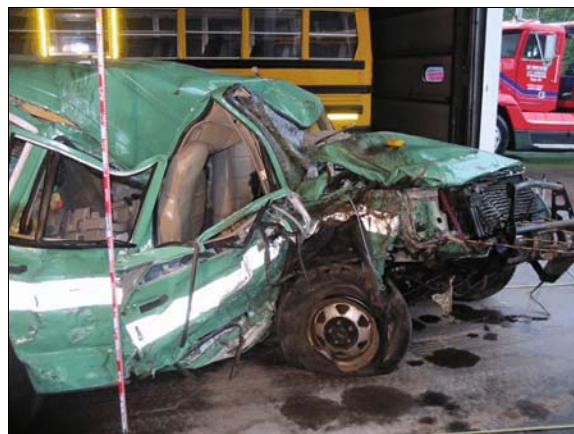
The Jeep sustained numerous intrusions in this crash. The most severe intrusions occurred in the front right occupant space: The right instrument panel intruded longitudinally 88 centimeters (34.6 inches). The right toe pan intruded longitudinally 111 centimeters (43.7 inches). The right A-pillar intruded longitudinally 88 centimeters (34.6 inches), and the windshield header intruded vertically 27 centimeters (10.6 inches). There was also severe intrusion of the roof into the back right occupant space of 52 centimeters (20.5 inches), in addition the roof intruded into the back center seat position 45 centimeters (17.7 inches).

Figure 12: Overview of collapse of Jeep's passenger compartment and rearward displacement of front right passenger seat

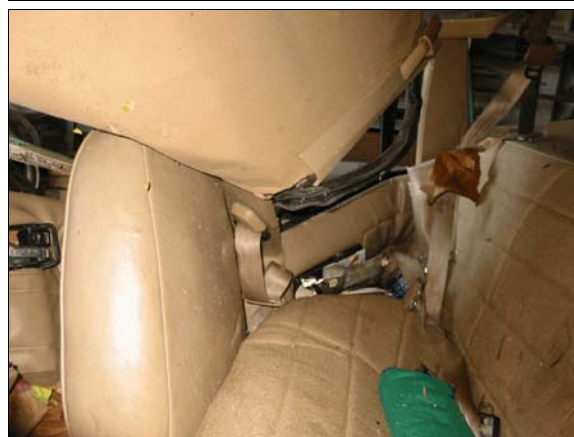
Figure 13: View from left showing Jeep's front right seat back pressed against back seat cushion and intrusion of roof into back right and back center seat positions
