ON-SITE ROLLOVER INVESTIGATION

CASE NUMBER - IN07017
LOCATION - TEXAS
VEHICLE - 2002 TOYOTA TUNDRA
CRASH DATE - October 2006

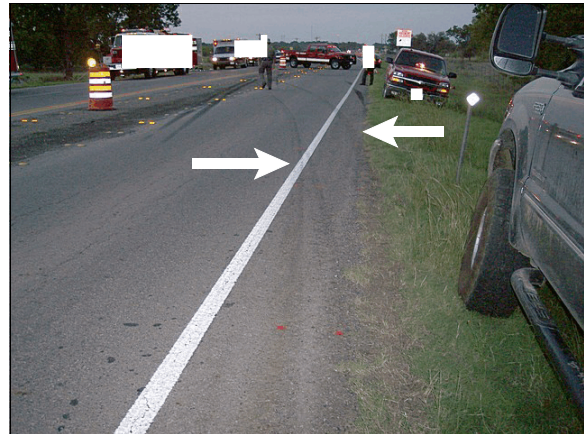
Pre-Crash: The Toyota was traveling north (**Figure 1**) at a driver estimated speed of 97 km/h (60 mph) and the driver intended to continue northbound. The Dodge was traveling south in the outside lane and the driver intended to continue southbound. The Toyota ran over a dip in the roadway and the vehicle lurched to the right. The driver steered left, right and then left again, the vehicle began to rotate counterclockwise and crossed into the southbound lanes (**Figure 2**). The crash occurred in the outside southbound lane. She stated during the interview that she only steered in an attempt to regain control and did not apply the brakes during the crash sequence.

Figure 1: Police photo showing Toyota's northbound approach to the crash; arrows show Toyota's yaw marks on the east shoulder and in the northbound lane

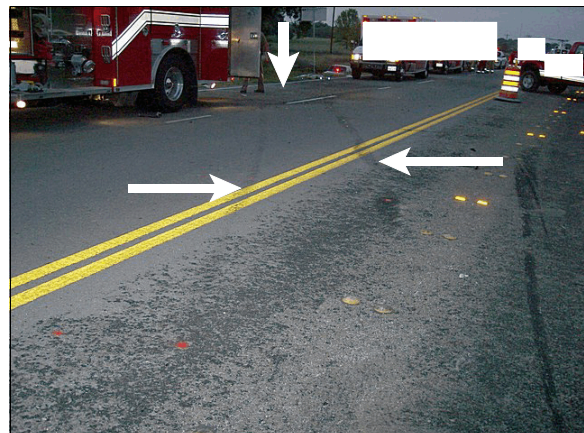
Crash: The Toyota's counterclockwise yaw increased as it approached impact with the Dodge (Figure 2). The front of the Toyota (Figure 3) impacted the Dodge's left fender (Figure 4) causing the Toyota's driver and front right passenger air bags to deploy. The impact also caused the Dodge's driver and front right passenger air bags to deploy. The impact accelerated the Toyota's counterclockwise rotation, and the unrestrained front right passenger was ejected through the right front window. The vehicle then rolled over onto its right side (Figure 5). The rollover occurred on the roadway as indicated by the pavement scratches on the right front door. The Dodge rotated counterclockwise, departed the west side of the roadway and rolled over with the right side leading three quarter turns. The Toyota came to rest on its right side on the west side of the road (Figure 6) heading east. The Dodge came to rest on its left side on the west side of the road (Figure 6) heading south. The police crash schematic indicated that the Toyota's ejected front right passenger came to rest on the north side of the Toyota near its undercarriage.

Figure 2: Police photo showing yaw marks (horizontal arrows) from Toyota entering the outside southbound lane; vertical arrow shows area of impact in outside southbound lane

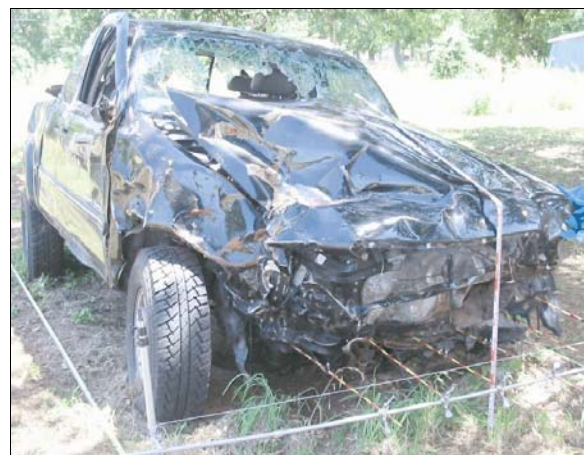
Figure 3: Damage to front of case vehicle due to impact with the Dodge, holed windshield is not related to crash

Exterior Damage: The Toyota's impact with the Dodge involved the front end and right fender. The front bumper, grille, hood, turn signal/headlamp assemblies, and right fender were directly damaged. The front frame members were shifted left 13 centimeters (5.1 inches). The direct damage began at the front right bumper corner and extended 130 centimeters (51.2 inches) across the front end. The front bumper was broken off of the Toyota, so the crush measurements were taken at the level of the lower radiator support. The residual maximum crush was measured as 36 centimeters (14.2 inches) occurring at C₁. The table below shows the Toyota's front crush profile.

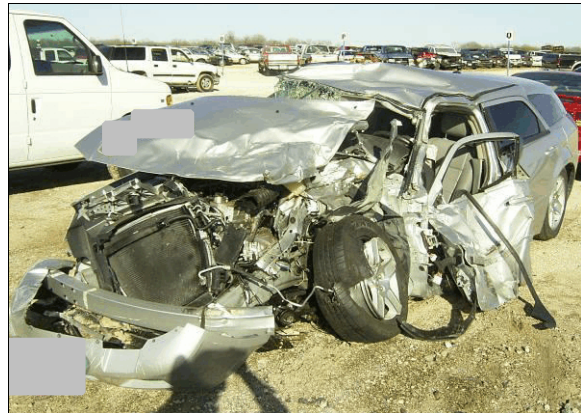
Figure 4: Insurance photo showing damage to the Dodge due to the impact with the Toyota

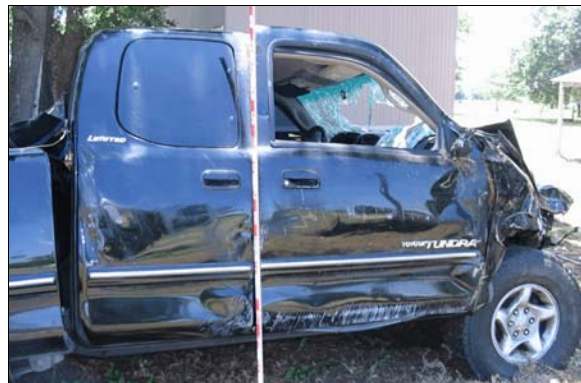
Figure 5: Pavement scratches to right side of Toyota's cab due to the rollover

The rollover damage involved the right side of the Toyota and consisted of scratches and induced damage folds on the side of the truck bed. Pavement scratches were present on the right front door and sill (**Figure 5**) as well as other scratches at the top of the right front window frame and on the right side of the truck bed. The induced damage folds were located aft of the right rear axle (**Figure 7**). Grass was embedded in the bead of the right front and right rear tires, as well as in the door seam at the front of the right front door and around the right side view mirror. The direct damage began 119 centimeters (46.9 inches) rear of the right rear axle and extended forward 396 centimeters (155.9 inches) along the right side. The maximum lateral crush was 12 centimeters (4.7 inches).

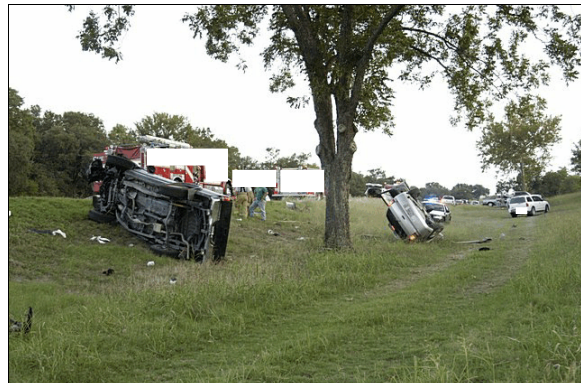
Figure 6: Police on-scene photo showing final rest positions of Toyota and Dodge

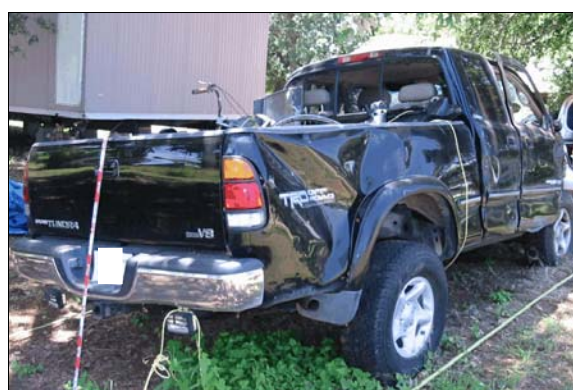
Figure 7: Overview of rollover damage to right side of Toyota and induced damage folds aft of right rear wheel due to rollover

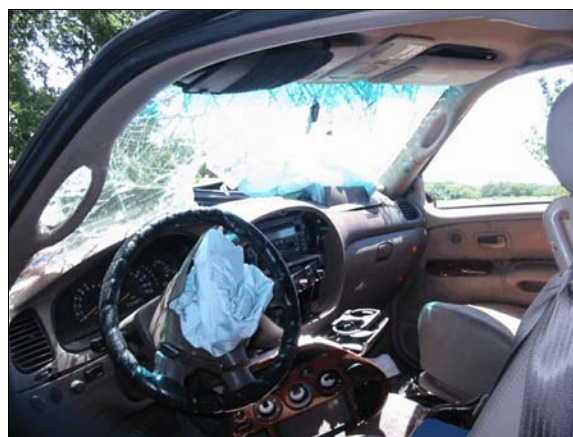
Vehicle Interior: Inspection of the Toyota's interior (**Figure 8**) revealed an occupant contact scuff mark on the driver's knee bolster (**Figure 9**), and the upper half of the steering wheel rim (**Figure 10**) was deformed forward 4 centimeters (1.6 inches). The contacts indicated the driver's left knee had contacted the knee bolster and she had ridden down the air bag and loaded the steering wheel with her chest. There was an occupant contact scuff mark on the glove box door (**Figure 11**), the right front door panel was slightly deformed outward, and the door panel control housing was displaced. These contact marks indicated that one of the front right passenger's knees had contacted the glove box door and his torso had loaded the right front door and window sill.

Figure 8: Overview of Toyota's front seating area

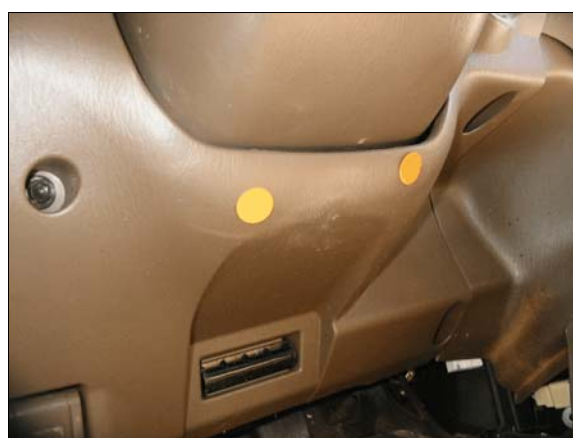
Figure 9: Occupant contact scuff on driver's knee bolster

The driver loaded the seat belt and her left knee contacted and scuffed the knee bolster (**Figure 9**). Her face and chest contacted the deployed air bag, she rode down the air bag and loaded the steering wheel. She continued to load the seat belt as the Toyota rolled over and she remained restrained in the seat.

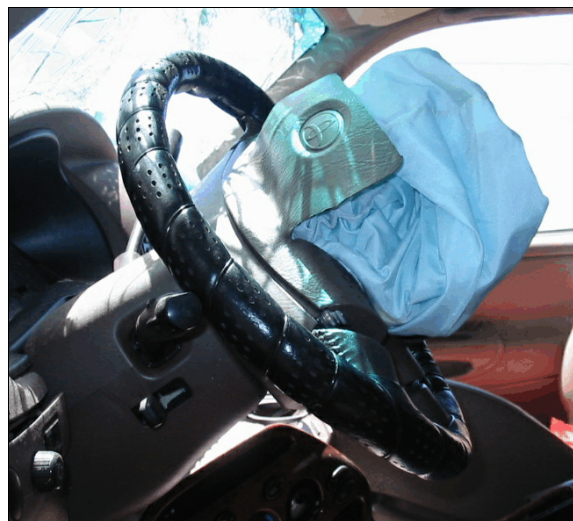
Figure 10: Left side view of deformation of top half of Toyota's steering wheel

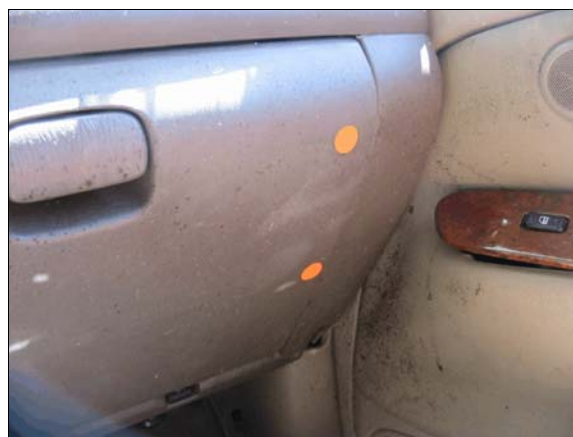
Figure 11: Orange dots show contact scuff on glove box door from front right passenger

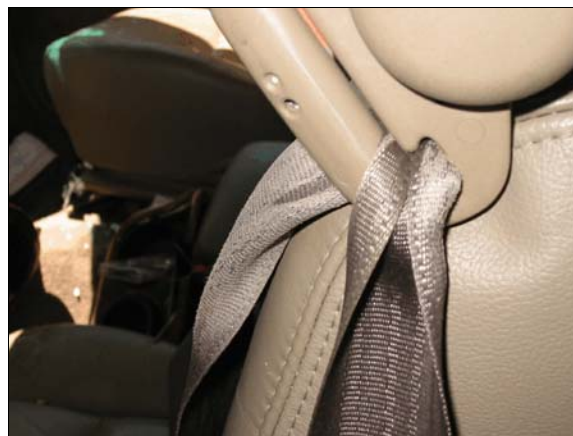
The Toyota's driver was restrained by the lap-and-shoulder seat belt. Inspection of the seat belt assembly revealed that the shoulder belt was jammed in the corner of the D-ring (**Figure 12**) and there were load abrasions on the belt. The driver also reported seat belt contusions on her left shoulder, chest and hips.

Figure 12: Toyota driver's shoulder belt jammed in corner of D-ring

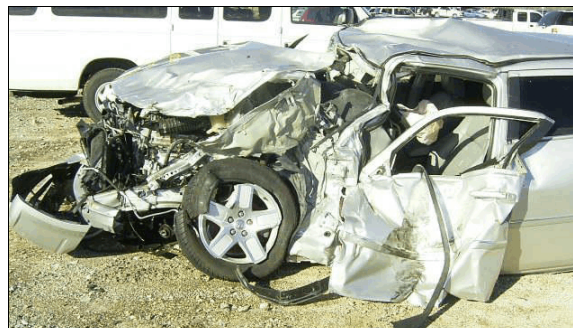
Exterior Damage: The Dodge's impact with the Toyota involved the left side (**Figure 13**). The left corner of the front bumper, fender, left front wheel, hood, left front door and A-pillar were directly damaged. The area of maximum crush occurred in the left front wheel area. Induced damage involved the left rear door and roof. The rollover damage appeared to involve primarily the right side of the Dodge (**Figure 14**). The right fender and quarter panel were dented, the right rear window was broken, and there were scratches along the right front door and right roof side rail.

Figure 13: Insurance photo showing damage to left side of Dodge from impact with front of Toyota

Damage Classification: Based on insurance photographs of the Dodge, the CDC for the left side impact with the Toyota was estimated to be **11-LYAW-3 (340 degrees)**. The CDC for the rollover damage was estimated to be **00-RDAO-2**. The WinSMASH reconstruction program, Missing Vehicle algorithm was used to reconstruct the Dodge's Delta Vs for the left side impact. The Total, Longitudinal, and Lateral Delta Vs were 43.0 km/h (26.7 mph), -40.4 km/h (-25.1 mph) and 14.7 (9.1 mph), respectively. The crash fit the reconstruction model and the results were borderline. The severity of the rollover was estimated to be minor based on the damage to the side. The Dodge was towed due to damage.

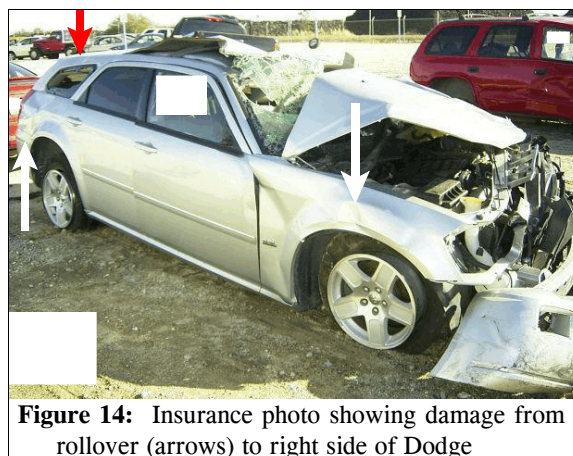
Figure 14: Insurance photo showing damage from rollover (arrows) to right side of Dodge
