Rollover Investigation
Dynamic Science, Inc. / Case Number: DS07018
2005 Chevrolet Aveo
California
February 2007

This on-site investigation focused on a 2005 Chevrolet Aveo that was involved in multiple impacts and a rollover. This two vehicle crash occurred in February 2007 at 0630 hours on a four-lane interstate highway. The roadway was wet and it was raining at the time of the crash. The 2005 Chevrolet Aveo was a four-door sedan that was being driven by an unrestrained 42-year-old female. The other vehicle was a 2003 Ford Focus. The Chevrolet Aveo was traveling westbound in the outboard lane and the Ford Focus was disabled in the second lane. As the Chevrolet Aveo approached the area where the Ford Focus was disabled, the driver steered to the right and onto the shoulder. The Aveo lost control and struck a concrete barrier with its right side. The Aveo rotated counterclockwise and entered the adjacent travel lanes. As a result, the left side of the Aveo struck the left front of the Ford Focus. The Aveo displaced the Ford and began a left side leading rollover. The Aveo rolled two quarter turns. After the crash, the Ford Focus came to rest facing south partially blocking the rig

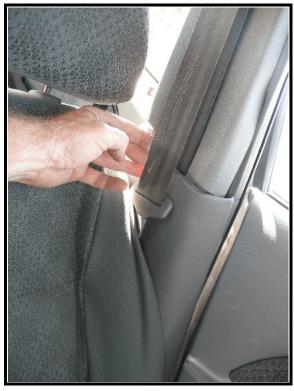
The driver's safety belt was configured with a sliding latch plate and an ELR type retractor. At the time of the vehicle inspection, the driver's seatbelt was locked in the stowed position by the vehicle intrusion and the pretensioner actuation. The belt webbing was taut along the B-pillar in an unused position.

Figure 9. Driver's safety belt locked in stowed position

The 2005 Chevrolet Aveo was configured with single stage frontal air bags and safety belt retractor pretensioners for the driver and front right passenger positions. There were no air bag deployments. The driver's safety belt pretensioner actuated while the belt was in the stowed position.
