**CALSPAN ON-SITE CHILD SAFETY SEAT CRASH INVESTIGATION
SCI CASE NO: CA07-018**

**VEHICLE: 2007 CHEVROLET EQUINOX
LOCATION: NEW YORK
CRASH DATE: JUNE, 2007**

<p>1. Report No. CA07-018</p>	<p>2. Government Accession No.</p>	<p>3. Recipient's Catalog No.</p>	
<p>4. Title and Subtitle Calspan On-Site Child Safety Seat Crash Investigation Vehicle: 2007 Chevrolet Equinox Location: New York</p>		<p>5. Report Date: October 2007</p>	
		<p>6. Performing Organization Code</p>	
<p>7. Author(s) Crash Data Research Center</p>		<p>8. Performing Organization Report No.</p>	
<p>9. Performing Organization Name and Address Calspan Corporation Crash Data Research Center P.O. Box 400 Buffalo, New York 14225</p>		<p>10. Work Unit No. C00410.0000.0317</p>	
		<p>11. Contract or Grant No. DTNH22-07-C-00043</p>	
<p>12. Sponsoring Agency Name and Address U.S. Department of Transportation National Highway Traffic Safety Administration Washington, D.C. 20590</p>		<p>13. Type of Report and Period Covered Technical Report Crash Date: June 2007</p>	
		<p>14. Sponsoring Agency Code</p>

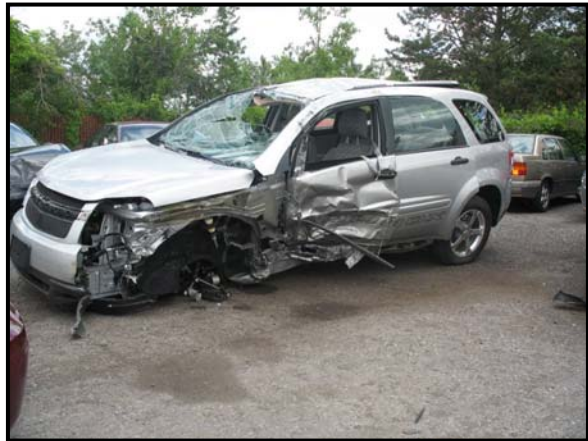
Figure 1: Left oblique view of the Equinox.

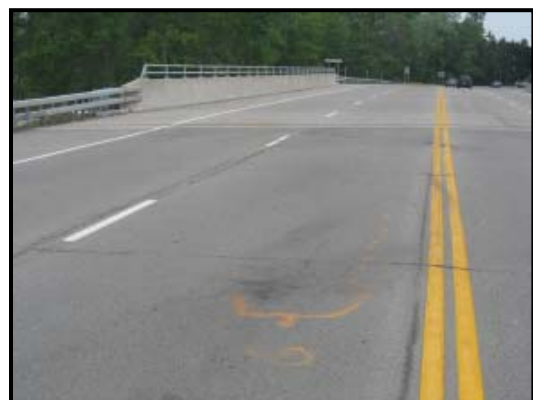
is a northbound trajectory view 30 m (100 ft) south of the point of impact. The point of impact was located within the inboard southbound lane, 0.9 m (3 ft) west of the double yellow centerline. The area of the impact (**Figure 4**) was denoted by a series of gouge and scratch marks and the beginning of a 24.4 m (80 ft) continuous scratch mark that defined the post-crash trajectory of the Buick. The post-crash trajectory of the Chevrolet was defined by a series of tire marks, scratches, and gouge marks on the southbound lanes of the road. The roadway physical evidence that defined the post-crash trajectories of the vehicles was documented during the SCI scene inspection.

Figure 4: Northbound view of the POI.

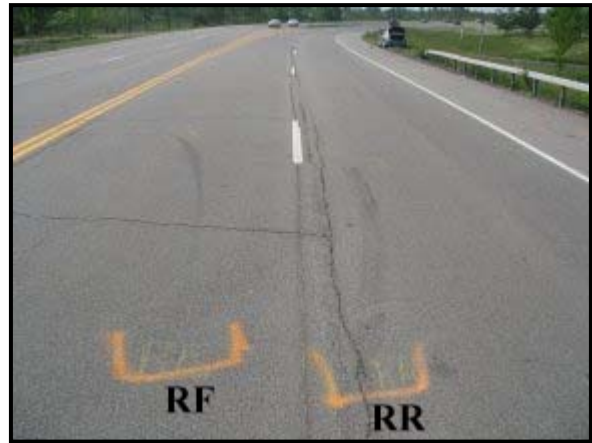
Figure 5: Southbound view of the yaw marks.

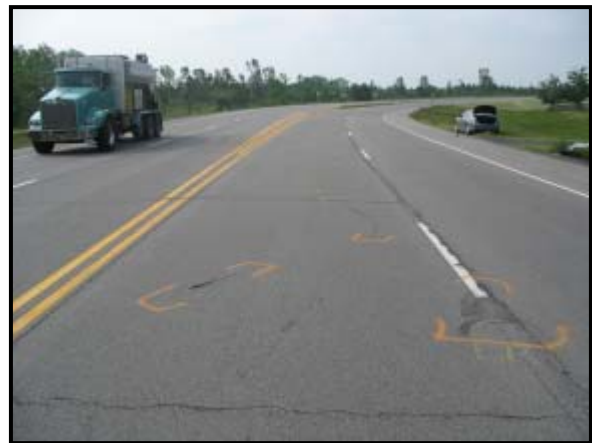
Figure 6: Left front and left rear gouge marks.

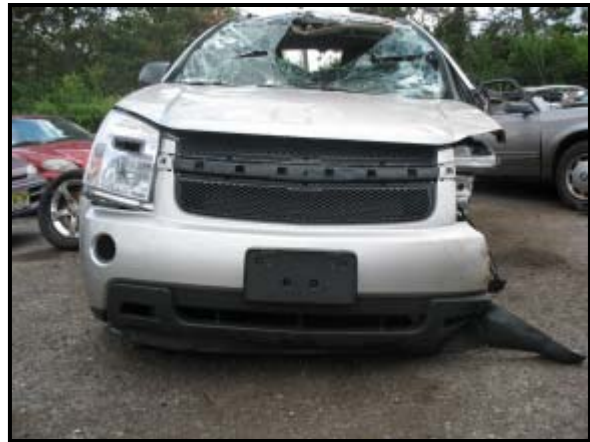
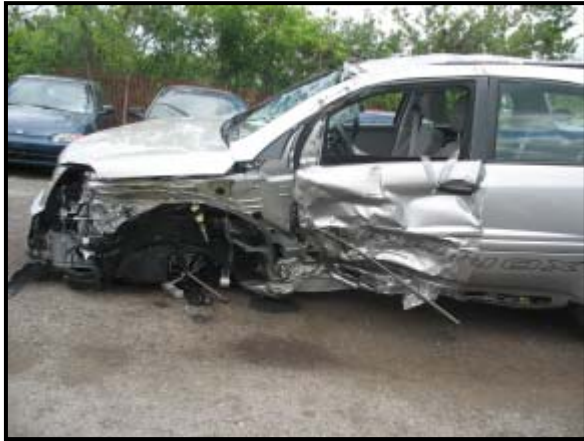
The exterior damage to the Chevrolet consisted of frontal impact damage and rollover damage consistent with the multiple event impact sequence. **Figures 7 and 8** are the front and left side views of the Equinox, respectively. The direct contact damage to the frontal plane measured 19 cm (7.5 in) and began 58 cm (23 in) left of center extending to the left corner. The frontal contact occurred immediately outboard of the forward left sub-frame. There was no longitudinal compression/deformation of this component. The force of the impact separated the left front wheel assembly at the lower control arm. The direct contact along the left side extended rearward to the trailing edge of the left front door and measured 235 cm (92.5 in). The maximum lateral deformation measured 19 cm (7.5 in) and was located at the lower aspect of the left A-pillar. The left wheelbase was reduced 30 cm (12 in). The right wheelbase lengthened 5 cm (1.8 in) due to deformation of the right rear suspension. The left front door was jammed shut. The left rear door and the right doors remained closed and were operational post-crash. The Collision Deformation Classification (CDC) was 12-FLEE9.

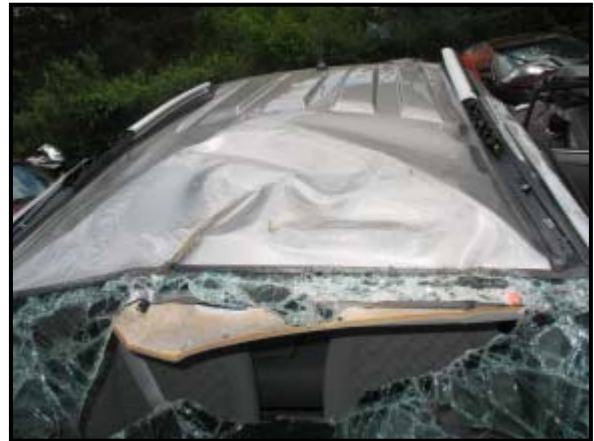
The Chevrolet's exterior damage was consistent with a six-quarter turn rollover event. The vehicle's two side planes, top plane and the wheels/tires exhibited damage from ground contacts. The scratch pattern along the right roof side rail was bi-directional in nature indicating the right side contacted the road at two different times. Similarly, bi-directional scratch patterns were observed on the roof and hood. The maximum vertical deformation of the roof was located at the junctions of both A-pillars and the respective roof side rails. The maximum vertical deformation measured 4 cm (1.5 in). There was no lateral deformation of the greenhouse. The CDC of the rollover damage was 00-TDD02

Figure 9: View of the roof.

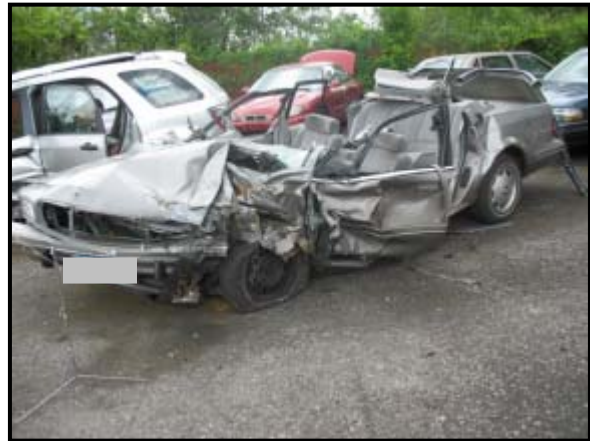
The Buick Century sustained severe damage as a result of the frontal impact with the Chevrolet. **Figure 10** is a left front oblique view of the Buick. The front plane sustained 30 cm (12 in) of direct contact damage that began 48 cm (19 in) left of center and extended to the left corner of the bumper. The combined width of the direct and induced damage extended across the entire 157 cm (62 in) frontal end width of the vehicle. The residual crush profile measured along the bumper reinforcement bar was as follows: C1 = 95 cm (37.5 in), C2 = 51 cm (20.0 in), C3 = 39 cm (15.5 in), C4 = 23 cm (9.0 in), C5 = 0, C6 = 0. The exterior damage associated with this corner impact extended 182 cm (71.5 in) rearward to the forward aspect of the left front door. The left front wheel rim was deformed in the impact and the tire was cut. The left wheelbase was reduced 29 cm (11.3 in). The right wheelbase lengthened 8 cm (3.2 in) due to body deformation. The left front door was jammed shut by deformation. The left rear door and the right doors remained closed and were operational post-crash. The left corner of the instrument panel was deformed rearward 13 cm (5 in). The roof was removed and base of the left B-pillar was cut to

Figure 10: Left oblique view of the Buick.

extricate the driver. The CDC of the exterior damage was 12-FLEE8. The delta V of the Buick calculated by the Barrier Equivalent Model of the WINSMASH program was 36 km/h (22.3 mph). The longitudinal and lateral components were -36 km/h (22.3 km/h) and 0, respectively.

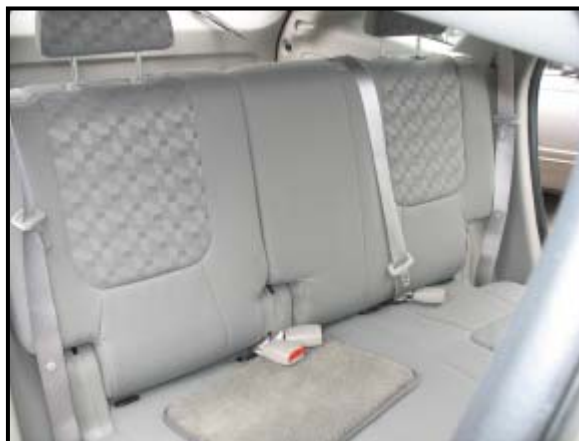
The second row of the Chevrolet Equinox consisted of an adjustable three passenger 60/40 split bench seat (left side wide). The seat was adjusted 10 cm (4 in) forward of full rear. The outboard seat positions were equipped with head restraints that were adjusted up 6 cm (2.5 in). The seat back angle measured 20 degrees. The horizontal distance from the rear seat back to the front row seat backs measured 81 cm (32 in). The rear seat was equipped with Lower Anchors and Tethers for CHildren (LATCH) in all three positions, **Figure 11**. Inspection of the lower

Figure 11: Second row seat with LATCH.

anchors revealed the surfaces of the bars were scratched from use. An interview with the driver indicated that LATCH was routinely used to install the child safety seats and the LATCH system was used at the time of the crash. Inspection of the second row seating area determined that there were no occupant contacts within the compartment.

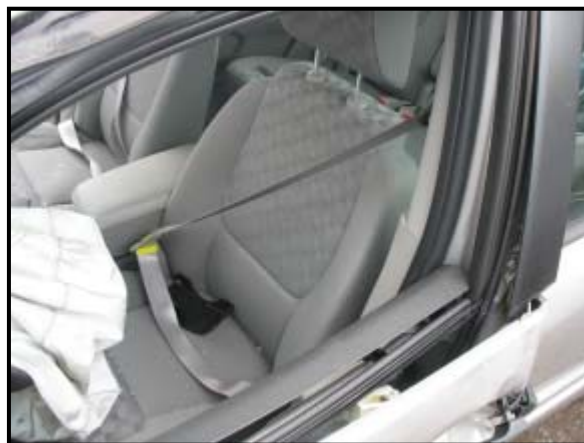
The manual restraint system in the Chevrolet Equinox consisted of three-point lap and shoulder restraints in the five seat positions. The driver's restraint consisted of continuous loop webbing, an Emergency Locking Retractor (ELR) with a pretensioner, an adjustable D-ring, and a sliding latch plate. The D-ring was 2 cm (1 in) above the lowest position. Upon initial inspection, the driver's webbing was found extended from the retractor and the retractor was locked due to the actuated pretensioner. **Figure 12** is a view of the driver's restraint in the reconstructed buckled condition. A 6 cm (2.5 in) abrasion to the webbing from latch plate loading was located 66 cm (26 in) above the outboard anchor. An 8 cm (3 in) webbing abrasion was located 2 cm (1 in) below/behind the D-ring. Due to its location (on the retractor side) below the D-ring, this abrasion was a result of the pretensioner actuating. The SCI inspection of the belt system determined the driver was restrained at the time of the crash.

Figure 12: Driver's restraint.

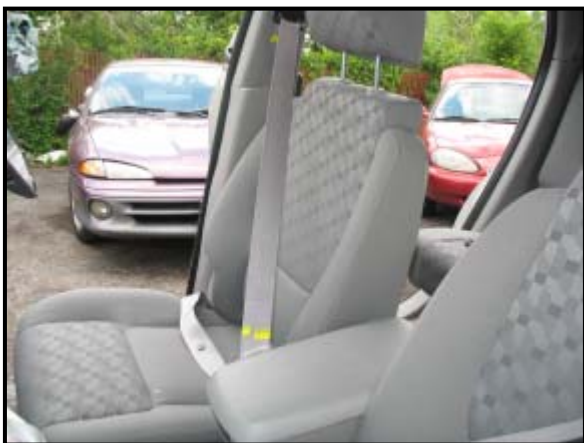
The front right passenger restraint consisted of continuous loop webbing, a switchable Automatic Locking/Emergency Locking retractor (ALR/ELR) with pretensioner, an adjustable D-ring, and a sliding latch plate. The D-ring was 2 cm (1 in) above the lowest position. Inspection of the restraint found the webbing extended and the retractor locked due to the actuated pretensioner (**Figure 13**). A 5 cm (2 in) webbing abrasion from latch plate loading was located 64 cm (25 in) above the outboard anchor. A 10 cm (4 in) abrasion was located on the retractor side of the webbing (below the D-ring) similar to the driver's belt. This abrasion began 5 cm (2 in) below the D-ring and occurred as a result of the actuated pretensioner. Inspection of this restraint determined that the front right passenger was restrained at the time of the crash.

Figure 13: Front right passenger's restraint.

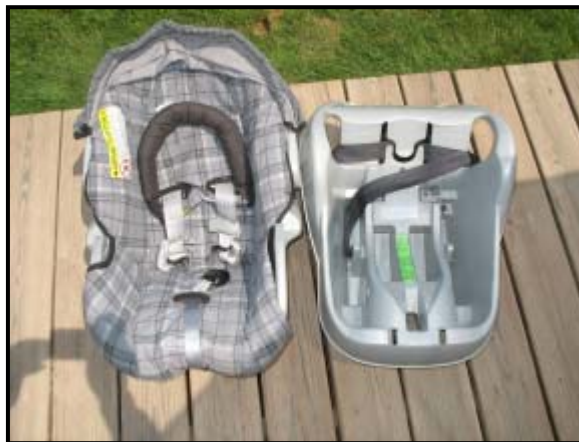
The two children seated in the second row of the Chevrolet were each restrained within a Child Safety Seat (CSS). The 1 month old female was restrained by the five-point harness system of a Graco Snug Ride rear-facing infant seat, **Figure 14**. The CSS was designed with a detachable base. The seat was identified by the Model No: 7411KBK and Serial No: JJ1205032109. The seat was manufactured on 12-05-2003 and was rated for rear-facing use by infants that weigh less than 9 kg (20 lb) and are less than 66 cm (26 in) in length. At the time of the crash, the infant seat and base were restrained by the LATCH belt to the lower anchors of the second row left seat

Figure 14: View of the Graco infant seat and base.

were not roped and were properly routed. There was no crash related evidence identified on the harness straps or on the safety seat shell.

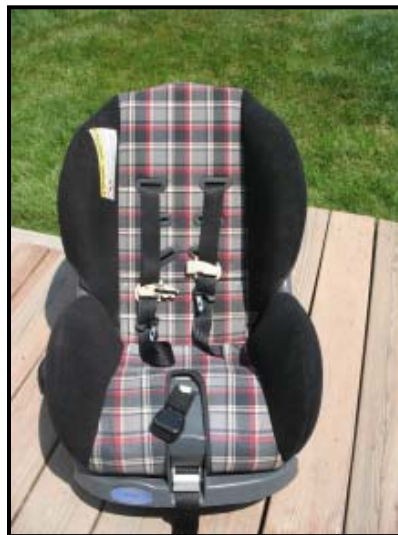
The 3 year old female was restrained within a Graco Comfort Sport convertible child safety seat, **Figure 15**. This seat was installed in a forward-facing mode in the second row right position with the LATCH system (lower anchors and tether). The seat was identified by the Model No: 863DEU and it was manufactured on November 17, 2004. The CSS was designed for rear facing use by children weighing 2.2 to 9 kg (5 to 20 lb) and for forward facing use by children that weigh from 9 to 18 kg (20 to 40 lb) and have a height less than 102 cm (40 in). The straps of the five point harness were to be adjusted to top slots for children weighing (30 to 40 lb). The five-point harness straps were adjusted to the top slots and were not roped or creased. The harness retainer clip was present and the retainer clip and buckle functioned properly. The adjustable foot was in the upright position as instructed for forward facing use. Examination of the shell was unremarkable for crash related evidence.

Figure 15: Convertible CSS.
