ON-SITE NOT IN TRAFFIC SURVEILLANCE BACK OVER INVESTIGATION

CASE NUMBER - IN-07-018

LOCATION - MISSOURI

VEHICLE - 2006 HONDA CR-V SE

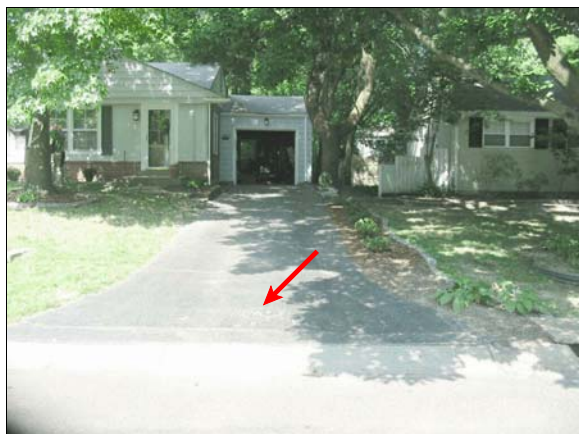
Figure 1: Overview of scene; arrow shows location of witness vehicle at time of impact

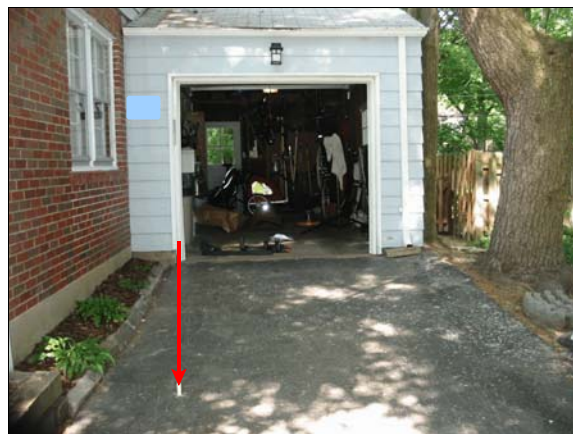
Figure 2: Overview of garage; arrow shows area of impact and final rest of pedestrian

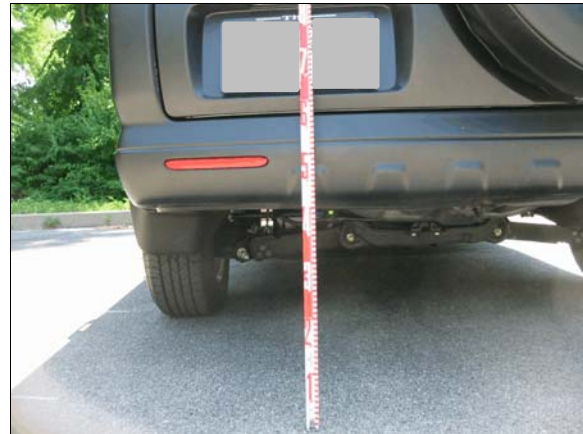
Figure 3: Back bumper and undercarriage of exemplar 2006 Honda CR-V; scale in tenths of meter

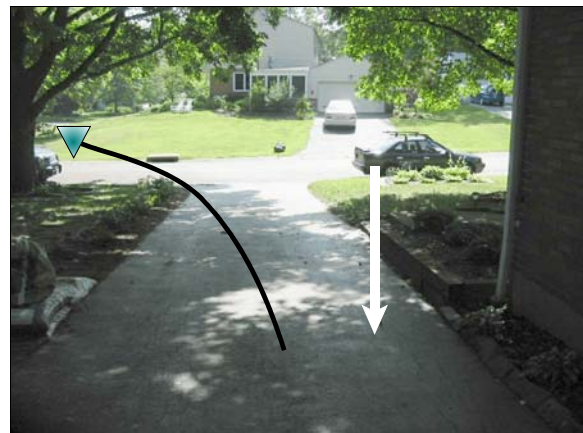
Post-Crash: The Honda continued rolling down the driveway and veered off the north side of the driveway (**Figure 4**), narrowly missing the husband's vehicle. The Honda continued into the street and came to rest in a clump of bushes in a yard across the street. The Honda traveled approximately 38 meters (~ 125 feet) from impact to its final rest position. At final rest, the

Figure 4: Honda backed straight out of garage to area of impact indicated by white arrow. Long arrow shows direction Honda rolled away after driver exited vehicle.

pedestrian was laying face down near the point of impact (**Figure 4** above). The pedestrian was transported by ambulance to a hospital and was pronounced dead.

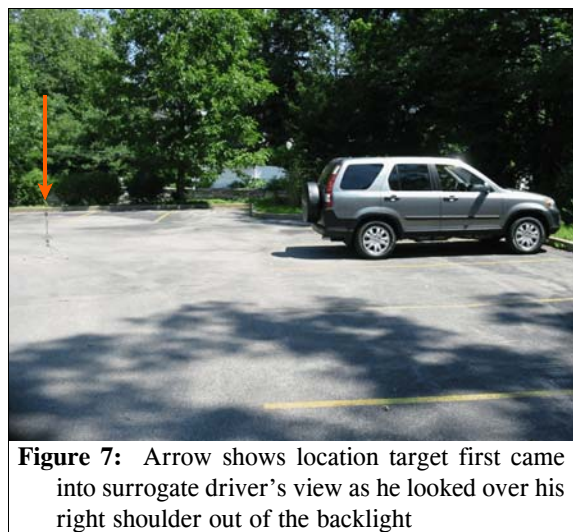
For the assessment of the blind zone behind the Honda, the target was positioned behind the Honda and moved rearward until it came into the surrogate driver’s view as he looked over his right shoulder out of the backlight. It was necessary to move the target rearward from the back of the Honda 4.6 meters (15.1 feet) before the surrogate driver could see it (**Figure 7**). At this point, if the target was moved 0.5 meters (1.6 feet) to the right of the approximate centerline, it became obstructed by a raised contour at the bottom of the backlight (**Figure 8** below). Therefore, the target was moved rearward an additional 90 centimeters (35 inches) where it could be seen over the raised contour. When the target was moved right 1.2 meters (3.9 feet) from the centerline, it became obstructed by the spare tire (**Figure 8** below), which was mounted to the tailgate exterior. It would have been necessary to move the target a additional short distance rearward to be seen over the top of the spare tire; however, this measurement was not taken. The target became visible on the right side of the spare tire when it was moved 2.1 meters (6.9 feet) to the right of the centerline. When moved 2.9 meters (9.5 feet) to the right of the centerline, the target became obstructed by the right “D”-pillar. The target became visible again through the right rear-most window when it was moved right an additional 1.4 meters (4.6 feet). When the target was moved 90 centimeters (35 inches) to the left from the Honda’s centerline, it became obstructed by the left “D”-pillar. The surrogate driver could not turn his head far enough to the right to see past the left “D”-pillar.

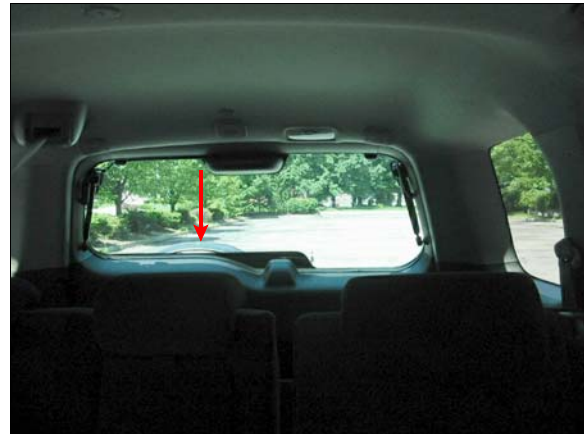
Figure 8: View out of backlight of exemplar Honda from driver’s seat; arrow shows raised contour at base of backlight and top of spare tire.

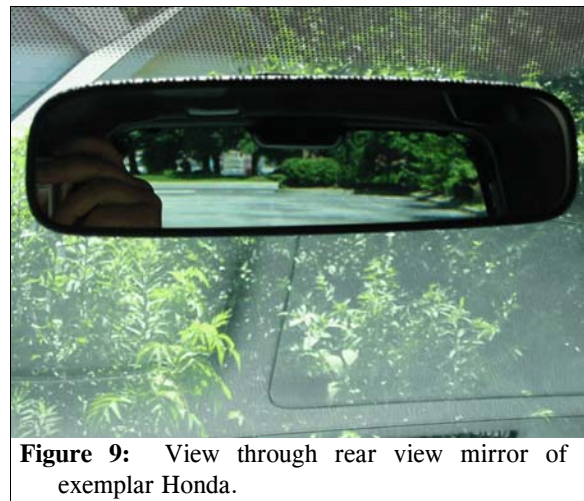
The surrogate driver was then asked to view behind the Honda through the rearview mirror (Figure 9). The target was not visible to the surrogate driver until it was moved rearward 6.7 meters (22 feet) from the back of the Honda (Figure 10). The target was moved to the right 1 meter (3.3 feet) from the centerline and was obstructed by the very top of the spare tire. As the target was moved further to the right, it became visible again at 1.7 meters (5.6 feet) from the centerline. At 2.5 meters (8.2 feet) to the right of the centerline, the target was obstructed by the right “D”-pillar. The target became visible again when moved right an additional 0.9 meter (3 feet), but was near the edge of the mirror. When moved left from the centerline 1.3 meters (4.3 feet), the target was obstructed by the left “D”-pillar as well as the driver’s face in the rearview mirror and could not be seen if moved further left.

Figure 9: View through rear view mirror of exemplar Honda.

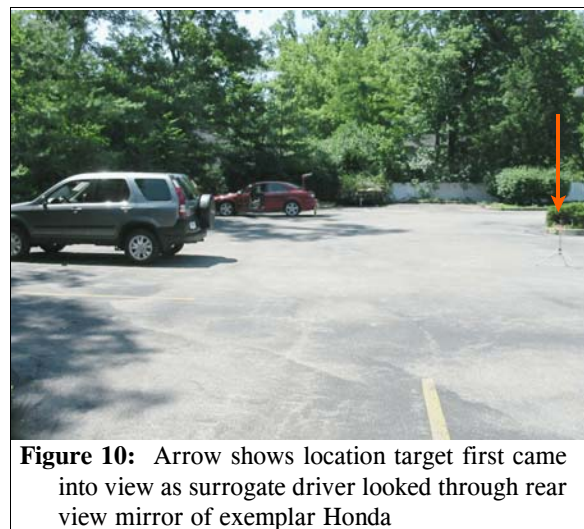
The driver stated in her interview that before backing the Honda out of the garage, she looked through the rearview mirror and continued to view through this mirror while backing. The visibility study showed that the pedestrian, who was standing approximately 3.9 meters (~13 feet) behind the Honda, was within the Honda’s rearview mirror blind zone and not visible to the driver.

Figure 10: Arrow shows location target first came into view as surrogate driver looked through rear view mirror of exemplar Honda
