Remote Not In Traffic Surveillance Back Over Investigation  
Dynamic Science, Inc. / Case Number: DS07021  
2006 Chrysler 300  
California  
March 2007

1. Report No. DS07021		2. Government Accession No.		3. Recipient Catalog No.	
4. Title and Subtitle Not In Traffic Surveillance Back Over Investigation				5. Report Date August 1, 2008

**Dynamic Science, Inc.**  
**Crash Investigation**  
**Case Number: DS07021**

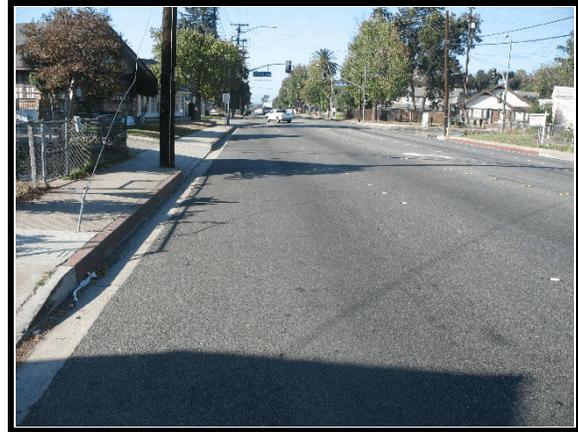
**Figure 2.** Overview of vehicle backing path (west)

The incident took place on an east/west urban roadway (**Figure 2**). The roadway was configured with two lanes in each direction that were separated by a double row of raised yellow pavement markers. The travel lanes were separated by single rows of raised white pavement markers. Just east of the area of impact, the yellow pavement markers shift to the south to accommodate a left turn lane. The roadway was bordered on both sides by raised concrete curbs. The curb at the area of impact is painted red, indicating a No Parking area. To the south of the roadway, there is a 1.8 m

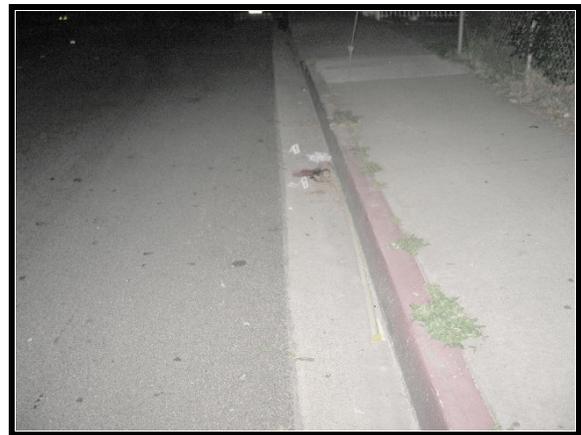
**Figure 3.** Area of impact (looking east)

The child left her position on the sidewalk and ran into the street and into the path of the Chrysler as it was backing. The child would have been in the driver's blind spot at this time. The driver's vision was likely degraded due to the vehicle's tinted windows, but he did report that he was able to see the child before backing. It is not known why the child left the sidewalk, but police investigators indicated that it was most likely that she was excited to see her father get home from work and was running to meet him at the driver's door of the vehicle. The driver reported a backing speed of 3.2-4.8 km/h (2-3 mph). The Chrysler traveled rearward approximately 5.1 m (16.7 ft). The driver recalled a "bump" and thought he may have struck the curb. The child was struck by the right rear bumper, knocked down, and likely hit her head on the curb (**Figure 3**).

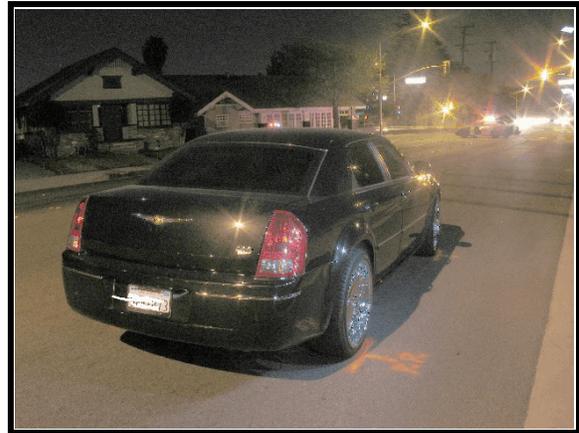
**Figure 4.** Chrysler 300 at final rest (west)

After the impact, the driver put his vehicle into DRIVE and pulled forward and made a U-turn to park along the north curb line (**Figure 4**), across the street from the residence. As he was turning, he looked to his left and observed that he had struck his daughter. The driver exited the vehicle and ran to the child who was lying near the curb (**Figure 5**). At this same time, a police patrol vehicle drove up to the scene while on their way to an unrelated call. The driver moved aside to allow the police officers to assist the injured child. The child sustained serious head injuries. She was transported to a local hospital where she was admitted and hospitalized for an unknown number of days.

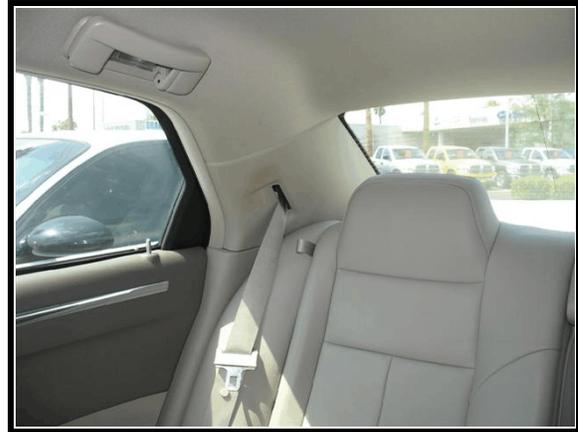
**Figure 7.** View over right shoulder, exemplar vehicle

The initial set of measurements were taken as if the driver were looking over his right shoulder through the backlight. The target was moved rearward from the back bumper along the vehicle's centerline until it became visible to the investigator. The point at which the target became visible to the investigator measured 7.32 m (24.0 ft) rearward of the back bumper. This measurement was used as the point of origin for two sets of lateral measurements which were then taken. Measurements taken laterally to the left and right would result in a visibility zone that could be viewed through the backlight. The second row head restraints and the center high-mounted stop lamp partially blocked the investigator's rearward vision through the backlight (**Figure 7**). The lateral measurements were taken from the vehicle's center line to the left and right sides of the backlight until the target was out of view either due to the presence of the head restraints, center high-mounted stop lamp or the C-pillars. At 7.32 m (24.0 ft) rearward of the back bumper, the left lateral aspect of the visibility zone fell between the lamp and the left rear head restraint and measured 1.47 m (4.8 ft) in width. The right lateral aspect fell between the lamp and the right rear head restraint and measured 1.73 m (5.7 ft). The blind zone created by the lamp was 0.94 m (3.1 ft) in width. The distance at which the roadway surface became visible to the driver when looking through the backlight was estimated to be 17.92 m (58.8 ft).

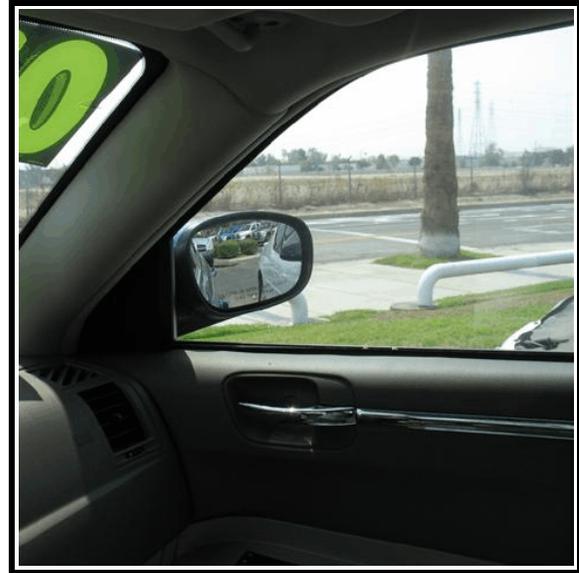
**Figure 8.** View through right side view mirror, exemplar vehicle

Since the SCI investigator was using an exemplar vehicle, he adjusted the side mirrors appropriately for the driver's seated eye height. With the SCI investigator seated, the side views were examined. The target was placed at the right side of the back bumper. The target was moved from the side of the vehicle laterally to the right until the target became visible through the right side view mirror. The target was then moved laterally to the right to the point where the target was no longer visible. These measurements resulted in a visibility zone which could be viewed through the side view mirror (**Figure 8**). This process was repeated on the left side of the vehicle. The area between the left and right visibility zones resulted in a blind zone. Directly behind the back bumper, the blind zone measured 1.9 m (6.2 ft) in width. The overall width of the vehicle was 1.88 m (6.2 ft). The target was then placed at 7.93 m (26.0 ft) rearward of the back bumper. Lateral measurements were

taken to the left and right at the points at which the investigator could view the target through the side view mirrors. The area between the two visible points resulted in a blind zone. At 7.93 m (26.0 ft) rearward of the rear bumper, the blind zone was approximately 1.2 m (4.0 ft) in width. The target was then moved further to the left and right until it could no longer be viewed through the rear view mirrors. The areas to the left and right in which the target could be viewed resulted in side view visibility zones. At 7.93 m (26.0 ft) rearward of the rear bumper, the resulting visibility zones measured 2.95 m (9.7 ft) for the left side and for the right side 3.69 m (12.1 ft).

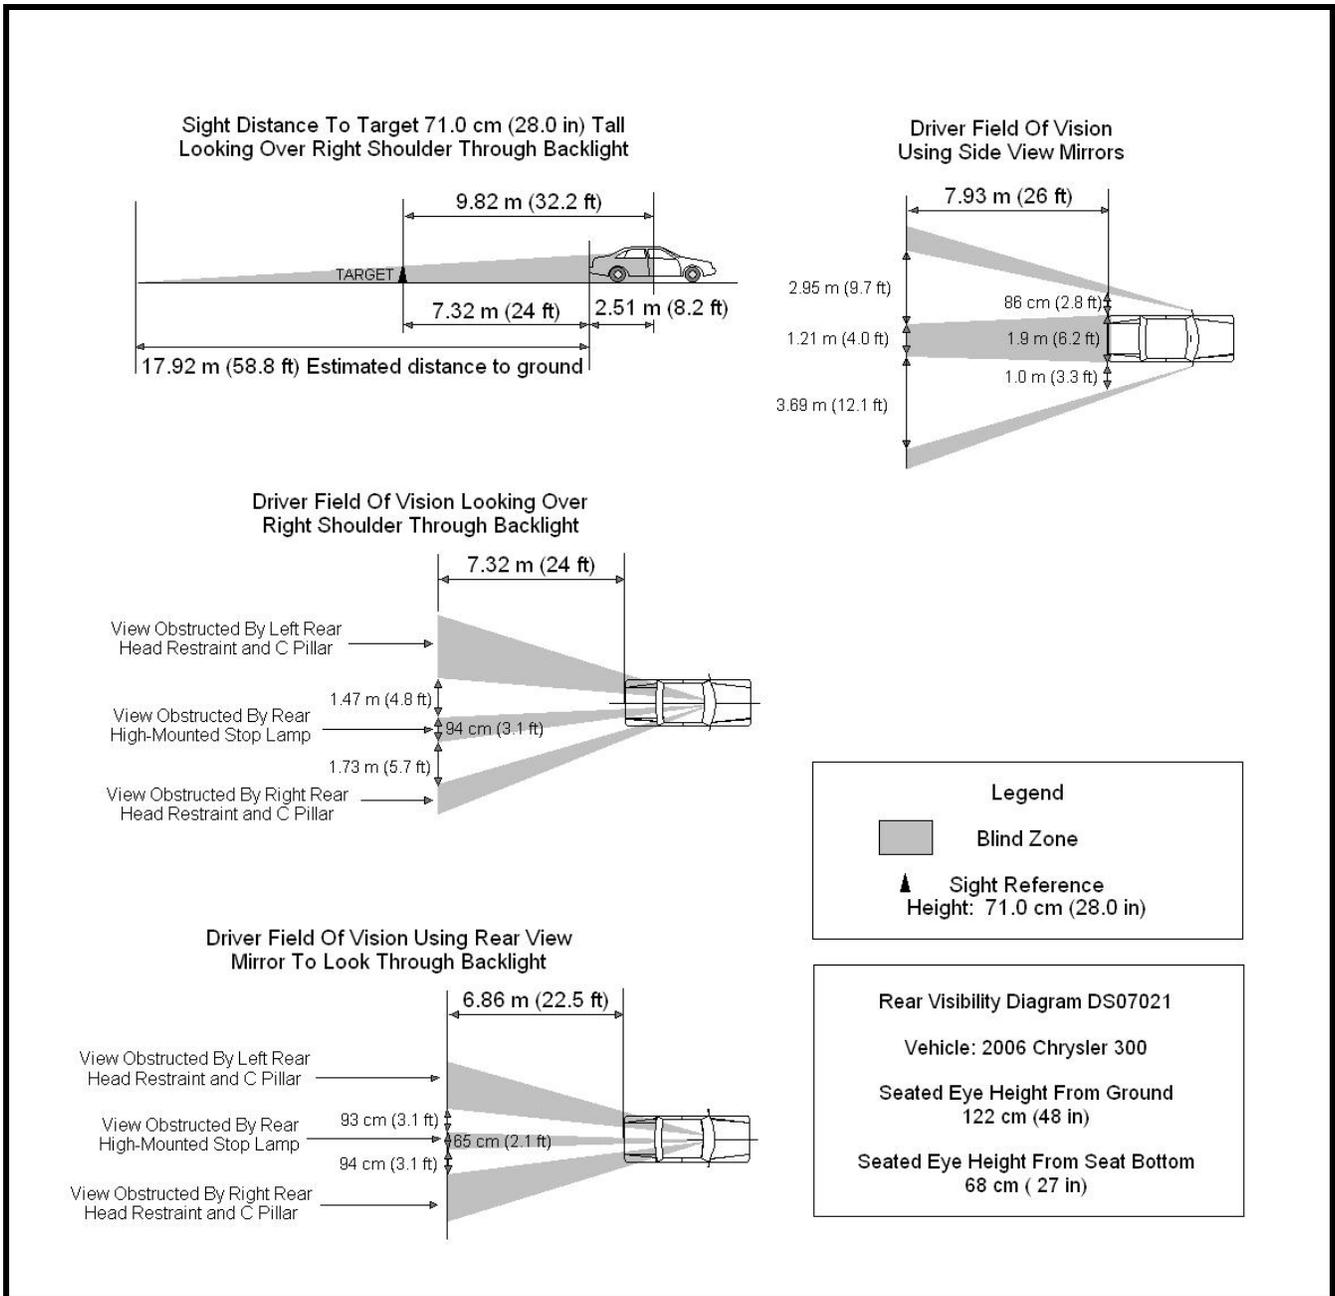
Figure 9. Nominal visibility diagram

A nominal visibility diagram is included on the following page (**Figure 9**).

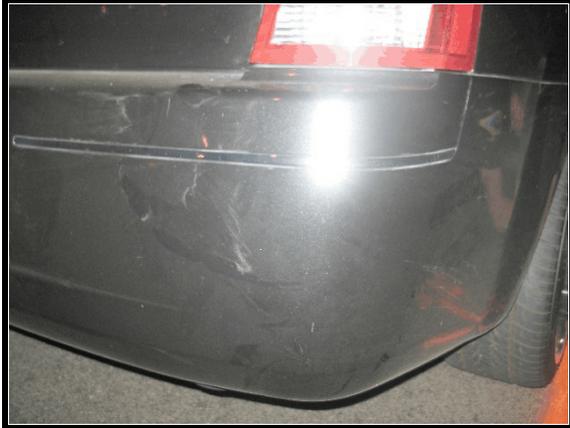
**Figure 10.** Scuffing to right rear bumper

There was no exterior damage to the vehicle. There was some light scuffing located on the right rear bumper corner area (**Figure 10**). There was also some light scuffing along the sill area just forward of the right rear tire (**Figure 11**).
