CALSPAN ON-SITE BACK OVER INVESTIGATION

SCI CASE NO.: CA07-022

VEHICLE: 2003 JEEP LIBERTY

CRASH DATE: JUNE 2007

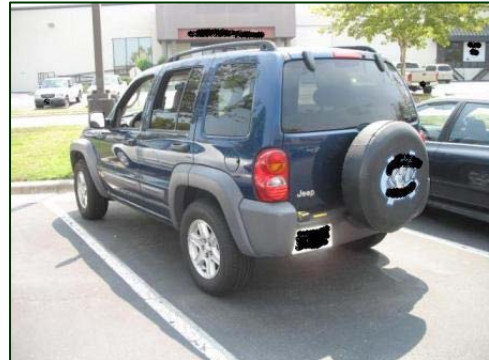
Figure 1. The involved 2003 Jeep Liberty

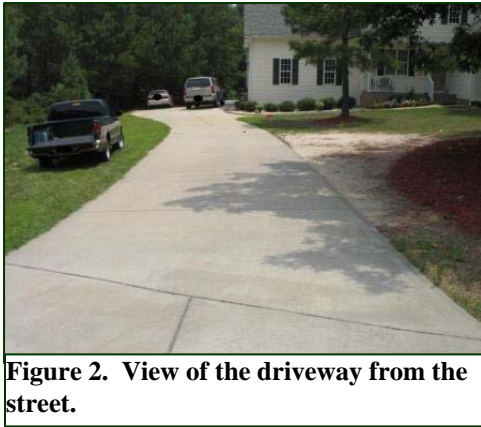
The driveway was 34 m (111.5') in length that terminated at a large concrete parking area in front of a side-loading garage (**Figure 2**). The house and the attached garage extended to the right of the driveway. The driveway curved slightly to the left when viewed from the road and had a slight super elevation due to the cross slope of the property (**Figure 3**). The mid section of the driveway where the crash occurred was level. A sidewalk that provided access to the front door exited the right side of the driveway immediately prior to the garage. The driveway had a width of 3.7 m (12.1') while the sidewalk was 1.2 m (3.9') in width.

Figure 2. View of the driveway from the street.

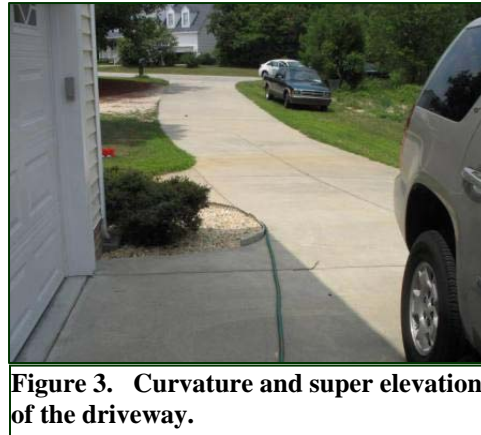
Figure 3. Curvature and super elevation of the driveway.

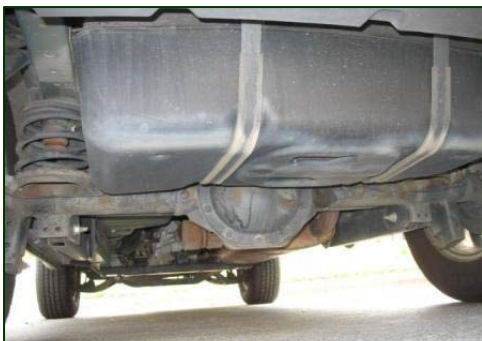
The exterior and undercarriage of the Jeep Liberty did not exhibit evidence of non-motorist contact at the time of the SCI inspection. The vertical clearance heights of the various components for this Jeep Liberty (**Figures 6 and 7**) are identified in the following table:

Figure 6. Rear undercarriage view of the Liberty.

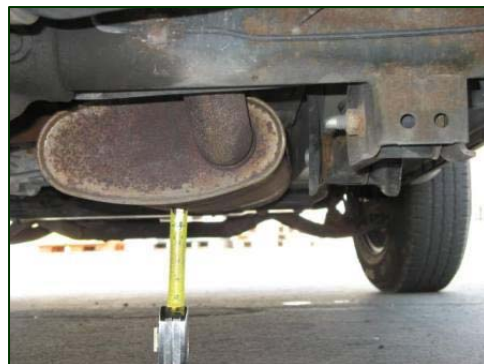
Figure 7. Muffler height.

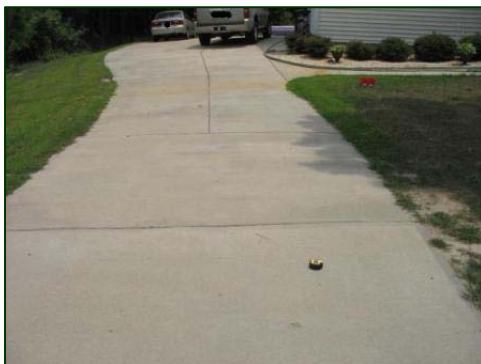
Figure 8. Approximate position of the Jeep Liberty at impact and final rest.

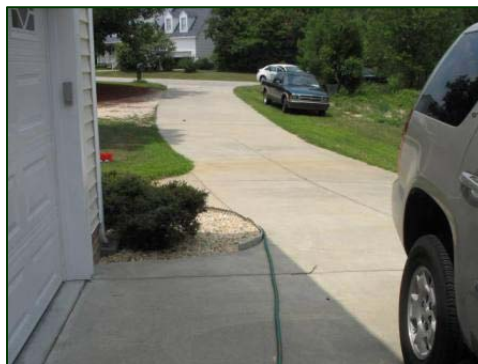
Figure 9. Trajectory of the 19-month old child non-motorist.

The 19-month old non-motorist exited the garage and proceeded down the driveway, initially approaching the Liberty from the front. The non-motorist continued to proceed along the right side of the Jeep (**Figure 9**). This travel path of the non-motorist was not witnessed by the driver or the daycare provider, therefore it is unknown if the child ran or walked toward the Jeep Liberty.

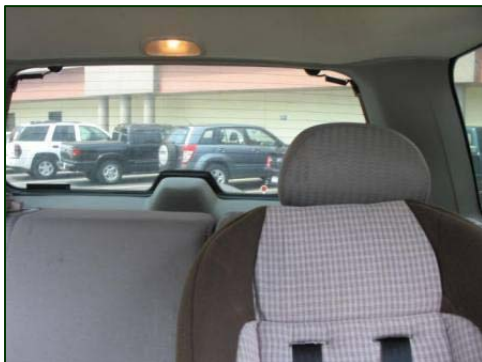
The SCI investigator positioned the reflective marker until it was fully visible to the driver through the interior mounted rear view mirror (**Figure 10**). The longitudinal distance from the back bumper to the target reflector was 5.9 m (19.4’). The driver’s line of sight through the rear view mirror to the ground was an additional 6.6 m (21.7’) for a total distance of 12.5 m (41’). It should be noted that the driver claimed the exterior-mounted spare tire obstructed her visibility. However, the SCI vehicle inspection determined the rear-mounted spare tire did not protrude above the base of the rear glazing to obstruct her rear visibility (**Figure 10**).

Figure 10. Rear visibility to the reflective marker.

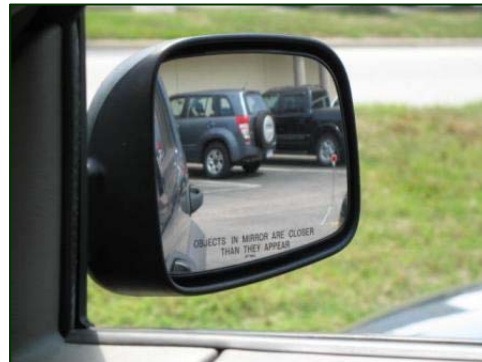
Figure 11. Right outside mirror visibility from the driver’s position.

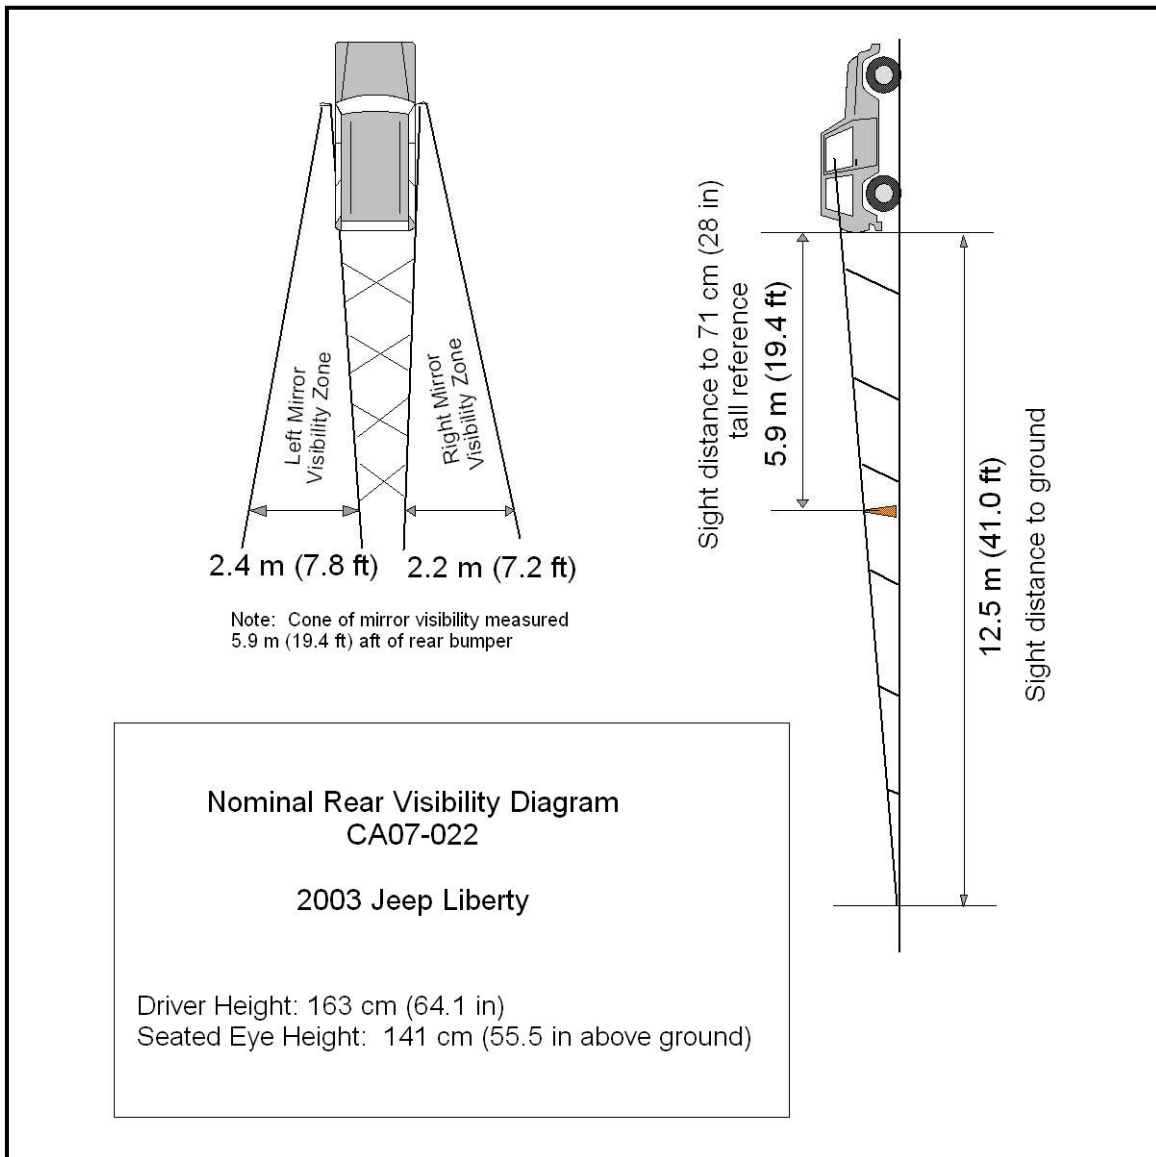
Figure 12: Rear Visibility Diagram

Lateral lines of sight were determined from the outside rear view mirrors using the referenced 5.9 m (19.4') as the baseline rear distance. The mirrors were adjusted to the same positions used at the time of this incident. Through the adjustment of the left outside mirror, the driver could see the 71 cm (28") tall reflector from a point that was 0.3 m (12") left of the centerline of the vehicle to a lateral left distance of 2.4 m (7.9'). The right outside mirror (**Figure 11**) provided the driver with a line of sight that began 0.6 m (28") right of the centerline to an outboard point that was 2.2 m (7.2') right of the longitudinal centerline. Based on these lines of site, the driver could not see the non-motorist as he crossed behind the vehicle. These sight distances are referenced in the Visibility Diagram that is attached as **Figure 12**.
