ON-SITE NOT IN TRAFFIC SURVEILLANCE BACK OVER INVESTIGATION

CASE NUMBER - IN07023

LOCATION - NEW MEXICO

VEHICLE - 2004 OLDSMOBILE ALERO

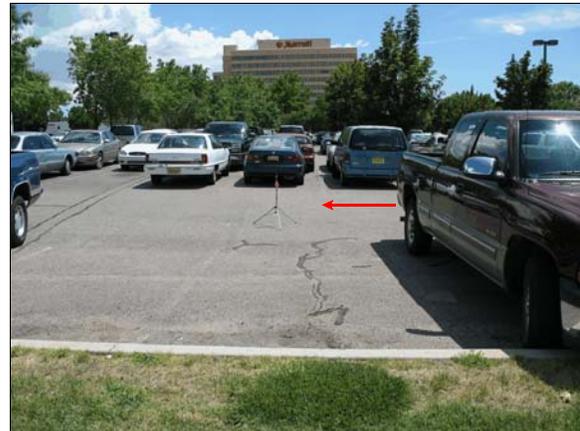
Figure 1: View south to parking space where Oldsmobile was parked; arrow shows path of pedestrian; tripod shows driver reported point of impact and area of final rest of pedestrian.

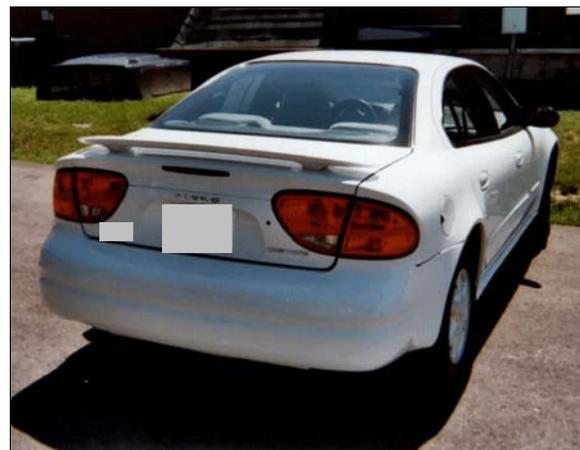
Figure 2: Overview of back of exemplar Oldsmobile Alero; pedestrian was struck by right portion of back bumper of subject vehicle

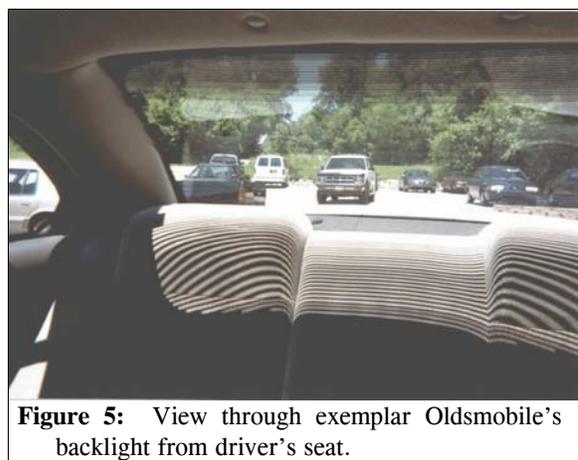
The initial observations were made with the surrogate driver looking over his right shoulder out of the backlight (**Figure 5**). The target was moved rearward from the back of the vehicle along the vehicle's approximate centerline until it came into the surrogate driver's view. The target had to be moved rearward from the exemplar Oldsmobile's back bumper 4 meters (13.1 feet) before it became visible to the surrogate driver. Although the gap was narrow, the surrogate driver had a small but clear field of view and could clearly see the target. Due to the position of the gap relative to the surrogate driver's eye height, the driver's normal line of sight passed through the gap when the surrogate driver looked over his right shoulder, although it was natural to look over the spoiler. When looking over the spoiler, it was necessary to move the target 8.7 meters (28.5 feet) rearward from the back bumper before the surrogate driver could see it. The lateral extent of the blind zone was assessed from the point where the target could first be seen in the gap between the trunk lid and the spoiler. When moved 3 meters (9.8 feet) to the right of the

Figure 5: View through exemplar Oldsmobile's backlight from driver's seat.

Oldsmobile's approximate centerline, the target became obstructed by the right "C"-pillar. The target became visible again when it was moved an additional 1.2 meters (3.9 feet) to the right. When moved 1.2 meters (3.9 feet) to the left of the centerline, the target went out of view because it was unnatural for the surrogate driver to turn his head any further to the right.

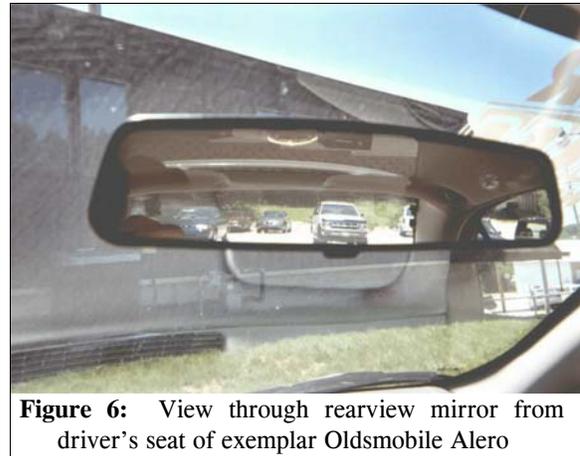
The surrogate driver then looked through the rearview mirror (**Figure 6**) as the target was again moved rearward from the back bumper.

The target had to be moved rearward 5.4 meters (17.7 feet) before it became visible to the surrogate driver. At this point, the target was moved 2.1 meters (6.9 feet) to the right of the approximate centerline where it became obstructed by the top right of the spoiler. The target was out of the rearview mirror's field of view when moved right beyond this point. The target was then moved to the left from the centerline. At 1.4 meters (4.6 feet) left of the centerline, the target became obstructed by the top left of the spoiler. The target was out of the rearview mirror's field of view when moved left beyond this point.

Figure 6: View through rearview mirror from driver's seat of exemplar Oldsmobile Alero
