TRANSPORTATION RESEARCH CENTER

ON-SITE NOT IN TRAFFIC SURVEILLANCE BACK OVER INVESTIGATION

CASE NUMBER - IN07024
LOCATION - NEW MEXICO
VEHICLE - 2003 CHEVROLET TAHOE
INCIDENT DATE - May 2007

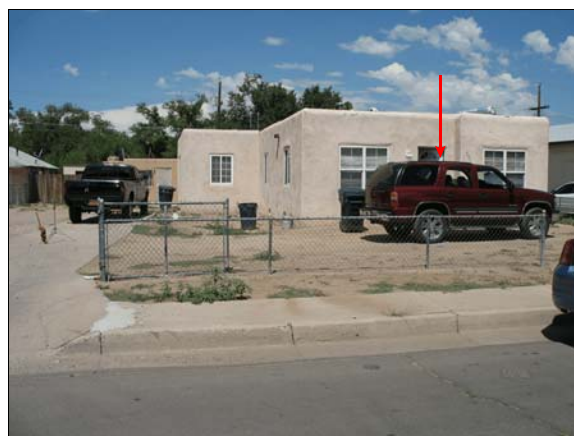
Crash Environment: The Chevrolet Tahoe was initially parked facing north in the level, front yard of the driver's home (**Figure 1**). The yard was just north of a paved driveway that was the common street access for the driver's residence as well as several other nearby residences. The driveway was approximately 2.8 meters (~ 9 feet) in width. The driver had to back onto the driveway in order to exit the yard and enter the

Figure 1: View west showing overview of crash scene, arrow shows Chevrolet parked in same position as at time of incident, truck at left was not present at time of incident

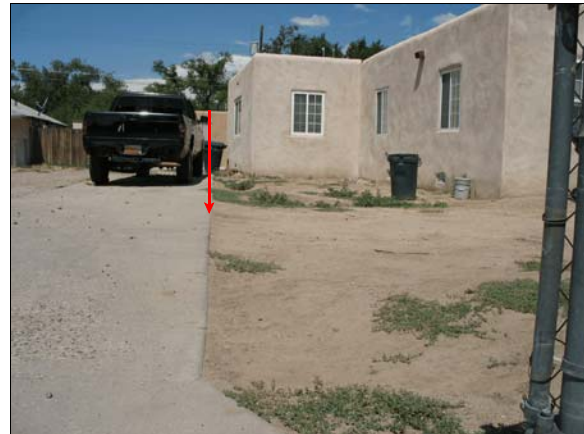
street. The yard was level where the Chevrolet was parked, but sloped up slightly toward the driveway edge and was approximately 3 centimeters (~1 inch) lower than the driveway (Figure 2), which required the driver to accelerate in order to get over the edge of the driveway. The driver indicated she would routinely “punch” the accelerator to get over this rise because letting the vehicle idle rearward was insufficient to travel up the rise. The nonmotorist, who lived in the residence behind the driver’s residence, was playing in the driveway riding around on a toy truck. The nonmotorist was located near the south edge of the driveway and just west of the southeast corner of the driver’s residence (Figure 3). A refuse container was also located near this corner of the residence adjacent to the left rear corner of the Chevrolet (Figure 3). The nonmotorist’s mother (i.e. the witness) was also outside and was located west of the nonmotorist. At the time of the incident, the light condition was daylight, the atmospheric condition was clear, and the driveway pavement was dry, level concrete. There were no other vehicles in the driveway at the time of the incident. The site of the incident was residential. See the Scene Diagram at end of this report.

Figure 2: Arrow shows rise from yard to driveway edge

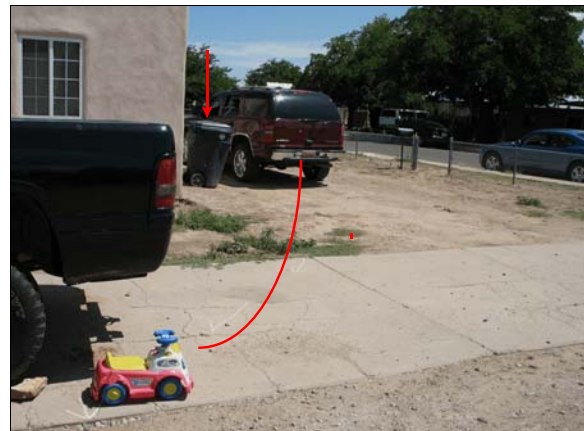
Figure 3: Red line shows approximate path of Chevrolet to area of impact indicated by toy truck nonmotorist was riding (truck left of toy truck was not present at time of crash), arrow shows refuse container near vehicle at time of crash

The on-site investigation determined that the Chevrolet had traveled backward from the parked position to impact approximately 10 meters (~33 feet). The Chevrolet traveled an additional approximate 1.2 meters (~4 feet) from impact to final rest. The Chevrolet’ impact speed was estimated to be approximately 4 km.p.h. (~3 m.p.h.) by considering the distance traveled from impact to final rest, a reasonable deceleration value for the Chevrolet and possible reaction times for the driver.

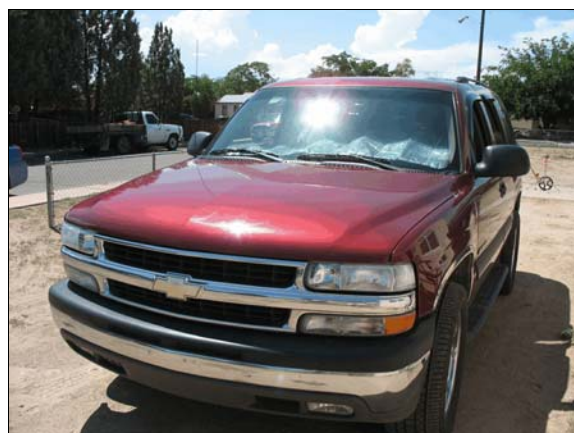
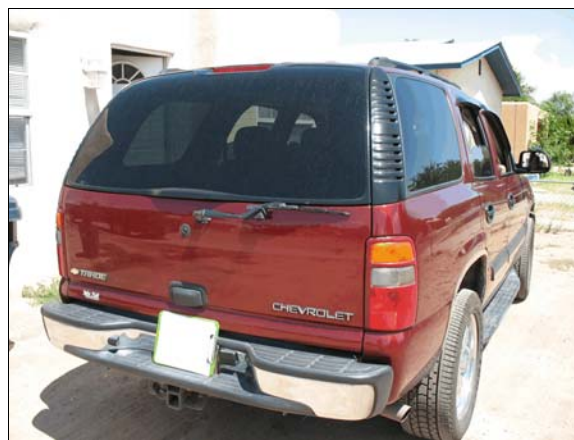
The 2003 Chevrolet Tahoe (**Figures 4 and 5**) was a rear wheel drive, four-door, sport utility vehicle (VIN: 1GNEC13V23R-----) equipped with a 4.8L, V8 engine and automatic transmission. The Chevrolet was equipped with tinted windows in the second seating row and in the cargo area as well as a tinted backlight. At the time of the incident, the driver had the left front and right front windows fully open and both second row windows partially open (i.e., they were open to their limit). The Chevrolet was not equipped with a backup/parking aid or any after-market equipment. The distance from the ground to the bottom of the back bumper was 54 centimeters (21.3 inches). The distance from the ground to the beltline was 126 centimeters (49.6 inches). The Chevrolet’s wheelbase was measured as 295 centimeters (116 inches). The

There was no evidence of damage or contact to the Chevrolet's back bumper and no evidence of contact to the right rear tire. However, based on the available information, and Collision Deformation Classification (CDC) guidelines for pedestrian impacts, a CDC was estimated to describe the contact to the nonmotorist. The CDC was determined to be **06-BRLN-1** for the back bumper impact. The Chevrolet was not damaged and remained at the scene.

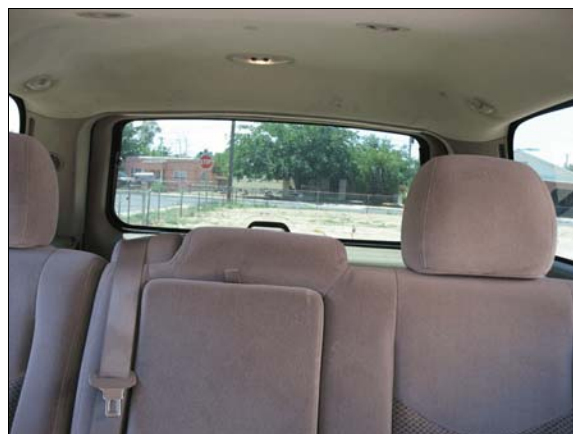
The target was positioned behind the Chevrolet and as the driver looked over her right shoulder (**Figure 6**), it was moved rearward until the target came into the driver's view. It was necessary to move the target rearward from the back of the Chevrolet 7.3 meters (23.9 feet) before the driver see it (**Figure 7** below). At this point, when the target was moved 4.2 meters (13.8 feet) to the right of the Chevrolet's approximate centerline, it became obstructed by

Figure 6: View out of back light from driver's seat showing view obstruction by left "D"-pillar and back left head restraint

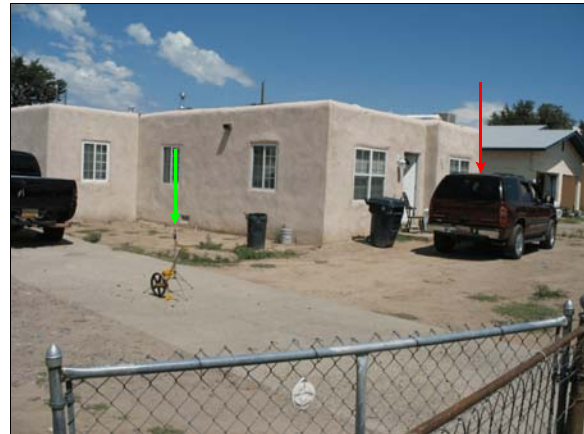
The visibility study showed that the Chevrolet had a large blind zone behind the

Figure 7: Overview of position of target relative to back of Chevrolet (red arrow); measuring wheel shows location target could first be seen by driver looking through rear view mirror, tripod (green arrow) shows location driver could first see target looking over her right shoulder out of backlight

vehicle as well as side view mirror blind zones down both sides of the vehicle that extended just beyond the back of the vehicle. However, since the driver reported that she was looking out of the open left front window during the backing maneuver, these blind zones were not a factor in this incident. The investigation indicated that as the driver initially looked out of the open left front window prior to backing, her view of the nonmotorist was likely blocked by the large refuse barrel near the back left corner of the Chevrolet and possibly by the southeast corner of her residence. As the driver turned the steering wheel to the left and the rear end of the vehicle angled to the southwest, her field of view out of the left front window continued to sweep to the southwest and the area where the nonmotorist was located was possibly blocked by the back left side of the Chevrolet and possibly the left “B”-pillar.

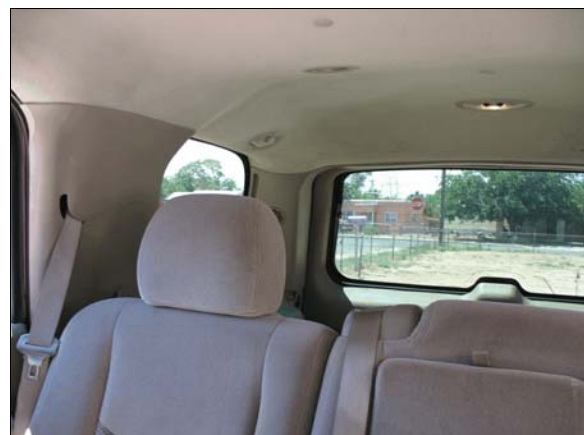
the right D-pillar (**Figure 8**). The target was then obstructed by the right rear head restraint when moved further to the right. When moved 0.8 meters (2.6 feet) to the left of the centerline, the target became obstructed by the left rear head restraint (**Figure 6** above) and did not come back into the driver's view when moved further to the left.

Figure 8: View out of backlight from driver's seat showing vision obstruction due to right "D"-pillar and back right head restraint

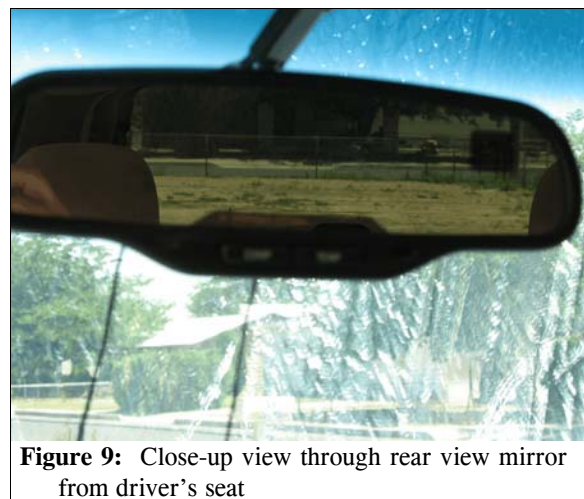
The driver was then asked to view behind the Chevrolet through the rear view mirror (**Figure 9**). The target was not visible to the driver until it was moved rearward 7.6 meters (24.9 feet) meters from the back of the Chevrolet (**Figure 7**). The target was then moved to the right 2.2 meters (7.2 feet) from the centerline where it became obstructed by the right rear head restraint. It was not visible when moved further to the right. When moved left of the centerline, the target was visible for 1.5 meters (4.9 feet) before being obstructed by the left rear head restraint.

Figure 9: Close-up view through rear view mirror from driver's seat

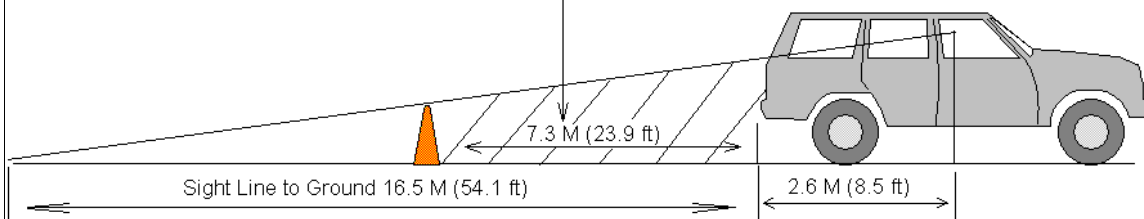
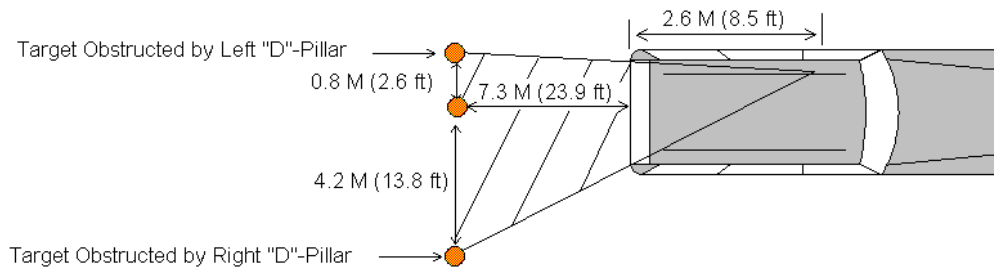
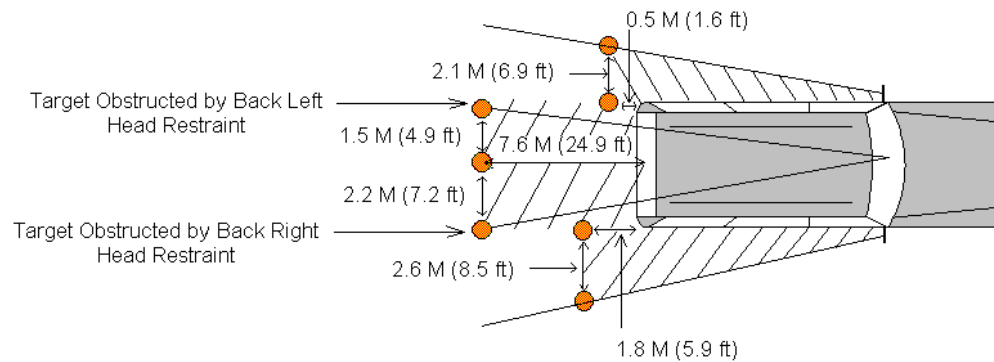
Nominal Visibility Diagram
Case Vehicle = 2003 Chevrolet Tahoe

1. Distance Back of Chevrolet
To Point a 71 cm (28 in) High Reference Target
Comes Into View as Driver Looks Over Right Shoulder

2. Rear View Mirror and Side View Mirror Blind Zones
