Rollover Investigation  
Dynamic Science, Inc. / Case Number: DS07025  
2006 Nissan Armada  
Washington  
May 2007

1. Report No. DS07025	2. Government Accession No.		3. Recipient Catalog No.	
4. Title and Subtitle Rollover Investigation		5. Report Date October 12, 2007

**Dynamic Science, Inc.**  
**Crash Investigation**  
**Case Number: DS07025**

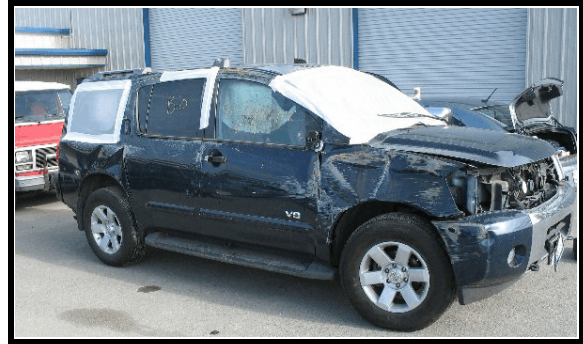
This on site investigation focused on a 2006 Nissan Armada (Figure 1) that was involved in a rollover crash. This single vehicle crash occurred in May 2007 at 1805 hours. The crash occurred on a three-lane divided interstate highway. The speed limit at this location is 115 km/h (70 mph). The case vehicle was a 2006 Nissan Armada that was being driven by a restrained 45-year-old male. There were three additional occupants in the vehicle, including a 43-year-old female front right seat occupant, a 7-year-old female second row left occupant, and an 11-year-old male second row right occupant. All occupants were restrained.

**Figure 1.** Rollover damage, 2006 Nissan Armada

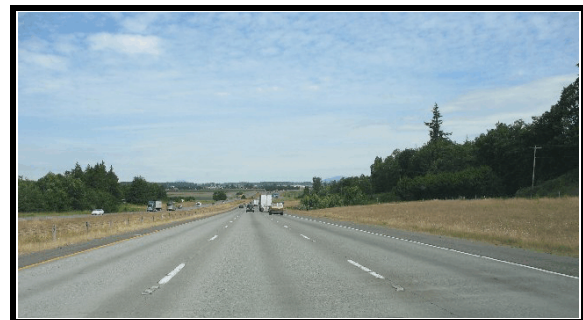
This single vehicle crash occurred in May 2007 at 1805 hours. The crash occurred on a three-lane divided interstate highway (Figure 2). At the time of the crash, there were no adverse weather conditions and the concrete roadway surface was dry. The highway was configured with three lanes that were separated by broken white lines. The roadway was bordered on the east by an asphalt shoulder that was separated from the roadway by a solid white line. The roadway was bordered on the west by an asphalt shoulder that was

**Figure 2.** Area of overturn (north)

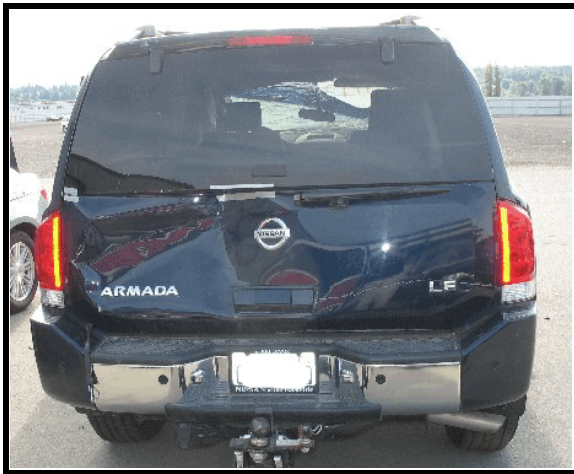
The 2006 Nissan Armada sustained minor rear damage as a result of the intra-unit contact with the travel trailer, possibly prior to the rollover (Figure 3). The direct damage began 12.0 cm (4.7 in) left of the vehicle centerline and extended 60.0 cm (23.7 in) to the left. The maximum crush measured 12.0 cm (4.7 in) on the tailgate. There was also a light scratch that began 14.0 cm (5.5 in) right of the centerline and extended 66.0 cm (25.9 in) to the right. The CDC for the intra-unit contact was 06BDMW1. There also appeared to be some damage to the stop on the trailer hitch that occurred during the movement between the vehicle and the trailer (Figure 4).

**Figure 3.** Trailer damage, Nissan Armada

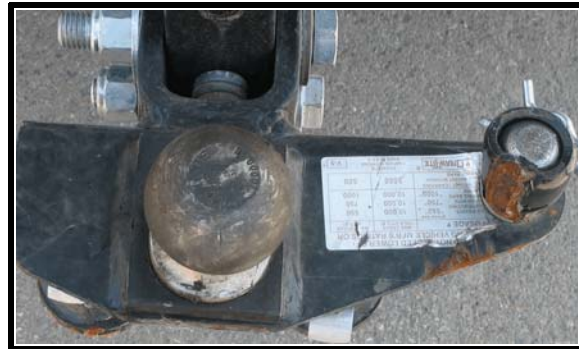
**Figure 4.** Damage to trailer hitch

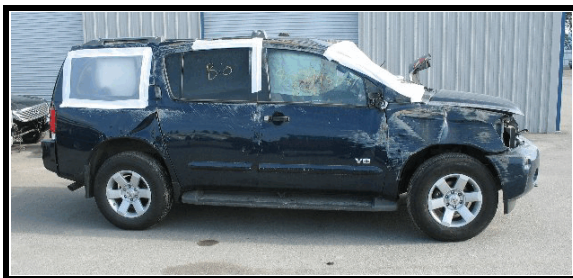
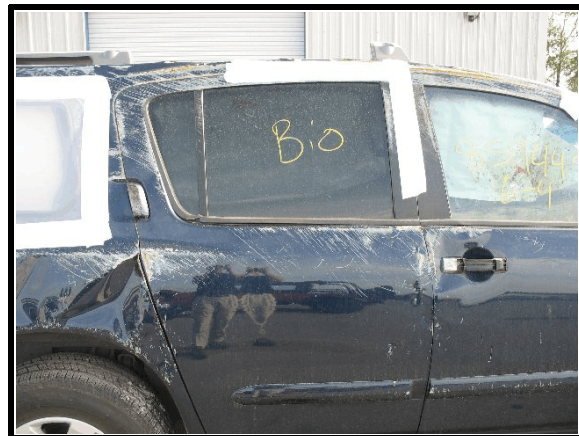
The Armada sustained moderate right side damage as a result of the one quarter turn rollover (Figures 5 and 6). The direct damage began at the front right bumper corner and extended 462.0 cm (181.9 in) rearward along the right side plane. The maximum crush was located near the base of the C pillar at the right rear door edge and measured 4.0 cm (1.6 in). The CDC for the rollover was 00RDAO2.

Both right side doors were jammed shut. The windshield cracked. It was later holed by heat sag. The third row right side glass disintegrated.

**Figure 5.** Right side rollover damage

**Figure 6.** Close up of rollover damage

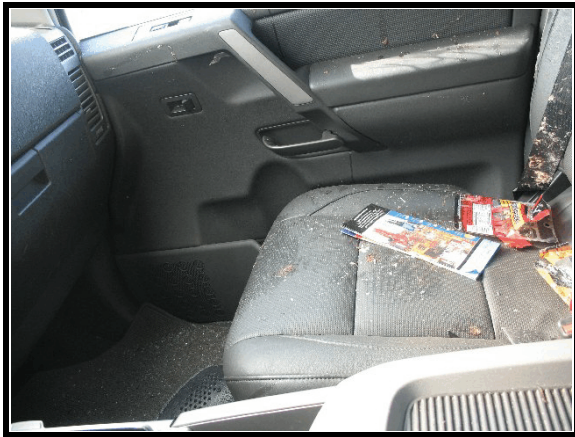
The 2006 Nissan Armada sustained minor interior damage as a result of passenger compartment intrusion. The right side doors, right roof rail and right B pillar sustained lateral intrusion.

Position	Intruded Component	Magnitude of Intrusion	Direction
Right front	Roof rail	2.0 cm (0.8 in)	Lateral
Right front	B pillar	3.0 cm (1.2 in)	Lateral
Right front	Door	4.0 cm (1.6 in)	Lateral
Second row right	Door	3.0 cm (1.2 in)	Lateral

**Figure 7.** Front right door/B pillar intrusion

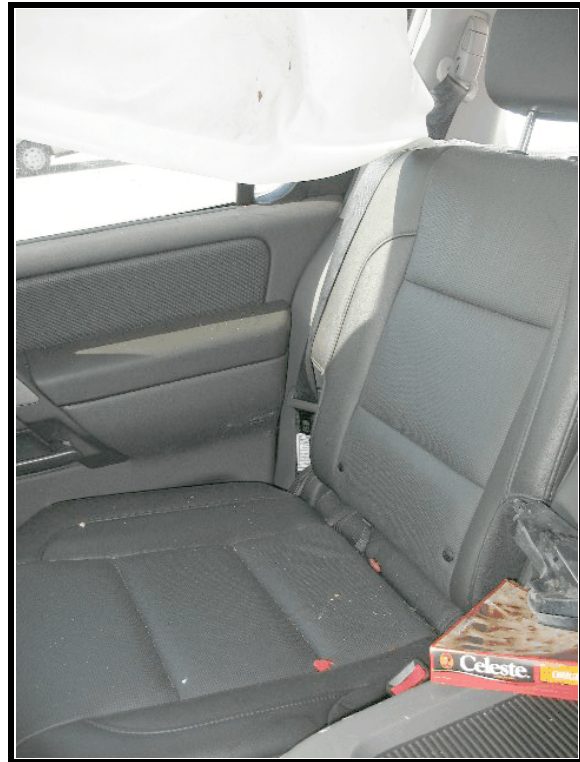
**Figure 8.** Second row right door intrusion

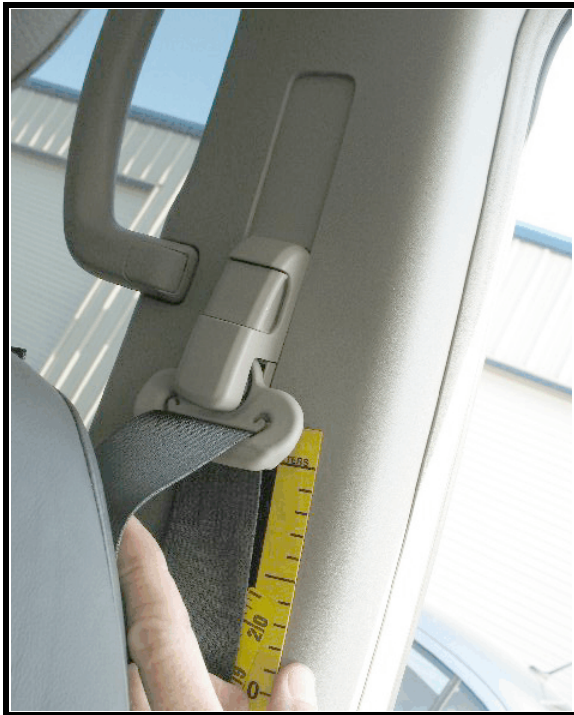
The 2006 Nissan Armada was configured with manual 3-point lap and shoulder belts for all seven seating positions. Both front seat belts were equipped with retractor and buckle pretensioners and adjustable D-rings that were in the full down positions. According to the EDR report, both front seat belt pretensioners actuated. The driver's safety belt was configured with a sliding latch plate and an Emergency Locking Retractor (ELR). At the time of the vehicle inspection, the driver's retractor was restricted in the used position as a result of pretensioner actuation. There were loading marks found on the driver's seat belt webbing (Figure 8).

**Figure 9.** Load marks to driver's seat belt webbing

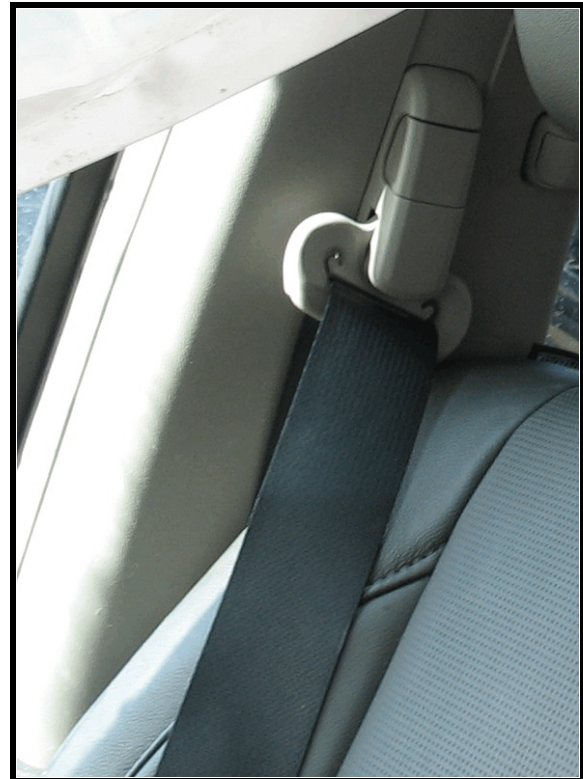
**Figure 10.** Front right passenger seat belt D ring/shoulder adjustment

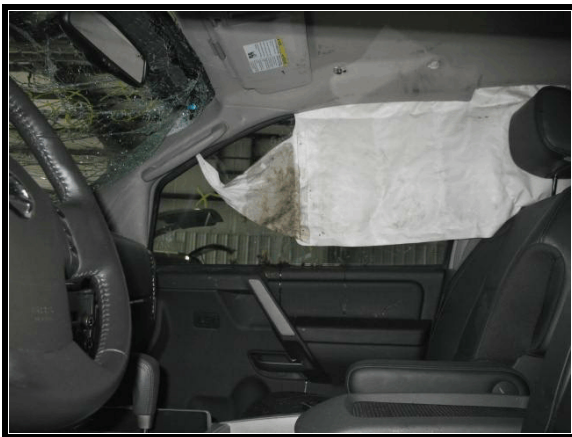
The side IC bags deployed from the roof rail cladding. The IC bags provide coverage for all three rows of seats. The IC was anchored to the A pillar in the front by a tether/sail that measured 34.0 cm (13.4 in) along the base by 27.0 cm (10.6 in) along the top. The IC height at this location was 39.0 cm (15.4 in). The IC extended rearward to the C pillar for 159.0 cm (62.6 in). The IC height at this location was 43.5 cm (17.1 in). There was a gap of 28.0 cm (11.0 in) between the IC in the second row seat and the IC in the third row seat. The IC that covered the third row was connected to the second row IC by a 63.0 cm (24.8 in) tether. The IC in the third row was 63.0 cm (24.8 in) wide by 53.0 cm (20.9 in) high.

**Figure 11.** Front right IC

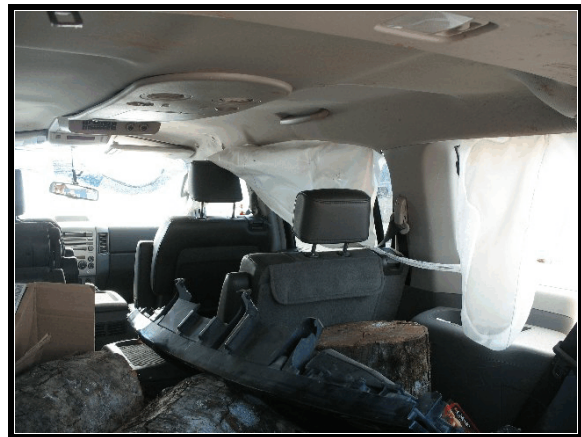
The 2006 Nissan Armada was equipped with dual-stage advanced frontal air bags, driver and front right seat seatback mounted side air bags, and roof rail mounted side inflatable curtains (IC). The frontal air bags were Certified Advanced 208-Compliant (CAC). A CAC vehicle is certified by the manufacturer to be compliant to the Advanced Air Bag portion of the Federal Motor Vehicle Safety Standard (FMVSS) No. 208. The frontal air bags and seat back mounted side air bags did not deploy. The left and right IC air bags deployed during the rollover.

**Figure 12.** Right side deployed IC

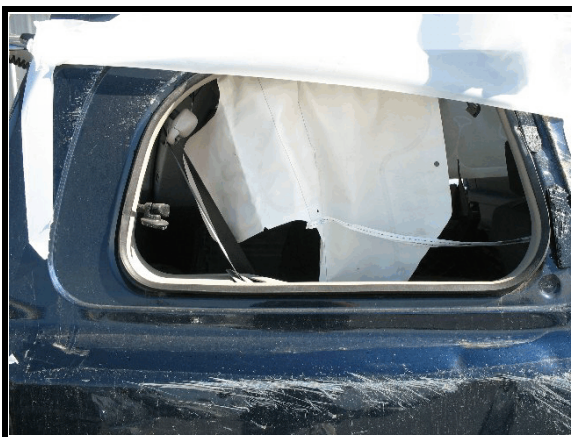
**Figure 13.** Exterior view of third row portion of side IC
