## ON-SITE NOT IN TRAFFIC SURVEILLANCE BACK OVER INVESTIGATION

CASE NUMBER - IN-07-026

VEHICLE - 1994 FORD RANGER

INCIDENT DATE - June 2007

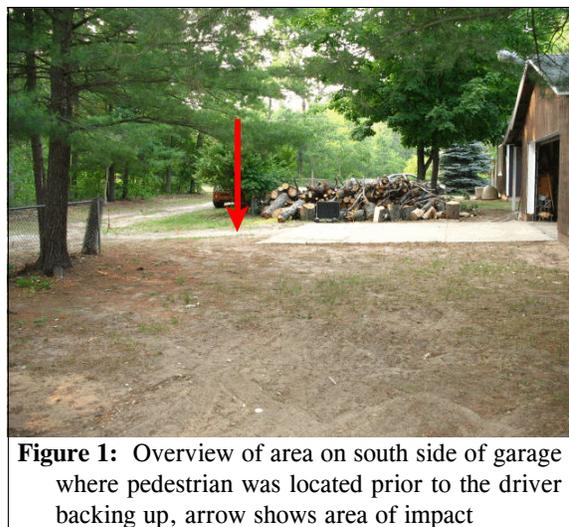
**Figure 1:** Overview of area on south side of garage where pedestrian was located prior to the driver backing up, arrow shows area of impact

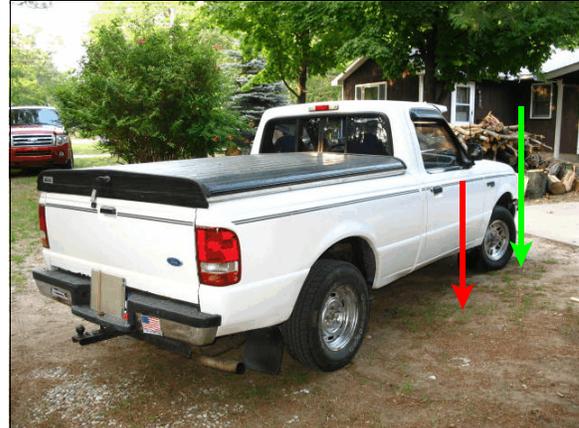
intersecting portion of the driveway. As the pedestrian and the cat approached the backing vehicle, and the vehicle entered the sandy portion of the driveway (**Figure 2**), she bent down and reached for the cat and her head impacted the truck bed rear of the right rear wheel (**Figure 3**). However, it could not be determined if the pedestrian made contact with the back or right side plane of the vehicle. She fell to the ground toward the southwest and the right rear tire rolled over her left arm as the Ford continued to back counterclockwise. The driver stated he thought he had run over a piece of fire wood. He stopped the Ford, got out, walked around behind the vehicle to the passenger side, and discovered the pedestrian laying face down on the right side of the Ford with her head toward the front of the vehicle (**Figure 2**). It is not known if she had moved any prior to the driver reaching her.

**Figure 2:** Rest position of Ford as positioned by driver, green arrow shows approximate impact location, red arrow shows area of final rest of pedestrian

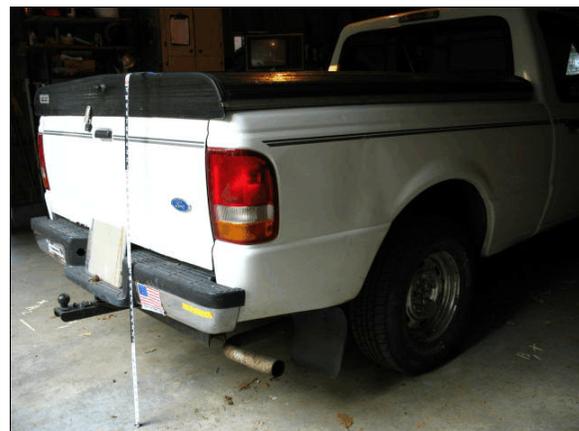
**Figure 3:** Overview of back right corner of truck bed; unknown if impact was to back plane or right side plane, black/white increments on scale are 0.3 meter (1 foot)

There was no evidence of pedestrian contact to the Ford's back bumper or the back right corner of the truck bed. The Ford was driven from the scene.

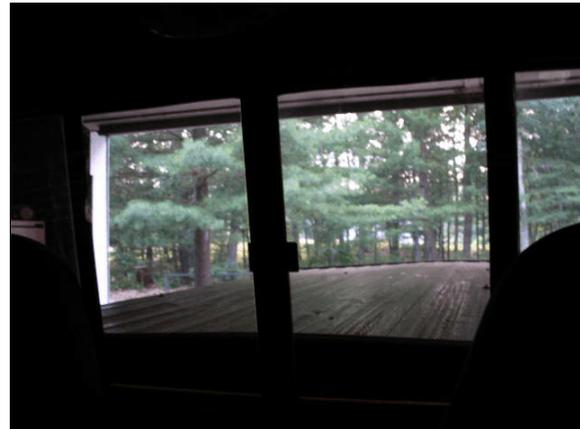
The initial observations were made with the driver looking over his right shoulder out of the backlight while the SCI investigator moved the standard 71 centimeters (28 inch) high target rearward from the back of the vehicle along the vehicle's approximate centerline until the driver could see it. The target had to be moved rearward 12.3 meters (40.2 feet) down the negative grade of the driveway (3.6% negative on the concrete portion and 5% negative on the sand portion) before it came into the driver's view (**Figure 7**). The target was then moved to the right 4.9 meters (16.1) where it became obstructed by a fence and tree. The target was moved an additional 7 meters (23.1 feet) to the right where it became obstructed by the edge of the garage door frame

**Figure 6:** View out of Ford's backlight from driver's seat; Ford parked in garage by driver in same location as at time of incident

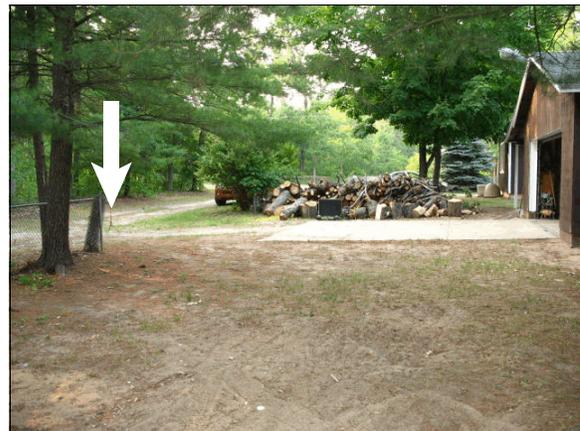
**Figure 7:** View from south side of driveway showing target (arrow) at location driver stated he could first see it as he looked over his right shoulder out of the Ford's backlight (Ford parked in the garage)

and could no longer be seen. The target was then moved to the left from the vehicle's approximate center line 2.1 meters (6.9 feet) where it went out of the driver's view because it was unnatural for him to turn his head any further to the right.

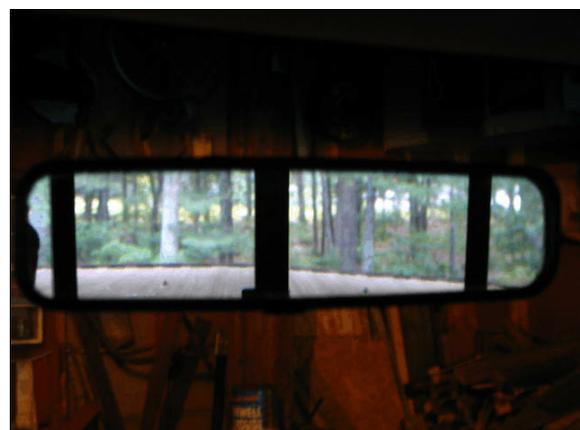
**Figure 8:** View through rear view mirror from driver's seat

The driver was then asked to view out the backlight through the rearview mirror (**Figure 8** above). The target was again moved rearward from the back of the vehicle down the negative grade of the driveway until the driver could see it. It had to be moved rearward 16.6 meters (54.4 feet) before the driver could see it. The target was then moved from this location 3.6 meters (11.8 feet) right of the Ford's approximate centerline where it went out of the rearview mirror's field of view. The target was then moved to the left from the centerline 3.4 meters (11.2 feet) where it again went out of the rearview mirror's field of view.

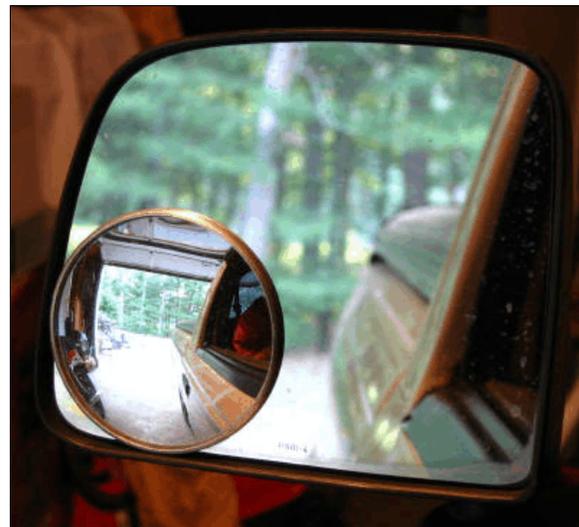
The target was also placed at the left side of the Ford adjacent to the driver's seat position as the driver viewed through the left side view mirror. The target was then moved rearward from the driver's seated position 2.4 meters (7.8 feet) before it came into the driver's view. The target was then moved to the left from the side of the vehicle 0.6 meters (1.9 feet) where it went out of the left side view mirror's field of view. The left side view mirror had a small after market convex mirror, which the driver had mounted to the regular mirror. The convex mirror provided a wide angle view of the area adjacent to the left side of the vehicle as well as behind the left side of the vehicle (**Figure 9**). The visibility zone of the convex mirror was not assessed because it was a non-standard mirror, the driver did not look through the left side view mirror prior to backing, and the pedestrian approached the Ford from the right. The target was repositioned on the right side of the vehicle adjacent to the driver's seated position and moved rearward as he looked through the right side view mirror. The target had to be moved rearward 1.2 meters (3.8 feet) before the driver could see it in the right side view mirror. The target was then moved to the right from the side of the vehicle 0.8 meter (2.5 feet) where it went out of the mirror's field of view.

**Figure 9:** View through Ford's left side view mirror from driver's seat

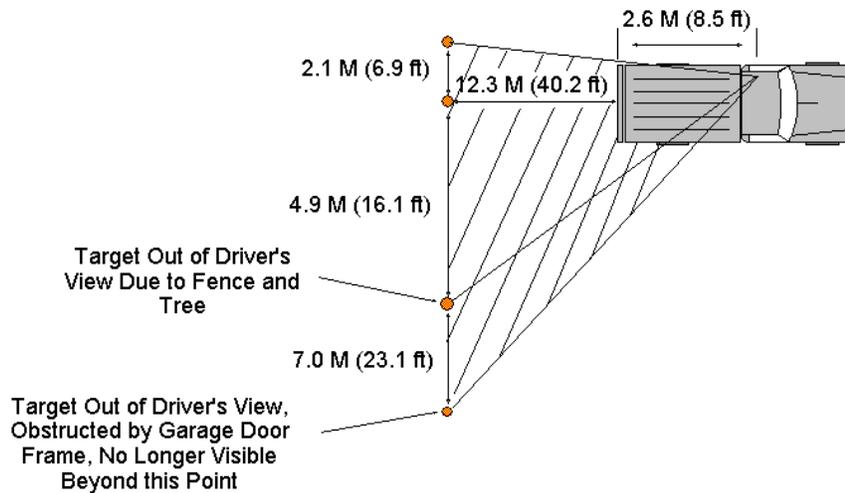
1. Distance Back of Ford  
To Point a 71 cm (28 in) High Reference Target  
Comes Into View

Nominal Visibility Diagram  
Case Vehicle = 1994 Ford Ranger 4X2 Pickup Truck

Ford Driver's Eye Height From Ground = 142 cm (56 in)
