CALSPAN ON-SITE CHILD SAFETY SEAT CRASH INVESTIGATION
SCI CASE NO: CA07-026

VEHICLE: 2006 FORD FOCUS
LOCATION: VIRGINIA
CRASH DATE: JULY, 2007

**CALSPAN ON-SITE CHILD SAFETY SEAT CRASH INVESTIGATION
SCI CASE NO.: CA07-026**

**VEHICLE: 2006 FORD FOCUS
LOCATION: VIRGINIA
CRASH DATE: JULY, 2007**

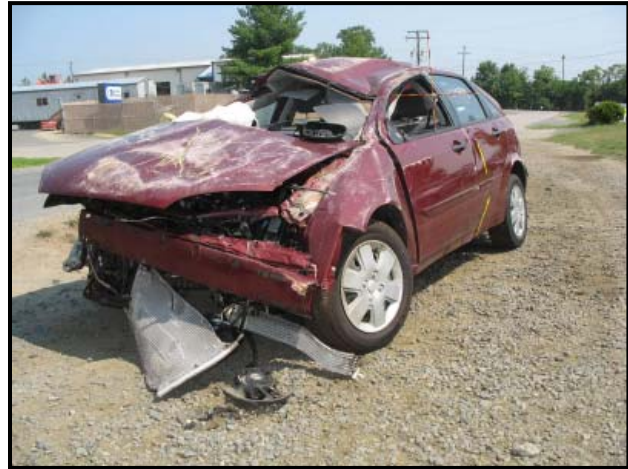
This investigation focused on the installation and usage of two child safety seats used to restrain two male children (year ages 3 and 4) within the rear seat of a 2006 Ford Focus during a high-speed, three-quarter turn, tripped rollover crash. **Figure 1** is a left front oblique view of the Ford Focus. The vehicle was driven by a restrained 23 year old male and was occupied by a 3 year male restrained within a Century Smart Move forward facing child safety seat in the rear left position and by a 4 year old male restrained within an unknown make/model backless booster in the rear right position. The vehicle was traveling southbound in the right lane of a divided two-lane state route at a driver reported speed of 105 km/h (65 mph). The driver became distracted by the children and allowed the vehicle to drift off the outboard (right) shoulder of the road. The driver then steered counterclockwise (left) and overcorrected causing a loss of control. The Ford yawed counterclockwise across the southbound lanes and impacted the depressed center median. The vehicle exited the median, tripped, and rolled over. The Ford impacted the pavement with its hood and roof and came to rest on the inboard northbound lane. The three occupants of the Ford were transported to a local hospital with minor injuries, treated and released within two hours of the crash.

Figure 1: Front left oblique view of the Ford Focus.

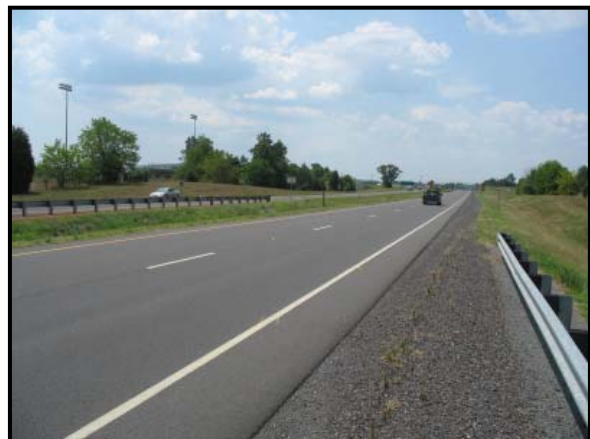
Figure 2: Southward view of the crash site.

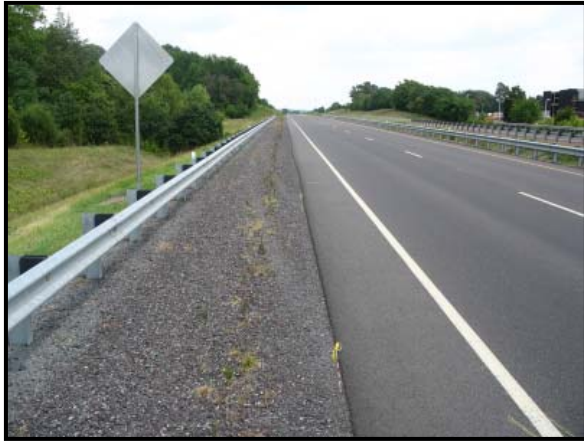
Figure 4: Look back view of the right side tire marks in the gravel.

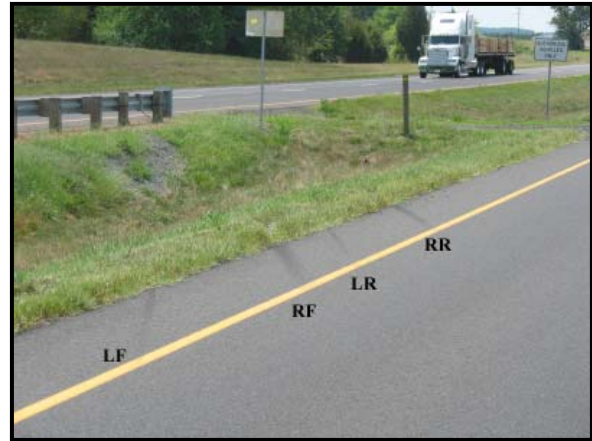
Figure 5: Yaw marks at the inboard roadside departure.

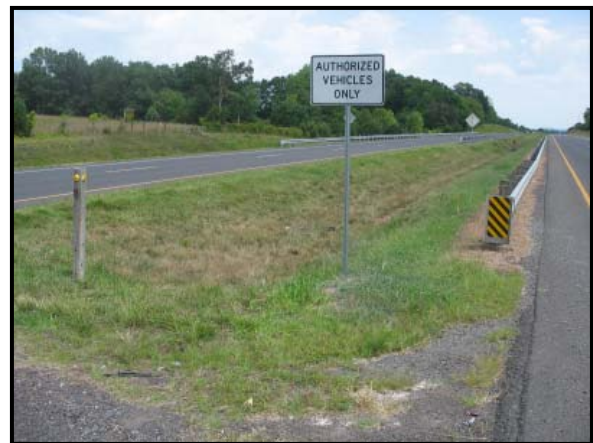
The Ford exited the center median immediately south of the guardrail that bordered the inboard northbound lanes at the gravel crossover. Refer to **Figure 6**. The Focus had rotated approximately 325 degrees. A road sign located 2.6 m (8.5 ft) southwest of the end of the guardrail was struck by the vehicle's left side plane and deformed. The total rotation of the Focus reached approximately 425 degrees when the right side tires encountered the gravel crossover. The Focus tripped about the front right tire and rolled two-quarters impacting the ground with its roof. A series of gouge and

Figure 6: Lookback view at the vehicle's trip point.

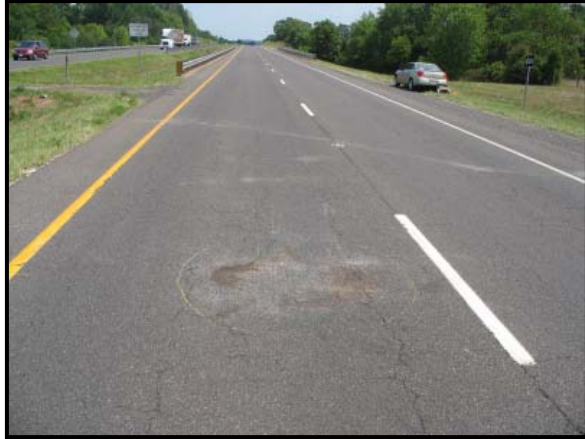
scratch marks in the inboard northbound lane identified this impact (**Figure 7**). The gouges were located 18.5 m (60.8 ft) south of the guardrail end and extended laterally across the inboard northbound lane 2.7 m (8.8 ft) from the yellow lane line. The vehicle's battery was dislodged in this impact and slid diagonally across the road coming to rest in the outboard northbound lane. The Ford rolled onto its left side and slid to rest. As the Ford came to rest, it rolled back onto its roof facing north in the center of the inboard northbound lane 28 m (92 ft) from the end of the guardrail. The approximate distance from the vehicle's trip point to final rest was 25.9 m (85 ft). **Figure 8** is an on-scene police photograph depicting the final rest position of the vehicle.

Figure 7: View of the northbound lanes at the time of the SCI inspection. The final rest position of the vehicle is in the foreground.

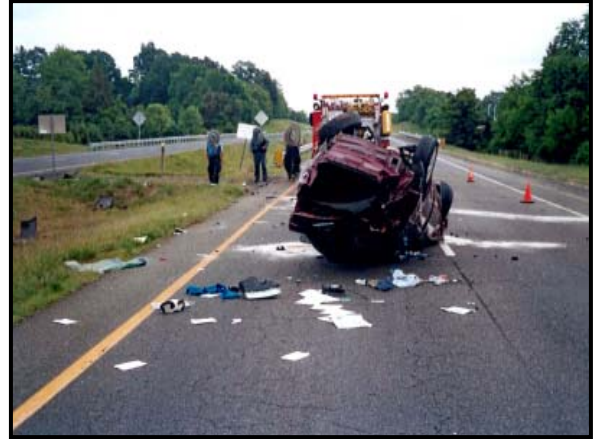
Figure 8: On-scene police photograph of the final rest position of the Ford.

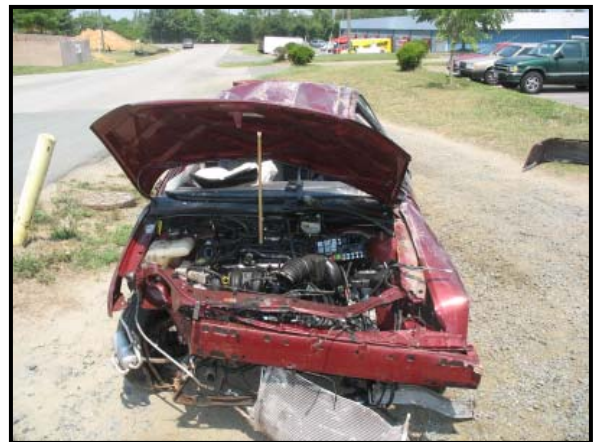
The Ford Focus sustained damage to both end planes, both side planes and the top plane as a result of the multiple impact rollover crash sequence. **Figure 9** is a front view of the Focus. The vertical face of the front bumper fascia was heavily abraded by ground contact and had separated. The front bumper reinforcement bar was shifted to the left due to the deformation of the forward uni-body frame structure. The shift of the left and right frame members measured 28 cm (11 in) and 20 cm (8 in), respectively. This

Figure 9: Front view of the Ford.

impact resulted in an induced outboard deflection of the front left fender structure. The Collision Deformation Classification (CDC) for this impact was 83-RFLE2. The left shift of the front structure was denoted by incrementing the 3 o'clock direction by 80. The driver's safety belt pretensioner was probably actuated by this impact.

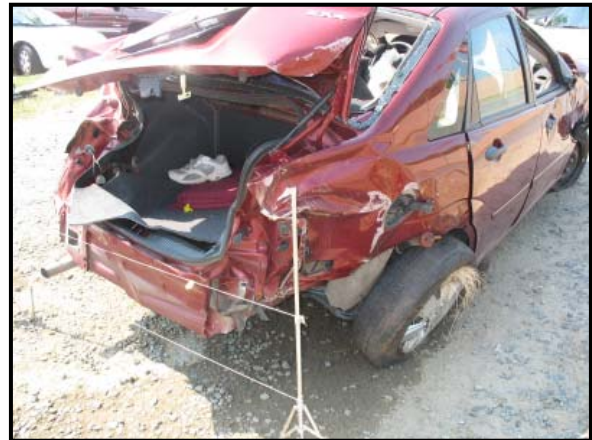
The right rear quarterpanel and back plane sustained a damage pattern consistent with continuous contact to the backslope of the ditch embankment during the vehicle's rotation. The direct contact damage began on the right rear quarterpanel 20 cm (8 in) aft of the right rear axle and extended to the right rear corner. The quarterpanel was buckled and deformed inboard collapsing the right side of the trunk well. The impact force in the 5 o'clock sector displaced the right rear wheel assembly forward into the forward aspect of the wheelhouse. The upper shock absorber mount fractured and the right rear coil suspension spring was dislodged. The right wheelbase was shortened 9 cm (3.7 in). The rear bumper fascia separated during the impact sequence. Inspection of the displaced component revealed that the fascia was intact but fractured on both corners. The right rear bumper mount was crushed forward 5 cm (2 in). The trunk lid opened by deformation and would not close. The left rear quarterpanel buckled forward and collapsed over a 25 cm (10 in) length into the left aspect of the trunk well. **Figure 10** is the right rear oblique view of the Ford. The CDC of this impact was 05-RBEW-3.

Figure 10: Right rear oblique view.

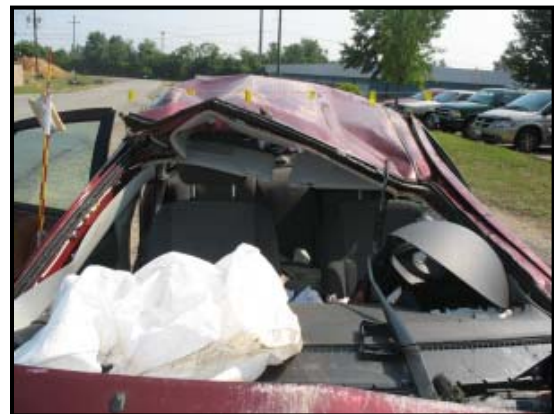
The Ford rotated an additional 100 degrees past the sign post and tripped into a three-quarter turn right side leading rollover. The vehicle rolled two-quarter turns and landed on its hood and roof evidenced by the vertical deformation of the windshield header and left A-pillar area. The deployment of the frontal air bags probably occurred at this time. The roof was crushed down and to the right, buckling the right A-pillar area of the roof, **Figure 11**. The maximum lateral and vertical crush was located at the left A-pillar and measured 9 cm (3.5 in) and 20 cm (7.9 in), respectively. The Focus rolled an additional quarter turn and the left side plane

Figure 11: View of the maximum crush at the left A-pillar area.

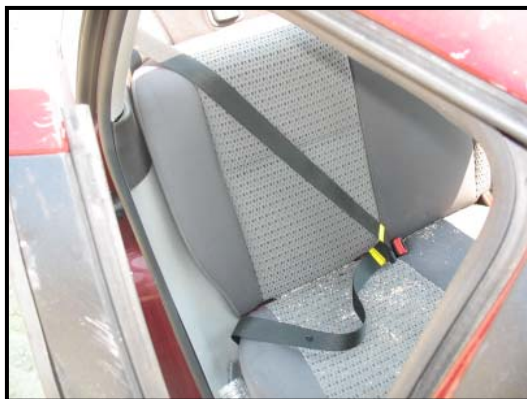
The right rear manual restraint consisted of continuous loop webbing, a sliding latch plate and a switchable Automatic Locking Retractor/ELR (ALR/ELR) attached to the right C-pillar. The webbing extended through a guide in the C-pillar trim. The webbing was stowed within the retractor upon initial inspection and the retractor was operational. Extension and examination of the webbing revealed a 6 cm (2.5 in) loading crease located 74 cm (29.0 in) from the anchor, **Figure 12**. Examination of the friction surface of the latch plate revealed a corresponding abrasion to the hardware. This safety belt was in use at the time of the crash to restrain the 4 year old male seated in the backless booster seat.

Figure 12: Right rear safety belt.

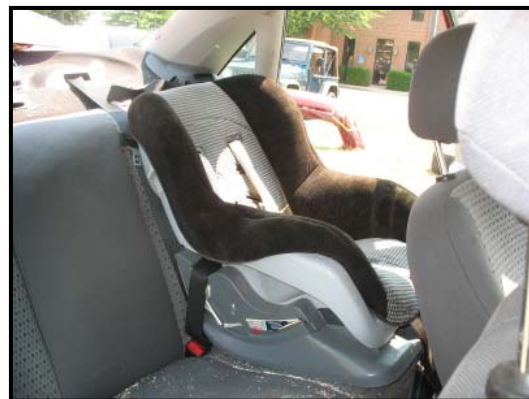
The left rear manual restraint consisted of continuous loop webbing, a sliding latch plate and a switchable ALR/ELR attached to the left C-pillar. The webbing was stowed within the retractor upon initial observation. Examination of the webbing revealed the belt was abraded in two areas that were attributed to the inboard and outboard edges of the child safety seat's forward facing belt path. The webbing abrasions were located 33 cm (13 in) and 71 cm (28 in) above the anchor respectively. Examination of the latch plate identified an abrasion on the friction surface of the hardware. The lower inboard aspect of the child seat base was abraded by contact from the latch plate. The evidence identified on this restraint was consistent with its use to restrain the forward-facing child safety seat. **Figure 13** is a view of the left rear safety belt and child safety seat. Refer to the *Child Safety Seat Section* of this report for further detail regarding the condition of the CSS.

Figure 13: Left rear seat belt and CSS.

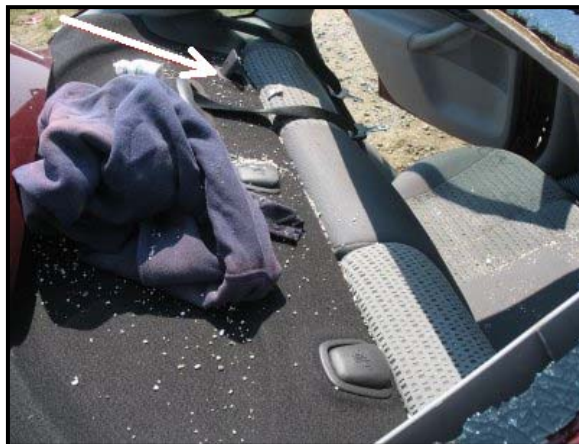
A tether anchor for each rear seat position was located across the rear package shelf. Each anchor was equipped with a plastic trim cover. The trim cover was hinged on its rear aspect and concealed the anchor with a positive “snap” closure. It was observed during the SCI inspection that the cover for the left rear tether was open. Refer to **Figure 14**. Examination of this anchor revealed that the anchor was abraded (paint removed) from repeated contact with the CSS tether fastener. The tether of the CSS was in use at the time of the crash.

Figure 14: Rear tether locations.

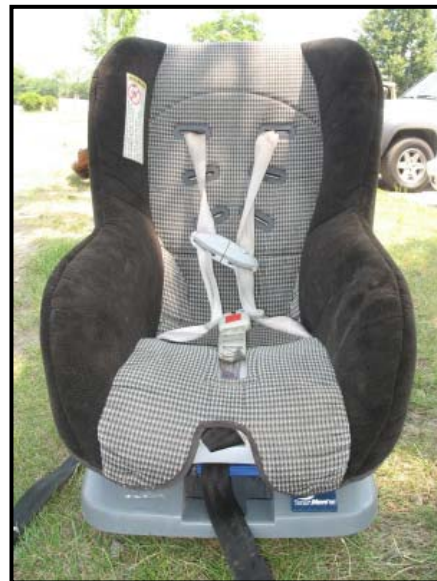
Figure 15 is a front view of the Century Smart Move SE Child Safety Seat (CSS) in use at the time of the crash. The CSS was restrained in the rear left position of the Ford by the vehicle's three-point lap and shoulder belt in a forward facing mode. The model number and serial number of the CSS were not present on the shell. The markings and seat design indicate the seat was manufactured approximately December 2001. The seat was labeled for rear facing use by infants weighing up to 14 kg (30 lb) and for forward facing use by toddlers 9 kg to 18 kg (20 to 40 lb). The labeled maximum height restriction was 102 cm (40 in). The instruction manual was not present and there was no locking clip. Many of the instructions labels affixed to the side of the CSS were missing from repeated washing.

Figure 15: Front view of the convertible CSS.

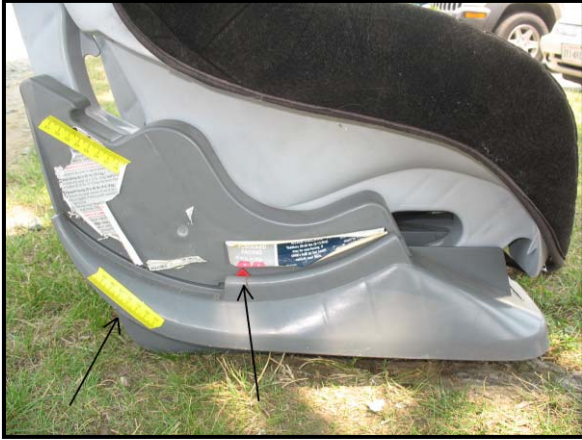
The CSS was configured with a five-point harness system and a top tether. The harness was routed through the top slots. Both harness straps were twisted over, roped, and creased. The chest retainer clip was located 27 cm (10.5 in) below the top slots. The harness buckle and chest retainer clip latched properly. Examination of the forward facing belt path revealed abrasions consistent with the evidence observed on the vehicle's safety belt. An abrasion to the inboard aspect of the base consistent with interaction with the latch plate was observed. Refer to **Figure 16**. The seat was designed with an adjustable base. The shell was adjusted to Forward Facing Position 4. There were no fractures of the plastic shell. A Styrofoam absorber located under the fabric covering was attached to the shell. It was observed the right upper aspect of the Styrofoam was fractured, **Figure 17**. It did not appear that the fracture was related to the crash. There was no other contact evidence related to the Styrofoam fracture.

Figure 16: Inboard aspect of the CSS.

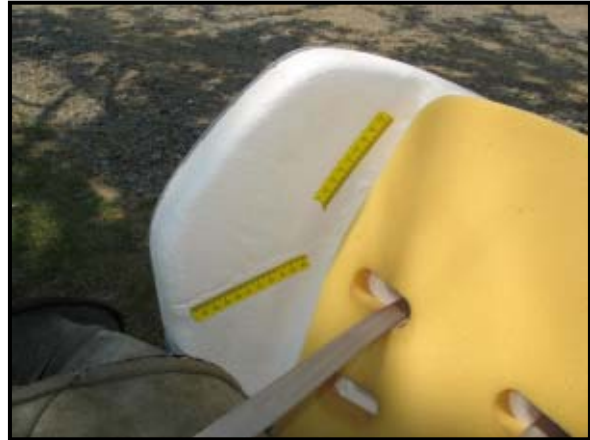
Figure 17: Fractured Styrofoam absorber.

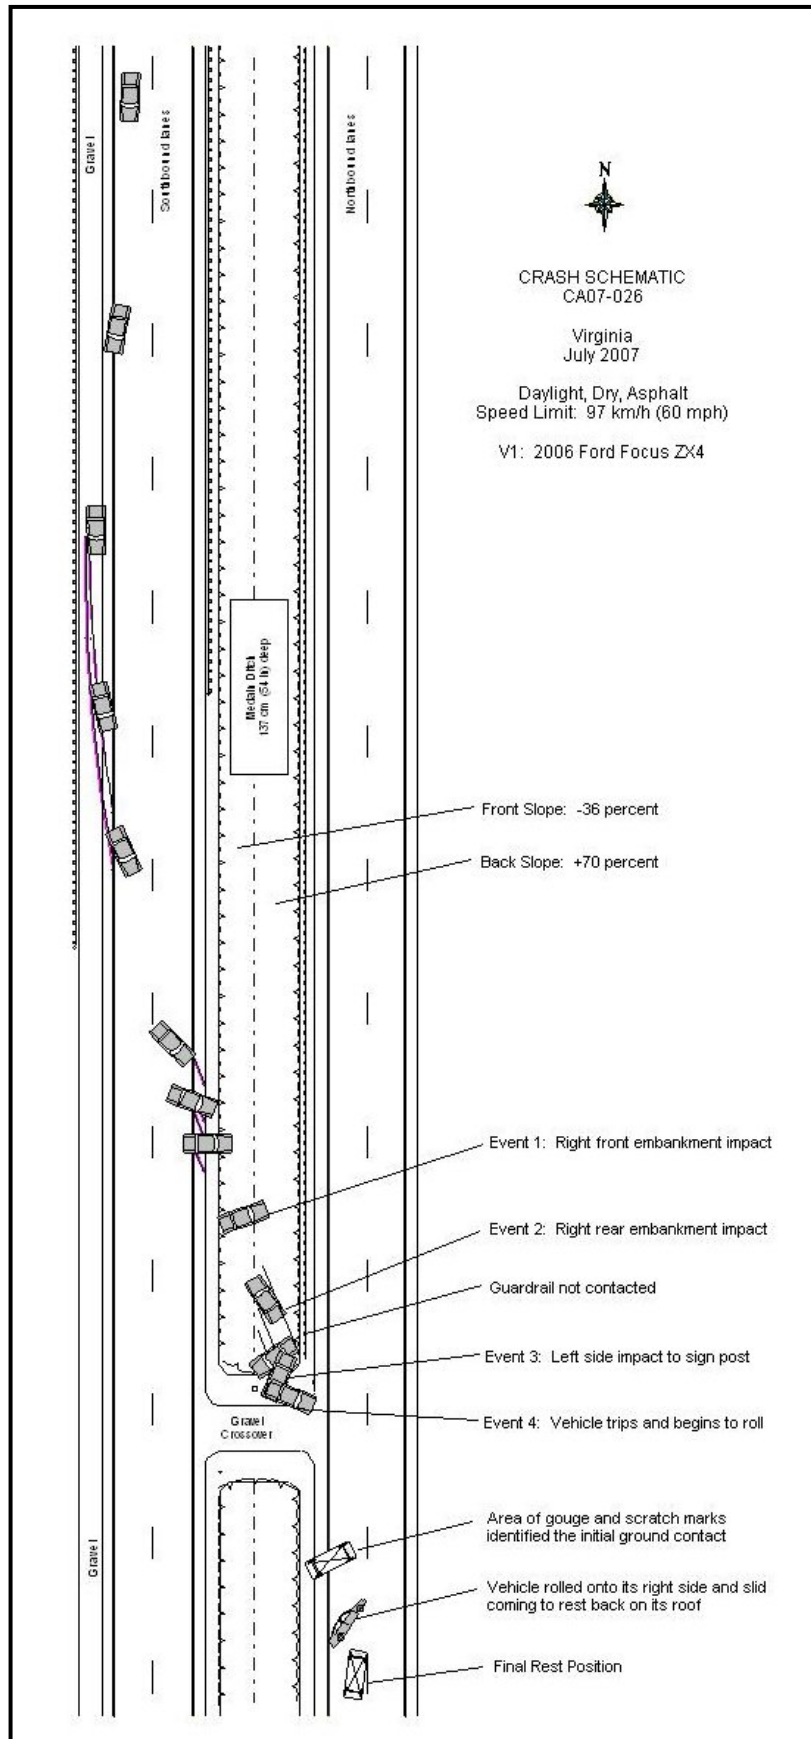
Figure 18: Crash Schematic.

edges of the southbound traffic lanes were delineated by solid lane lines. The outboard lane line was white in color. The inboard lane line was yellow. Outboard of the southbound traffic lane, the west roadside consisted of a 1.0 m (3.3 ft) wide asphalt shoulder, a 2.1 m (7.0 ft) wide gravel shoulder and W-beam guardrail. The northbound and southbound traffic lanes were separated by a 10.0 m (32.7 ft) wide depressed grass median. The center of the median ditch was 1.3 m (4.4 ft) below road level. The front slope of the median ditch measured negative 36 percent, the back slope of the ditch measured positive 70 percent. The slopes of the median ditch altered the trajectory and crash dynamics of the Ford. The ditch transitioned into a culvert pipe that was buried under an 8.3 m (27.1 ft) wide gravel crossover located along the vehicle's trajectory. A guardrail that bordered the inboard northbound road shoulder was not contacted during the crash sequence. A schematic of the crash site is attached to the end of this narrative report as **Figure 18**.
