Remote Child Safety Seat Investigation
Dynamic Science, Inc. / Case Number: DS07028
1998 Buick Century
North Dakota
January 2007

1. Report No. DS07028		2. Government Accession No.		3. Recipient Catalog No.	
4. Title and Subtitle Remote Child Safety Seat Investigation				5. Report Date May 27, 2008

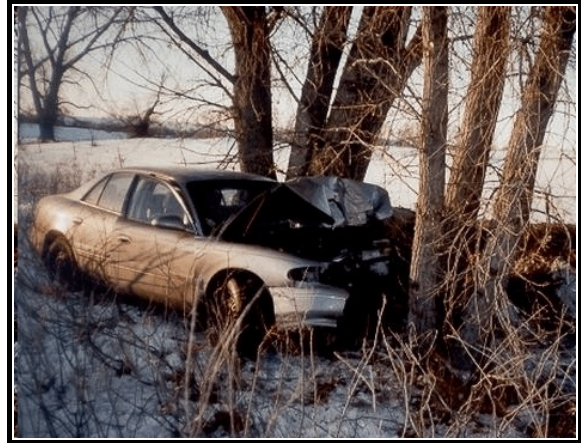
The focus of this remote level case was on the dynamics of a 1998 Buick Century Custom that was involved in a single vehicle crash with a tree, and the injury sources for a 4-year-old male passenger seated in a child safety seat in the second row left position. The vehicle was being driven by a restrained 46-year-old female and was occupied by the 4-year-old child who was restrained within an Evenflo Big Kid booster seat by a manual lap and shoulder belt. The crash took place in the afternoon hours in January 2007 as the vehicle was traveling eastbound on a two-lane roadway. As the Buick was traveling, the driver reportedly heard a loud noise from the back of the vehicle and immediately turned toward the second row to monitor the status of the child. As she did so, the Buick crossed the roadway's centerline, departed the north roadside and began descending down a snow-covered embankment. The frontal plane of the vehicle impacted a medium-sized hardwood tree on the roadside resulting in moderate-to-severe damage (**Figure 1**).

Figure 1. 1998 Buick Century at scene

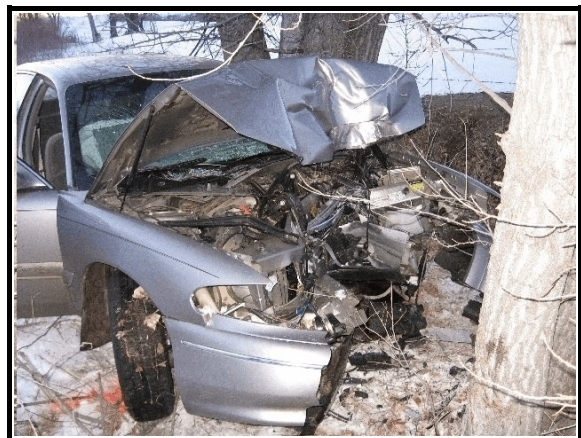
The Buick's front end contacted a medium-sized tree. The vehicle rebounded rearward a short distance from the tree and came to rest approximately 1.0 m (3.0 ft) from the tree (**Figure 4**). The impact with the tree resulted in moderate-to-severe damage to the Buick's front end. The damage algorithm of the WinSmash program computed a total delta V of 36.0 km/h (22.4 mph)¹.

Figure 4. Buick at final rest

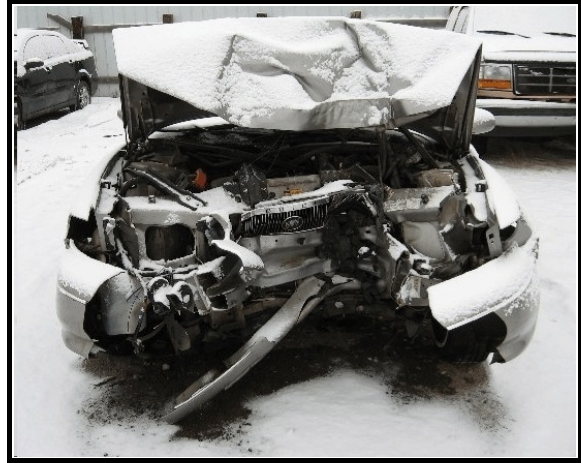
The Buick sustained moderate-to-severe damage to the front end due to the impact with the tree (**Figure 5**). The center aspect of bumper fascia was missing. The hood was buckled and displaced rearward. The bumper backing bar, radiator and engine were displaced rearward. The driver reported that the front left door was jammed shut. The direct damage was located laterally near the center and left of the front end, and vertically from the frame to the beltline. The estimated location for the direct damage began 37 cm (14.6 in) from the left front bumper corner and measured 25 cm (9.8 in) to the right laterally across the bumper. The combined estimated direct and induced damage began at the left front bumper corner and measured 155 cm (61.0 in) laterally across the entire front end. The estimated Collision Deformation Classification (CDC) for the tree impact was 12FYEN3.

Figure 5. Front end damage

Six crush measurements were estimated at bumper level as follows: C1 = 0 cm, C2 = 35 cm (13.8 in), C3 = 48 cm (18.9 in), C4 = 33 cm (13.0 in), C5 = 16 cm (6.3 in), C6 = 0 cm. The estimated maximum crush measurement was 50 cm (19.7 in) and was located between C2 and C3.

The barrier algorithm of the WinSmash program computed a total delta V of 36.0 km/h (22.4 mph) for the tree impact. The longitudinal and lateral components were -36.0 km/h (-22.4 mph) and 0 km/h respectively.

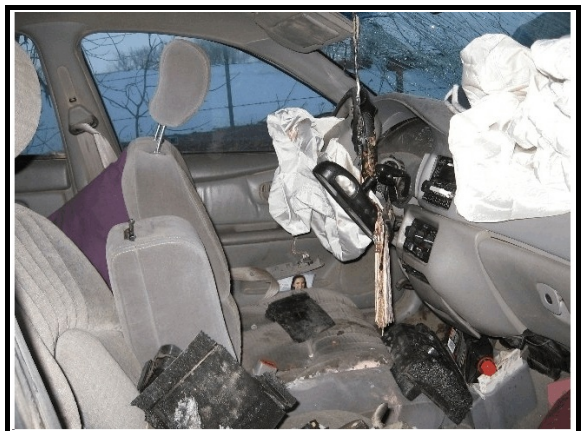
The Buick sustained moderate interior damage as a result of passenger compartment intrusion and occupant contacts (**Figure 6**). The windshield was cracked. The rear view mirror was displaced from the windshield, the right instrument panel was intruded, and the second row seat back was deformed and intruded by shifting cargo from the trunk. Based on a review of the interior images, the following specific intrusions were observed:

Figure 6. First row interior damage

Position	Intruded Component	Magnitude of Intrusion	Direction
First row right	Instrument panel	> 3 cm to < 8 cm	Longitudinal
Second row left	Second seat back	> 8 cm to < 15 cm	Longitudinal

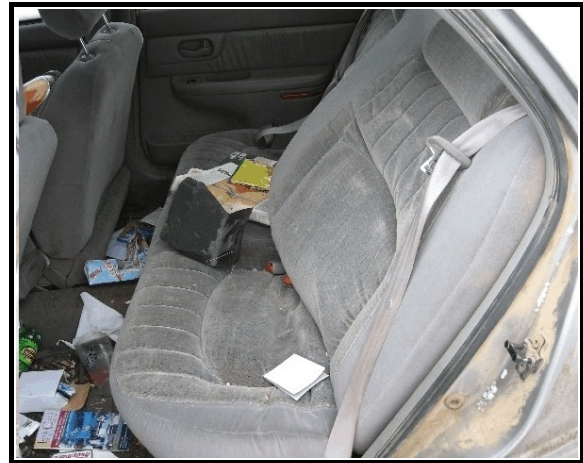
Figure 7. Second row interior belt restraints

The second row bench seat was configured with manual 3-point lap and shoulder belts for the outboard seat positions (**Figure 7**). The belts were equipped with sliding latch plates. A safety belt buckle was present for the middle seat position. The belt webbing was not visible in the interior images; this seat was probably equipped with a lap belt. The seat back was configured without head restraints.

The second row left lap and shoulder belt was used by the 4-year-old male passenger. Interior images showed the shoulder belt routed through the upper left belt positioning slot. The belt webbing showed stretch marks in this area, which indicated loading by the booster seat. The belt webbing was spooled out and laid in the booster seat. The latch plate's position on the belt was consistent with having been used. The child sustained contusions and internal trauma consistent with loading of the belt. A review of the injuries indicated the shoulder belt had been worn under the child's arm rather than over the shoulder.

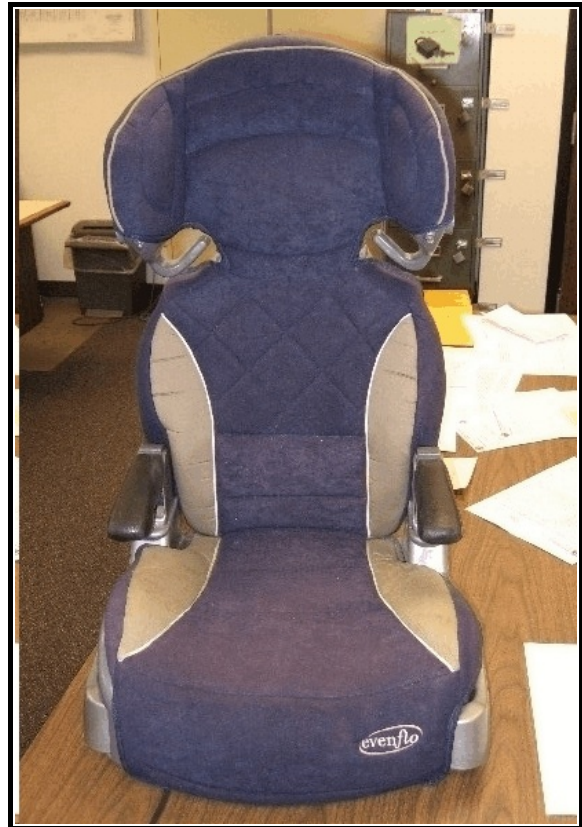
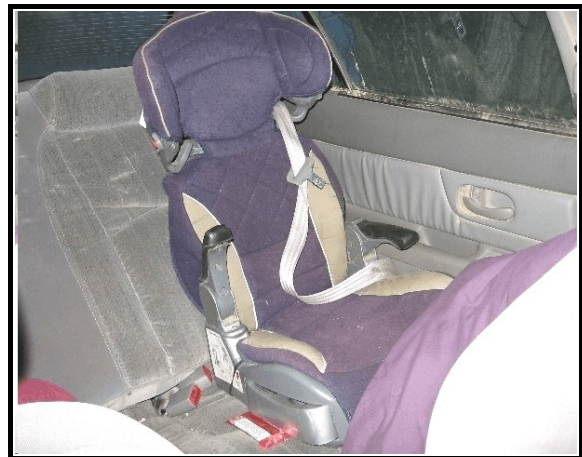
The 4-year-old male child occupied the second row left seat. The child was seated in an Evenflo Big Kid high-back belt positioning booster seat at the time of the crash (**Figures 8-9**). The model number and manufacture date are not known. The vehicle's 3-point manual lap and shoulder belt was used to restrain the child. The child seat was designed to be used only with a lap and shoulder belt. A review of on-scene images revealed that the shoulder belt was routed through the left side belt guide.

Figure 8. Evenflo Big Kid booster seat

Figure 9. Evenflo booster seat, on-scene

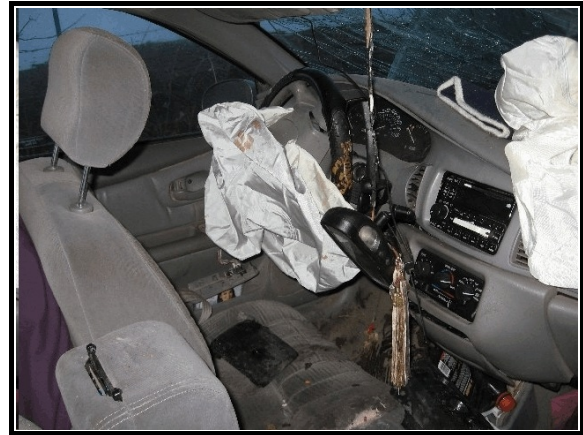
The Buick Century was equipped with frontal air bags for the front row driver and passenger positions. Both air bags deployed as a result of the impact with the tree. The driver air bag deployed from the steering wheel hub (**Figure 10**). The passenger air bag deployed from the top right instrument panel.

Figure 10. Driver's air bag
