ON-SITE NOT IN TRAFFIC SURVEILLANCE BACK OVER INVESTIGATION

CASE NUMBER - IN07028

VEHICLE - 2003 FORD EXPEDITION EDDIE BAUER

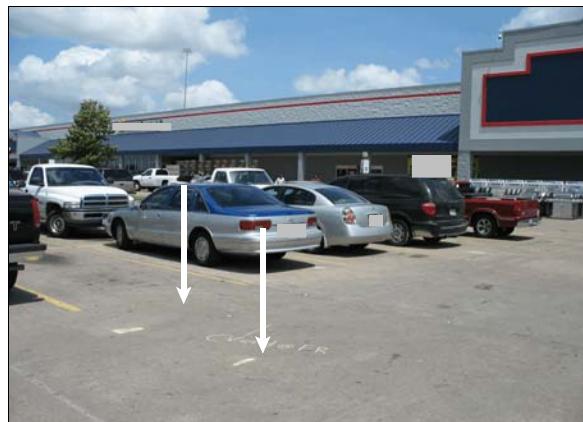
Crash Environment: The Ford was parked facing north in the parking lot of a large retail business (**Figure 1**). The parking lot was located on the west side of the building. The parking lot contained numerous rows of parking spaces and

Figure 1: Overview of crash scene, left arrow shows driver reported parked location of back of Ford, right arrow shows driver reported position of back of Ford following crash

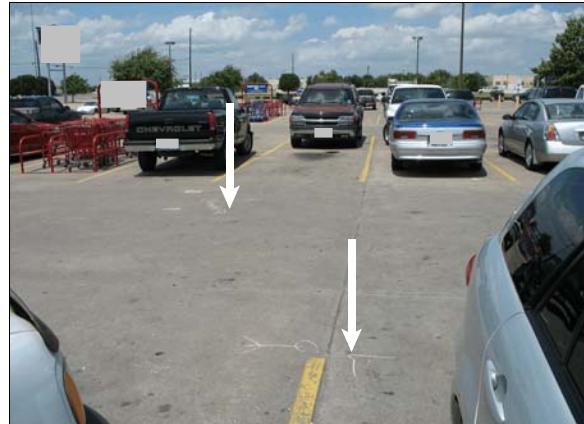
the distance the Ford backed to impact, and the distance the Ford traveled from impact to final rest. However, the investigating police officer stated to this contractor that the final positions of the Ford and the pedestrian reported to this contractor by the Ford's driver and shown in **Figure 2** were consistent with what the officer observed when he arrived on the scene. The distance between the back of the Ford and the pedestrian shown in **Figure 2** was 5.1 meters (16.7 feet)

Figure 2: View north to driver reported final rest position of pedestrian (right arrow) and back of Ford (left arrow)

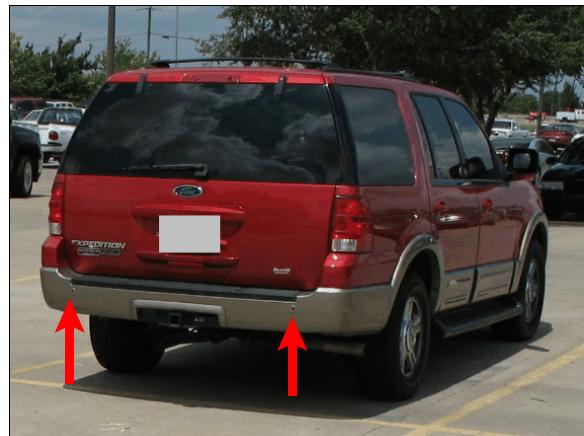
Figure 4: Overview of back of Ford Expedition; arrows show location of sensors for Reverse Sensing System

each of the two RSS sensors (**Figure 4** above) was 63 centimeters (24.8 inches). Each sensor was located approximately 20 centimeters (~8 inches) inboard of each back bumper corner (**Figure 4** above and **Figure 5**).

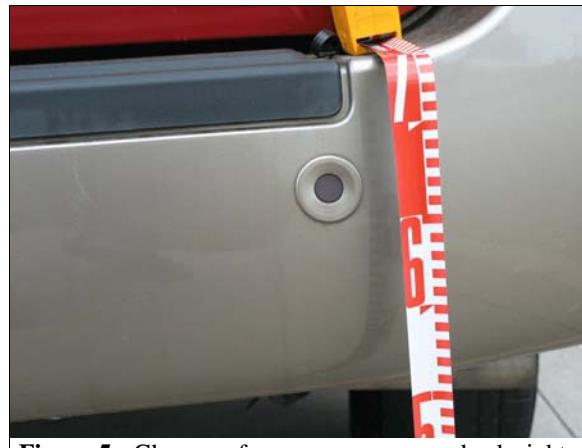
Figure 5: Closeup of reverse sensor near back right bumper corner, scale in tenths of meter, end of scale on ground

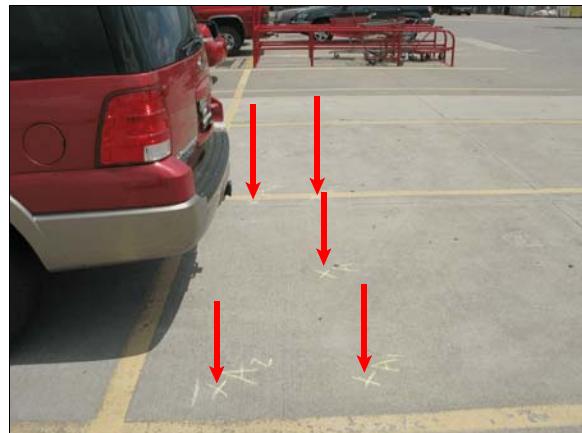
This contractor conducted tests to determine the detection zone for a test subject of the approximate size as the pedestrian [i.e., adult male, 178 centimeters (70 inches) tall and weighing 102 kilograms (225 pounds)]. The test subject was an adult male 180 centimeters (71 inches) tall and weighing 93 kilograms (205 pounds). The testing, as described in the following paragraph, determined that the detection zone for a person of this size extended only approximately 0.6 meters (~2.0 feet) rearward of the Ford's back bumper (**Figure 6**). The sensing system did not detect the test subject beyond this distance. Refer to the Reverse Sensing System Detection Zone diagram at the end of this report for a complete representation of the detection points determined by this contractor's testing.

The dimensions of the detection zone were determined by the SCI investigator approaching the back of the vehicle very slowly from each corner as well as along the approximate centerline while the driver sat in the driver's seat with his foot on the brake and the transmission in reverse. The driver honked the horn when the warning sounded and the SCI investigator marked and measured each location. The SCI investigator also approached each back corner from the side until the warning sounded and noted those positions as well. The driver reported that in each instance when the warning sounded, it would beep rapidly. At no time did it beep slowly when the test subject was detected. The driver reported that his experience with the reverse sensing system was only with large objects such as a vehicle. He estimated that the depth of the detection zone for such objects was approximately 1.8 to 2.4 meters (~6 to 8 feet). The driver indicated he was familiar with the RSS, how it worked and the purpose of the warning.

Figure 6: Arrows show Reverse Sensing System detection points for a test subject 180 centimeters (71 inches) tall and weighing 93 kilograms (205 pounds); the sensing system did not detect the test subject beyond these points

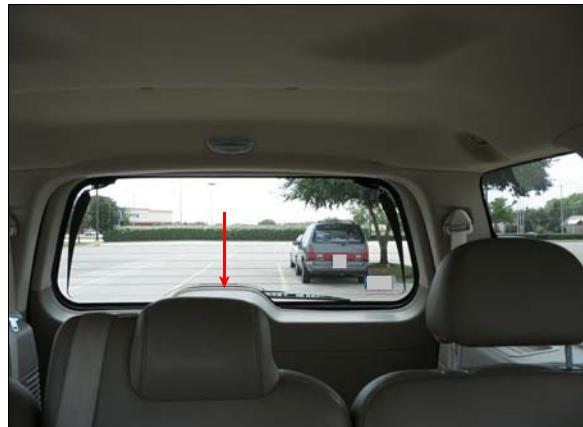
The initial observations were made with the Ford's driver looking over his right shoulder through the backlight (**Figure 7**). The target was moved rearward from the back of the vehicle along the vehicle's approximate centerline until the target came into the driver's view. The target had to be moved rearward from the Ford's back bumper 5.1 meters (16.7 feet) before the top of the target came into the driver's view. When the target was moved 2.6 meters (8.5 feet) right of the Ford's centerline, it became obstructed by the

Figure 7: View through backlight from driver's seat, arrow shows rear wiper motor housing, arrow also indicates approximate area behind vehicle where pedestrian said he was located when driver backed up

right D-pillar. The target became visible once again through the right rear window when it was moved an additional 1.5 meters (4.9 feet) to the right. When the target was moved to the left of the centerline 1.6 meters, it became obstructed by the left D-pillar and was no longer visible to the driver because it was not natural for him to turn his head any further to the right. The rear wiper housing (**Figure 7** above) formed a raised contour at the bottom center of the backlight, which extended the depth of the blind zone in a small area behind the wiper housing. The depth of the blind zone behind the wiper housing was not assessed.

The visibility study indicated that if the pedestrian was in the roadway behind the Ford at the approximate middle of the vehicle as the pedestrian had stated to police, then it would have been possible for the Ford's driver to see the pedestrian as the driver looked out of the backlight. The upper portion of the pedestrian's body would have extended above the blind zone behind the Ford. The distance from the ground to the bottom of the Ford's backlight was measured as 130 centimeters (51 inches) while the pedestrian was reportedly 178 centimeters (70 inches) tall indicating that the upper part of his body would have been visible through the backlight. See **Figure 7** above.

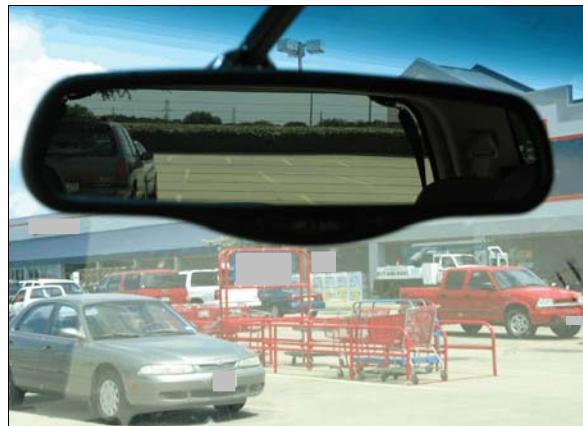
Figure 8: View through rearview mirror from driver's seat

The driver was then asked to view through the rearview mirror (**Figure 8** above). Again, the target was moved rearward from the back of the vehicle along the approximate centerline until it came into the driver's view. The target had to be moved rearward from the Ford's back bumper 5.9 meters (19.4 feet) before the top of the target came into the driver's view. At this point, if the target was moved to the right, it was immediately obstructed by the rear wiper motor housing. The target had to be moved 0.7 meters (2.3 feet) to the right to become visible on the right side of the wiper motor housing. When the target was moved an additional 1.1 meters (3.6 feet) to the right of the centerline, it became obstructed by the back right head restraint and was not visible again to the driver when moved further to the right. When the target was moved to the left of the centerline 1.3 meters (4.3 feet), it became obstructed by the back left head restraint and was not be visible again to the driver when moved further to the left.

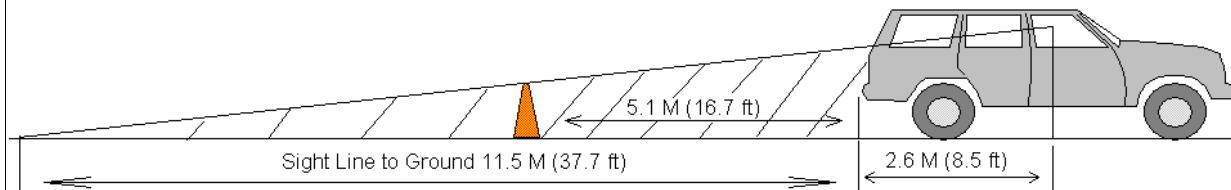
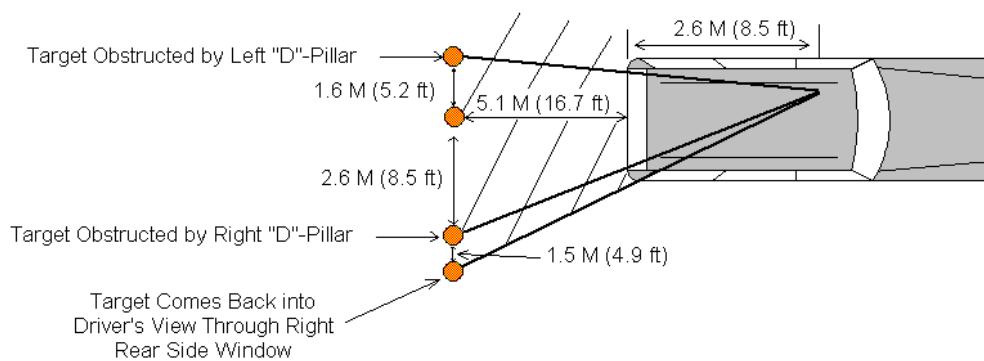
1. Distance Back of Ford
To Point a 71 cm (28 in) High Reference Target
Comes Into Driver's View as He Looks Over Right Shoulder Out of Backlight

Driver's Eye Height From Ground = 156 cm (61.4 in)

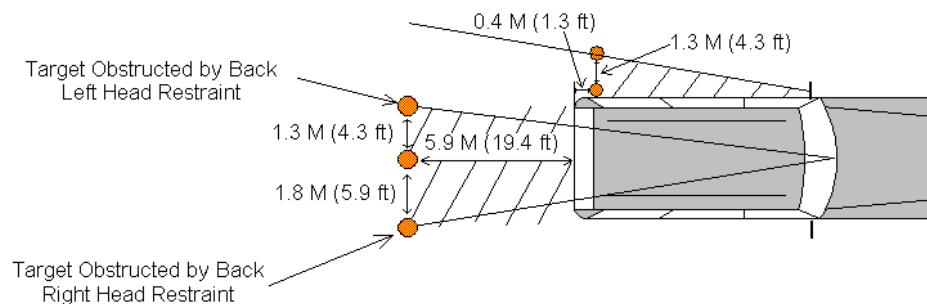
2. Rearview Mirror and Left Side View Mirror Blind Zones

The left side view mirror was assessed by placing the target at the back left bumper corner of the Ford and moving it forward until the driver reported he could no longer see it in the mirror. The target was moved forward from the back left bumper corner only 0.4 meter (1.3 feet) where it went out of the mirror's field of view. The target was returned to the back left bumper corner and moved to the left 1.3 meters (4.3 feet) where it went out of the mirror's field of view and the driver could no longer see it.

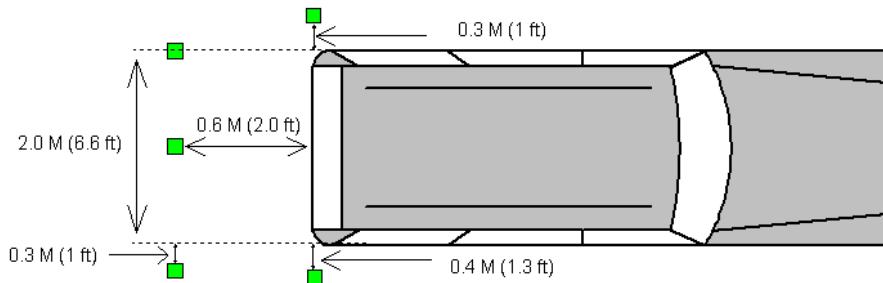
2003 Ford Expedition's Reverse Sensing System Detection Zone

■ = Reverse Sensing System's Points of Detection
for 180 cm (71 in) 93 kg (205 lb) Test Subject
(Note: The reverse sensing system did not detect the test subject beyond the detection points indicated on the diagram)
