CALSPAN REMOTE ROLLOVER INVESTIGATION

SCI CASE NO.: CA07-030

VEHICLE: 1994 DODGE B350 VAN

CRASH DATE: JULY 2007

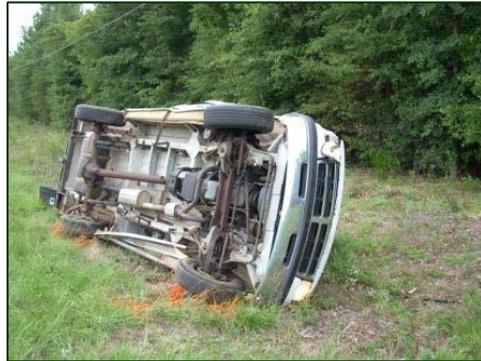
This remote investigation focused on an alleged left rear tire tread separation and the loss of directional control that resulted in a tripped five-quarter turn rollover crash of a 1994 Dodge B350 van (**Figure 1**). The Dodge was equipped with mismatched tires at all four positions. The vehicle was occupied by the 50-year old male driver and four female passengers, all police reported as restrained by the available safety belt systems. A 10-year old female passenger seated in the second row, center position was restrained by a lap belt and ejected during the rollover event. She was transported by ambulance to a local hospital where she expired approximately two hours after the crash. The other occupants were restrained by 3-point lap and shoulder safety belts and remained in the vehicle and sustained police reported minor severity injuries.

Figure 1. Final rest position of the Dodge B350 van.

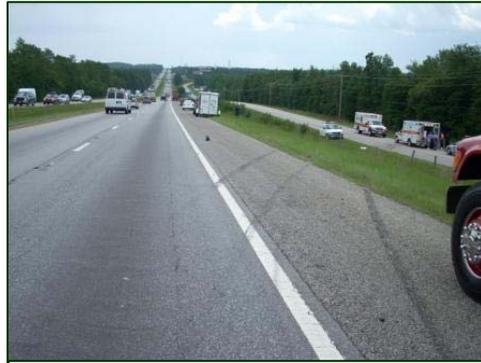
Figure 2. Overall view of the crash scene.

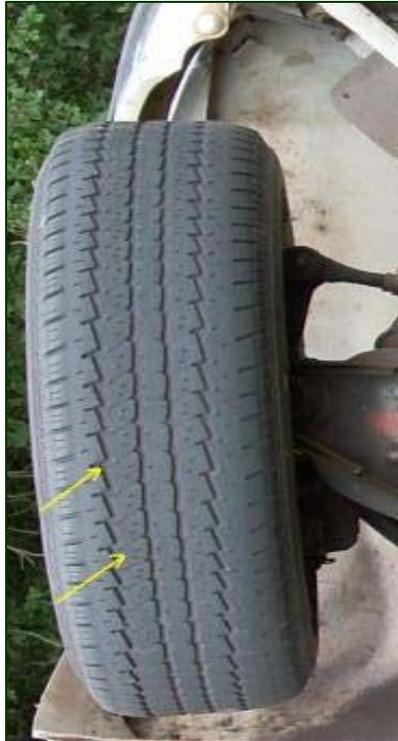
The OEM tire size for this vehicle was 225/75-16 with a Load Range of D. The front tires on the Dodge van were police reported as an unknown model Firestone, size P235/70R16. The passenger style all-season tread was reported in good condition. The left front tire was deflated, but remained on the OEM-style steel wheel. The right front was inflated. The tire pressures and tread depths were not reported. A close examination of the tread patterns in the police provided images revealed two different tread patterns for the front tires. The arrows point to the subtle differences in the tread patterns in **Figures 4 and 5**.

Figure 4. Right front tire tread.

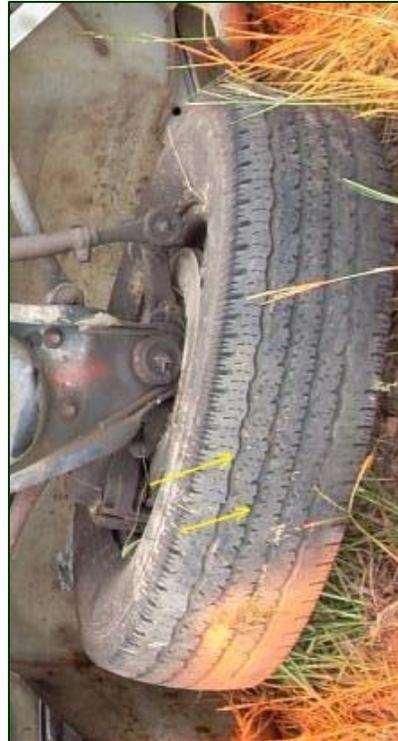
Figure 5. Left front tire tread.

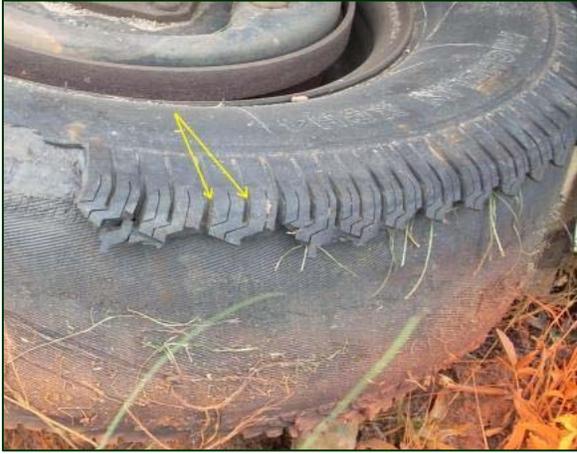
The rear tires were reported by the police as Michelin light truck tires, size LT225/75R16. The images of the left rear tire indicated that this tire was a Michelin XCH4 with an all-season tread pattern. The tires were mounted on OEM-style steel wheels. Although the tread depths and pressures were not reported, the police did note during their safety inspection of the vehicle that the left rear tire was deflated and the right rear tire remained inflated. The police reported the rear tires as in new condition. A close inspection and comparison of the tire treads through the provided images (remaining tread on the left rear tire) revealed two different tread patterns on the rear axle. The difference in the outer lugs, groves, and sipes are highlighted by the yellow arrows in **Figures 6 and 7**. There was no further tire data reported by the police.

Figure 6. Edge of the remaining tread of the left rear tire.

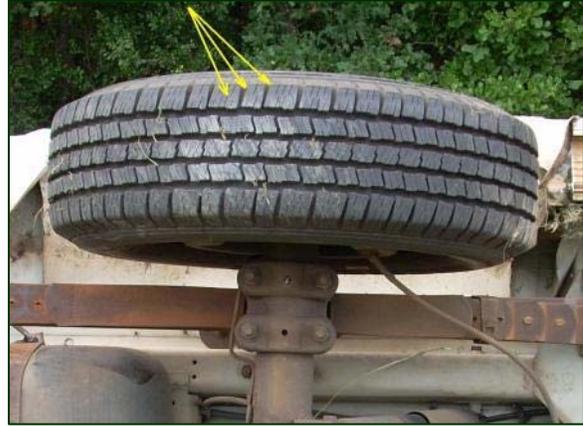
Figure 7. Edge of the tread of the right rear tire.

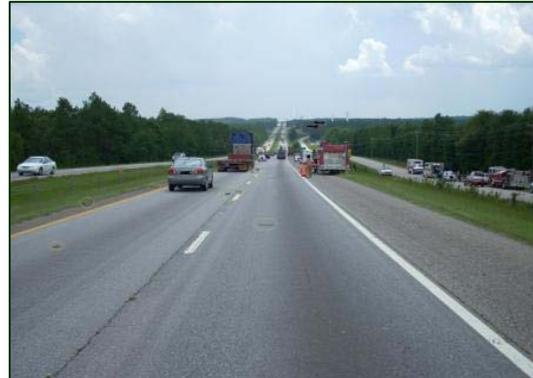
Based on the two available images of the left rear tire it appears that the entire inner and outer steel belt of the tread separated from the tire. The on-site police images detail the trajectory of the Dodge van with tire fragments (**Figure 8**) scattered along its travel path. Small fragments of the tread were observed at the crash scene. **Figures 9 and 10** show the tire malfunction.

Figure 8. Tire tread fragment highlighted in yellow circles.

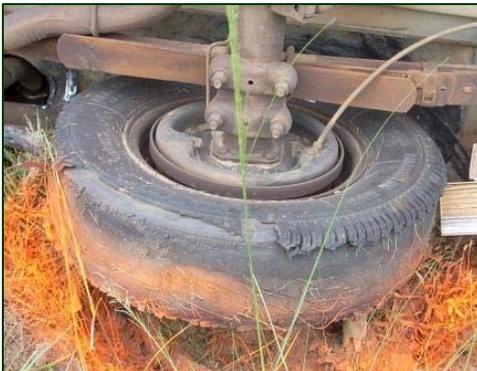
Figure 9. Tire tread separated from the left rear tire.

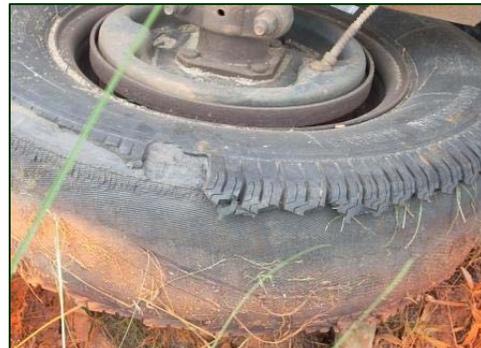
Figure 10. Close-up view of the remaining tire carcass and inner steel belt.

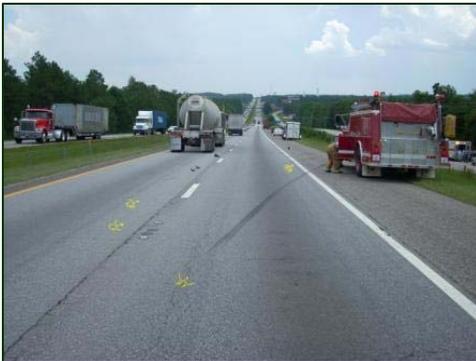
En route to his destination, the driver was traveling in the inboard travel lane. He had crested a hill and was descending a grade of approximately five percent on a straight segment of road. The left rear tire tread separated and fragmented onto the travel lane. The driver apparently applied a rapid clockwise steering input that induced a CW yaw. The Dodge van crossed the broken white lane line and entered the outboard travel lane in a yaw. Yaw marks from the left front and left rear tires began near the centerline of the travel lanes (**Figure 11**).

Figure 11. CW yaw marks on the travel lanes of the interstate.

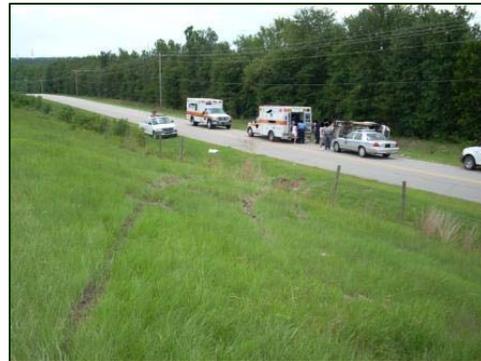
Figure 12. Continued CW yaw down the grass embankment.

The Dodge continued to rotate across the outboard travel lane and departed the south edge line onto the outboard shoulder. As the van exited the shoulder, it had rotated approximately 30 degrees CW as evidenced by a crossover of the right rear and left front tire marks. The Dodge entered the grassy slope and traversed the slope as it continued to rotate in a left side leading attitude (**Figure 12**).

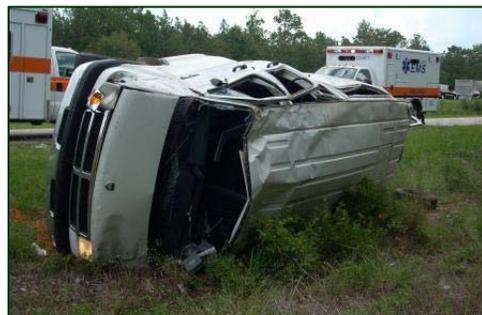
The B350 van sustained moderate severity damage as a result of the five-quarter turn rollover event (**Figure 13**). The maximum roof crush appeared to be located at the windshield header inboard of the right A-pillar. The crush was estimated at 15-20 cm (6-8"). There was ground contact damage distributed across the entire length of the roof at the roof side rail area. All tempered side glazing was shattered. The bonded laminated windshield was fractured and completely separated from the van. The right side doors appeared to have remained closed during the crash. The driver's door was not visible. The Collision Deformation Classification (CDC) for this event was estimated at 00-TDDO-3.

Figure 13. Rollover damage to the Dodge B350 van.

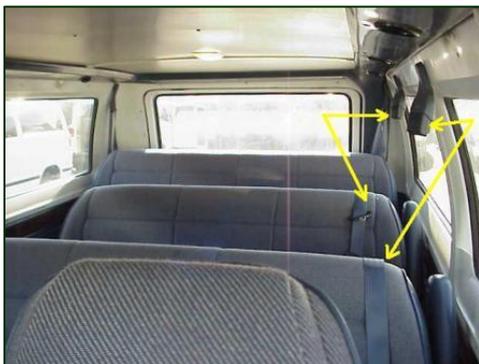
Figure 14. Detachable left side shoulder belts of an exemplar vehicle.

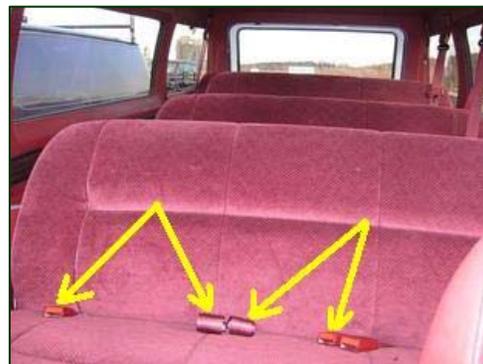
Based on the review of images of exemplar vehicles, the 1994 Dodge B350 van was equipped with continuous loop lap and shoulder belt systems for the driver and front right passenger positions. The second and third row left seat positions of an exemplar vehicle were equipped with a continuous loop lap and shoulder belt system that detached from a roof side mounted buckle (**Figure 14**). The center and right positions of the second row were equipped with adjustable length lap belts. The center position buckled to the left side of the seat position and the right position buckled to the outboard aspect of the seat (**Figure 15**).

Figure 15. Second row center and right lap belts of an exemplar vehicle.

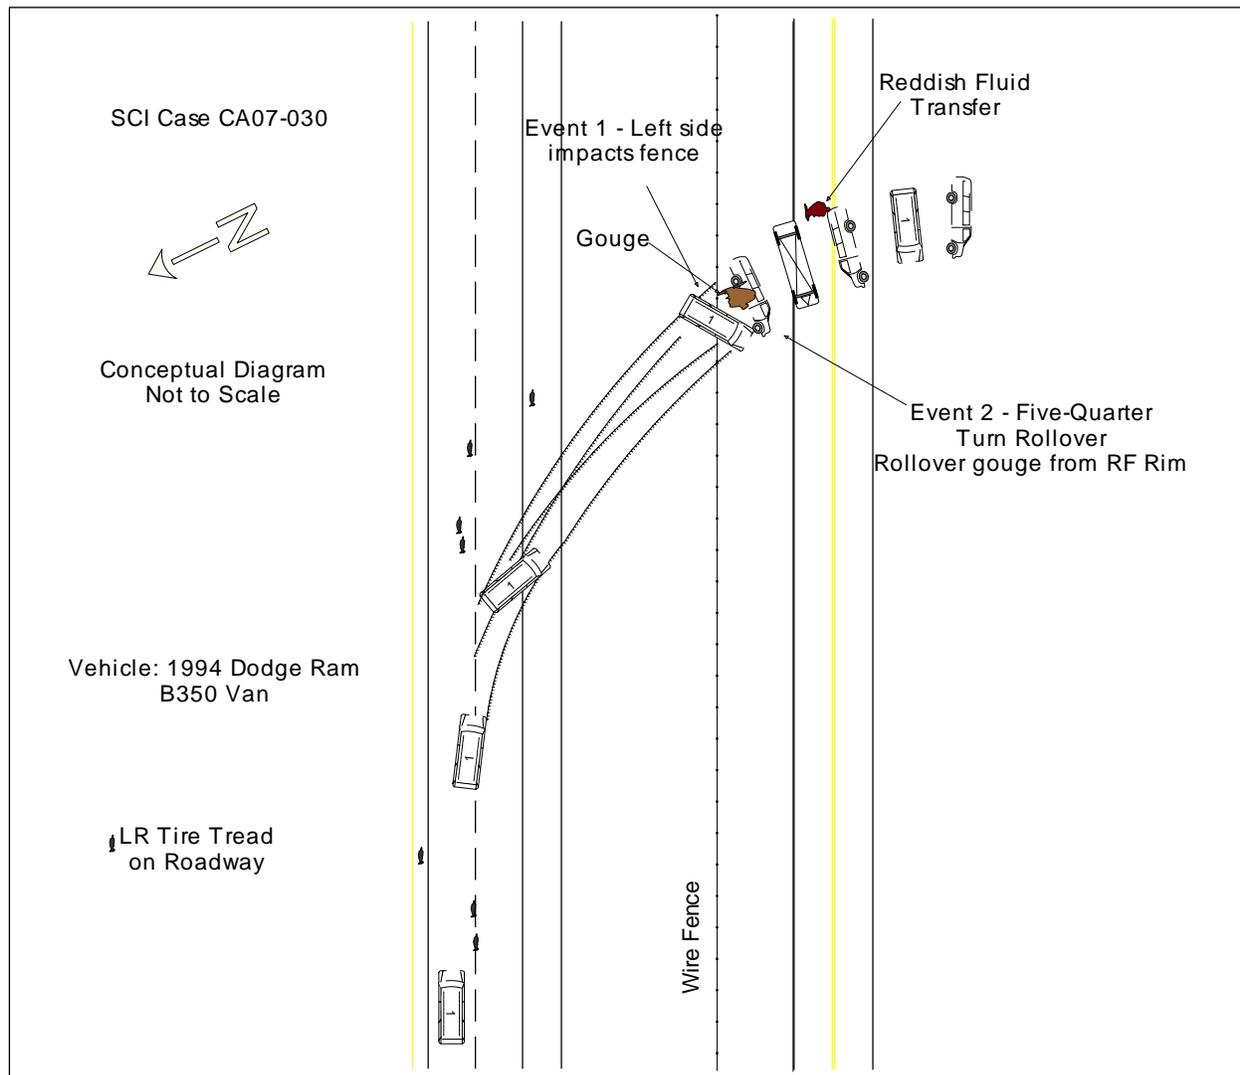
Figure 16 - SCI Crash Schematic

Adjacent to the outboard shoulder of the eastbound lanes was a grass embankment with a downhill grade of approximately 25-30 percent. A welded wire fence supported by wooden posts was located at the base of the embankment. A drainage ditch extended beyond the fence line and transitioned to a shallow positive grade. Located beyond the ditch and grassy slope was a two lane road that paralleled the interstate roadway. This asphalt surface road consisted of two travel lanes delineated by double yellow centerlines. The police documented the width of the lanes as 3.3 m (10.9') and 3.4 m (11.25'). The south roadside of the two lane road consisted of a grassy area with a shallow drainage ditch located approximately 7.6 m (25') south of the road edge. **Figure 2** is an overall view of the crash scene. A non-scaled conceptual schematic of the crash site is attached as **Figure 16**.
