ON-SITE NOT IN TRAFFIC SURVEILLANCE BACK OVER INVESTIGATION

CASE NUMBER - IN-07-030

VEHICLE - 2004 FORD EXPLORER SPORT TRAC XLT

INCIDENT DATE - July 2007

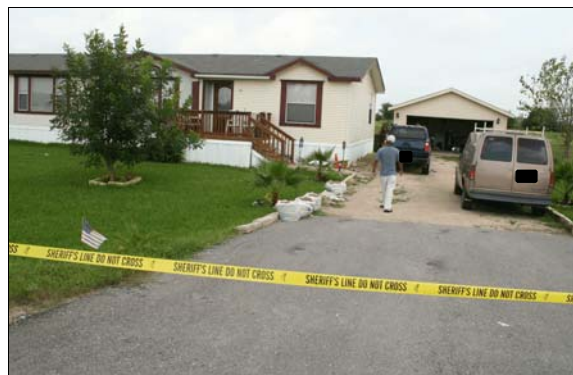
Figure 1: On-scene sheriff’s photo showing residence, porch, driveway, Ford, and minivan

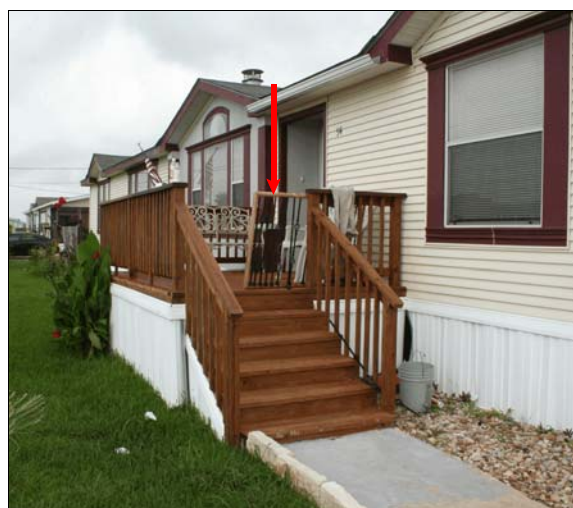
Figure 2: On-scene sheriff’s photo showing front porch of residence, arrow shows location of wooden/iron rod barrier following incident

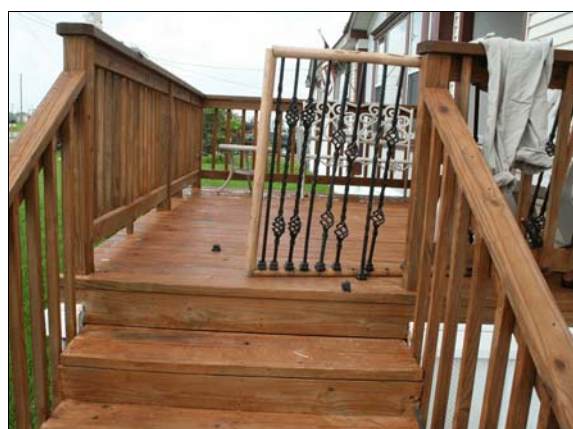
Figure 3: On-scene sheriff’s photo showing close view of wooden/iron rod barrier used on porch of residence

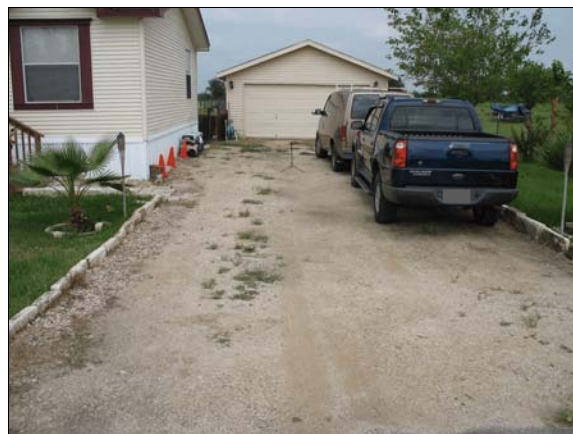
Figure 4: Ford driver's travel path around corner of residence toward garage; Ford and minivan along right side of driveway

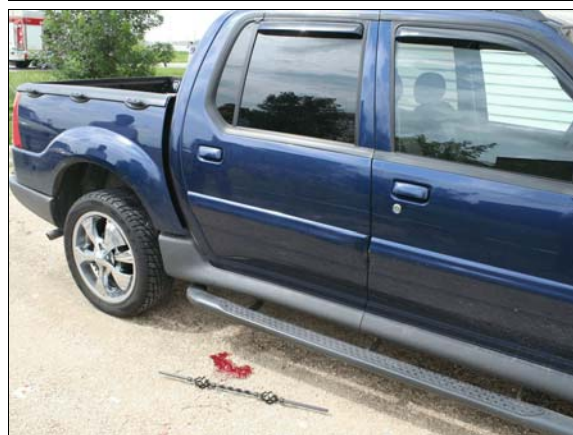
Crash: The driver began to back the Ford southeastward while looking rearward out of the open left front door. She turned the steering wheel slightly to the left as she backed. According to the driver, once the Ford's front doors were out of the garage, she braked but didn't come to a complete stop, and began to look through the rearview mirror as she continued backing. The driver backed up approximately 10.5 meters (~34 feet) where the back bumper of the case vehicle impacted and knocked down the pedestrian. The driver was unable to give an estimate of her impact speed, and there was insufficient information to determine an impact speed. According to the detective from the sheriff's department, the driver stated she felt a bump and stopped the Ford. According to the Sheriff's Department Incident Report, the right rear tire of the case vehicle had passed over the pedestrian's head crushing his skull. A small puddle of blood and brain matter was left by the pedestrian at final rest, 9.9 meters (32.5 feet) southeast of the garage door (**Figure 5**).

Figure 5: On-scene sheriff's photo showing blood spot denoting pedestrian's final rest position and approximate area of impact; Note: iron rod from stairway barrier pedestrian was most likely carrying

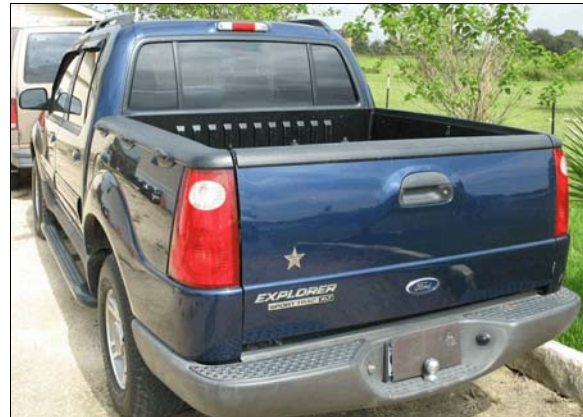
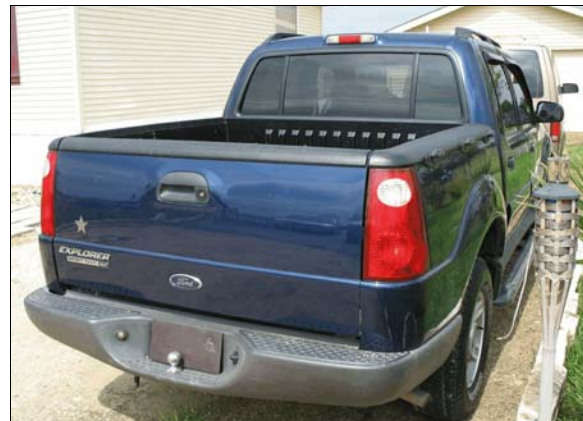
Figure 6: Ford's back viewed from left of back showing no apparent damage from pedestrian contact

Figure 7: Ford's back viewed from right of back showing no apparent damage from contact with pedestrian

There was no evidence of pedestrian contact to the Ford's back bumper, exhaust pipe or right rear tire (**Figures 6 and 7** above). Based on the available information and the Collision Deformation Classification (CDC) guidelines for pedestrian impacts, a CDC was determined to be: **06-BRLN-1 (180 degrees)**. The Ford was not damaged in the incident and was not towed. It was retained by the owner.

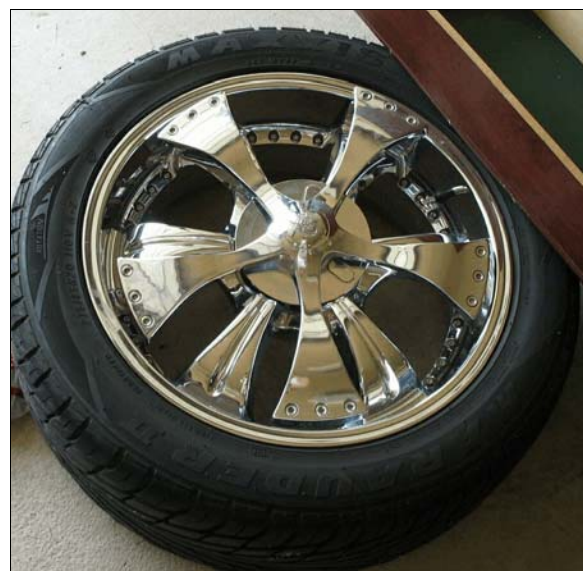
The Ford's recommended tire size was P255/70R16. The Ford was equipped with P275/45R20 tires (**Figure 8**) at the time of the incident, which would have lowered the vehicle only 51 millimeters (0.2 inch) assuming proper tire inflation. For an unknown reason, these tires were removed from the Ford prior to this contractor's on-site investigation. The Ford was equipped with the recommended size tires at the time of the inspection.

Figure 8: Close-up of one of the tires on the Ford at the time of the incident

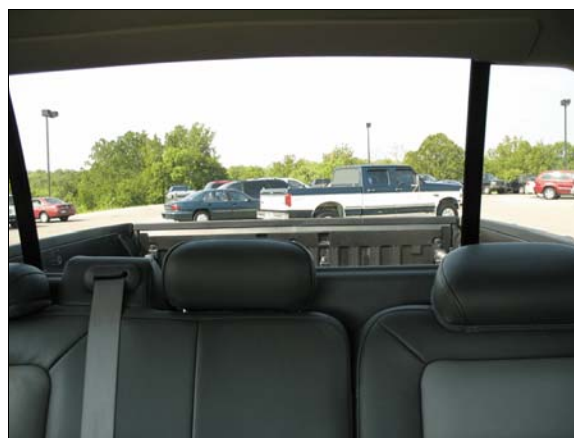
For the assessment of the blind zone behind the Ford, the surrogate driver was asked to look over his right shoulder out of the backlight (**Figure 9** and **Figure 10**¹ below). The target was positioned behind the Ford and moved rearward until it came into the driver's view. It was necessary to move the target rearward from the back of the vehicle 8.4 meters (27.6 feet) before the driver could see it (**Figures 11 and 12** below). At this point, the target was moved to the right from the vehicle's approximate centerline 6.4

Figure 9: View out of backlight from driver's seat of exemplar Ford; back right head restraint was in the full up position in the Ford involved in the incident

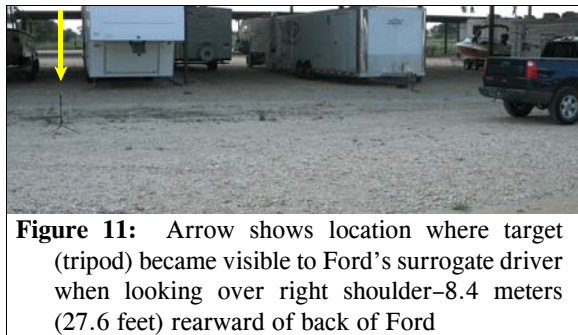
meters (21.0 feet) where it became obstructed by the back right head restraint, which was in the full up position. The target was then moved an additional 5.7 meters (18.7 feet) to the right where it became visible again through the right rear window. The target was then returned to the centerline and moved to the left. Once the target was moved 2.6 meters (8.5 feet) to the left, the surrogate driver lost view of the target because he could not turn far enough to his right to see it.

Figure 11: Arrow shows location where target (tripod) became visible to Ford’s surrogate driver when looking over right shoulder—8.4 meters (27.6 feet) rearward of back of Ford

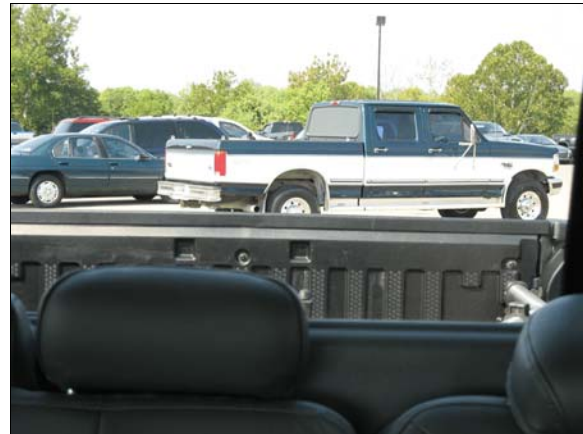
Figure 10: Closer view out of backlight from driver’s seat of exemplar Ford

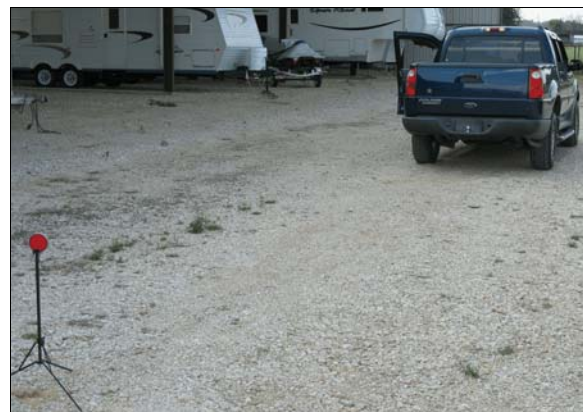
Figure 12: Closer view of target (tripod) where it became visible to Ford’s surrogate driver when looking over right shoulder—8.4 meters (27.6 feet) rearward of back of Ford

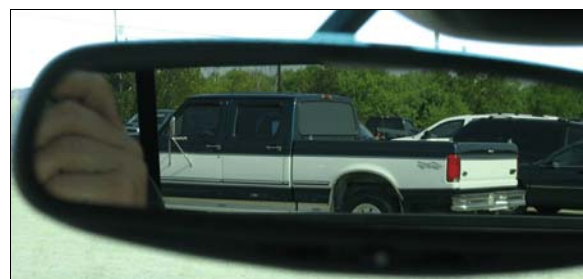
The surrogate driver was then asked to view behind the Ford through the rearview mirror (Figure 13¹). The target was not visible to the driver until it was moved rearward from the back of the vehicle 8.8 meters (28.9 feet). When moved 2.7 meters (8.9 feet) to the right of the vehicle’s approximate centerline, the target became obstructed by the back right head restraint. It was not visible to the surrogate driver again when moved further to the right. When moved 2.9 meters (9.5 feet) to the left of the approximate centerline, the target became obstructed by the reflection of the driver’s head in the rear view mirror.

Figure 13: View through rearview mirror from driver’s seat of exemplar Ford

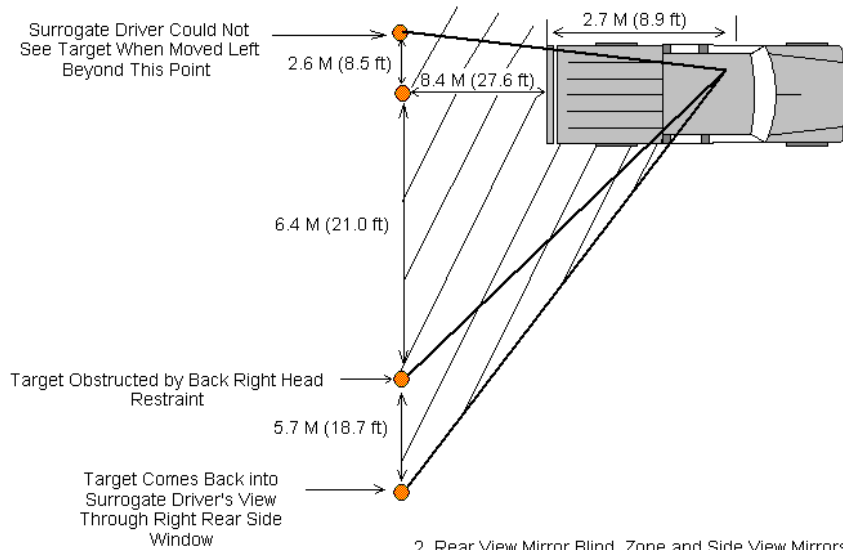
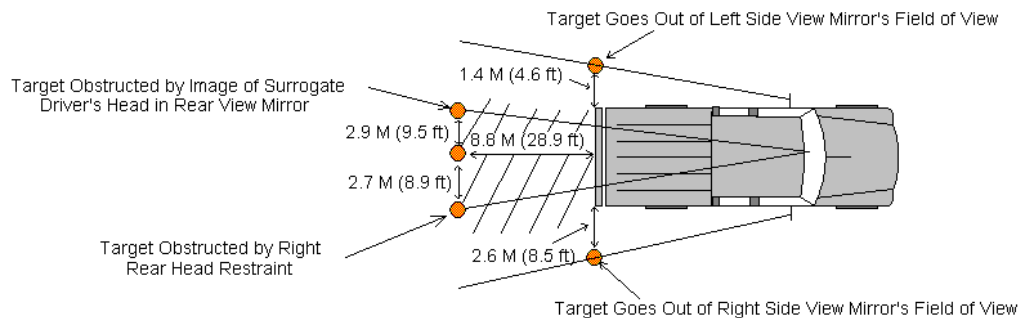
Nominal Visibility Diagram
Case Vehicle = 2004 Ford Explorer Sport Trac XLT

1. Distance Back of Ford
 To Point a 71 cm (28 in) High Reference Target
 Comes Into Surrogate Driver's View as He Looks Over Right Shoulder Out of Backlight
