Rollover/Child Safety Seat Investigation / Vehicle to Object
Dynamic Science, Inc. / Case Number: DS07032
1989 Toyota Pickup
California
May 2007

1. Report No. DS07032	2. Government Accession No.		3. Recipient Catalog No.	
4. Title and Subtitle Rollover/Child Safety Seat Investigation			5. Report Date October 19, 2007

**Dynamic Science, Inc.
Crash Investigation
Case Number: DS07032**

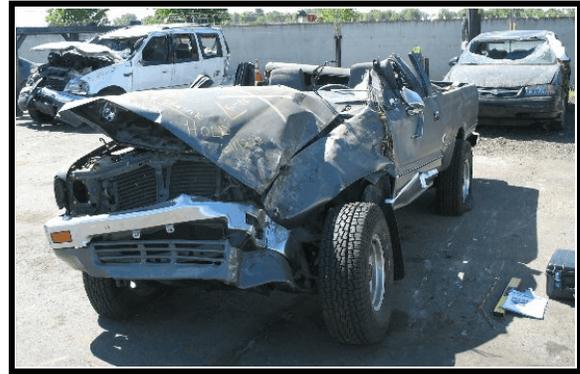
Figure 1. Case vehicle, 1989 Toyota pickup

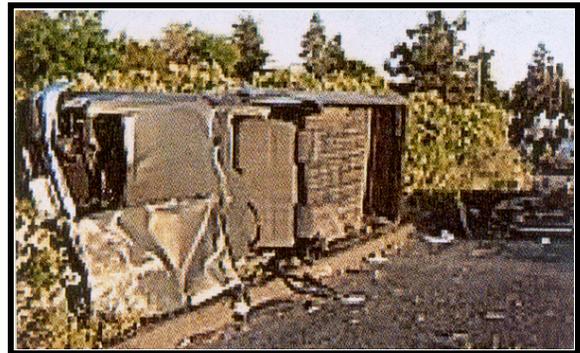
The driver of the Camry changed lanes to the right, possibly attempting to access the off-ramp. The driver of the Toyota pickup steered to the right to avoid the impact, but the front right side of the Camry contacted the left side of the Toyota pickup bed. The driver of the Toyota lost control of his vehicle. The vehicle went into a clockwise rotation as it entered the gore area and overturned after traveling approximately 48 m (160 ft). While in the rollover, the vehicle struck a wooden exit sign after traveling approximately 21 m (70 ft). The vehicle continued rolling as it traveled northbound in the gore area. The vehicle rolled five quarter turns. The vehicle came to rest on its left side facing north on the east roadway edge dirt shoulder approximately 48 m (160 ft) north of the impact with the sign (Figure 4).

Figure 4. Case vehicle at final rest

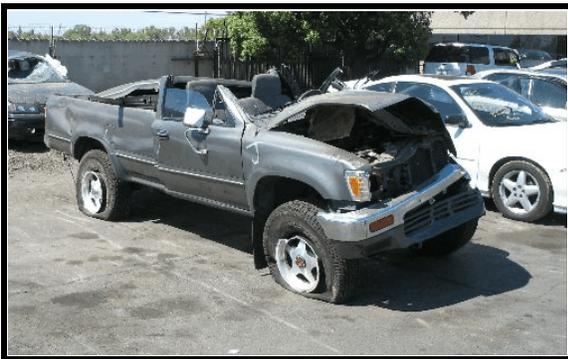
The 1989 Toyota pickup sustained moderate top damage as a result of the rollover impact. There was direct damage to the cab roof that measured 107 cm (42.1 in) wide by 70 cm (27.5 in) long. The bed cap was knocked off during the rollover. There was direct damage to the top of the cap that measured 214 cm (84.3 in) in length by 114 cm (44.9 in) in width. There was direct damage to the left front of the hood. The cab roof had been cut off by rescue personnel. The right front, right rear, and left rear tires were flattened and their rims were cracked. The Collision Deformation Classification (CDC) for the rollover was 00TDDO3.

Figure 7. Right side of case vehicle

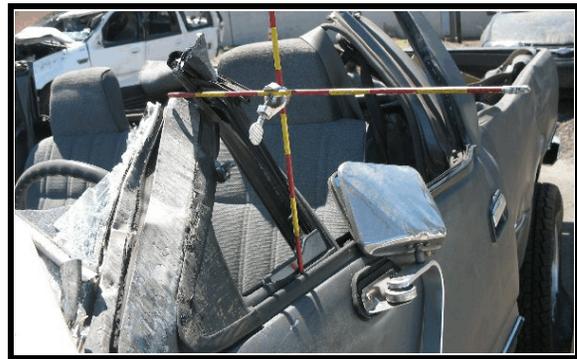
Figure 8. Crush at left A pillar area

The 1989 Toyota pickup sustained moderate interior damage as a result of passenger compartment intrusion. There was vertical intrusion of the A-pillars, the left B-pillar, roof, windshield header, and the left and right side rails. There was also lateral intrusion of the left A-pillar. The roof had been cut off the vehicle. The maximum intrusion appeared to be at the left roof/left windshield header area and measured approximately 15 cm (5.9 in) vertically.

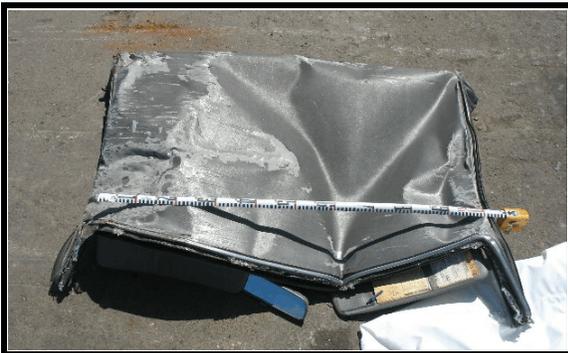
Figure 9. Direct contact damage and crush to cab roof

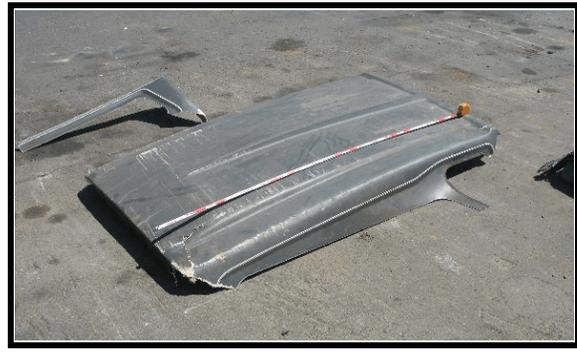
Figure 10. Contact damage to top of box cap

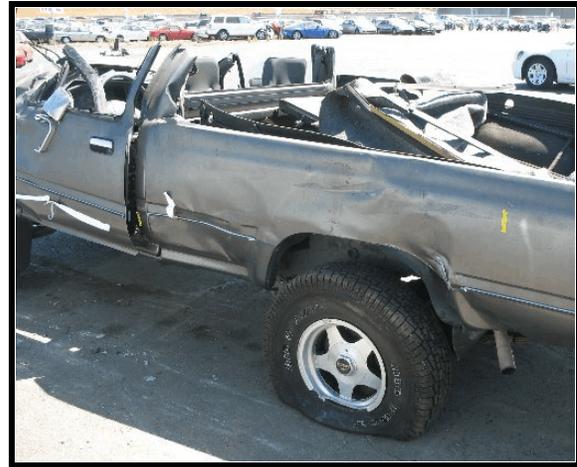
The pickup sustained minor left side damage as a result of the impact with the Toyota Camry. The direct damage began 64 cm (25.2 in) rear of the rear axle and extended 182 cm (71.7 in) forward along the left side plane. The maximum crush was located between C1 and C2 and measured 5 cm (1.9 in). Six crush measurements were taken at the belt line level and measured: C1 = 0 cm (0 in), C2 = 3 (1.2 in), C3 = 0 cm (0 in), C4 = 1 cm (0.4 in), C5 = 2 cm (0.8 in), C6 = 0 cm (0 in).

Figure 11. Left side contact damage from Event 1

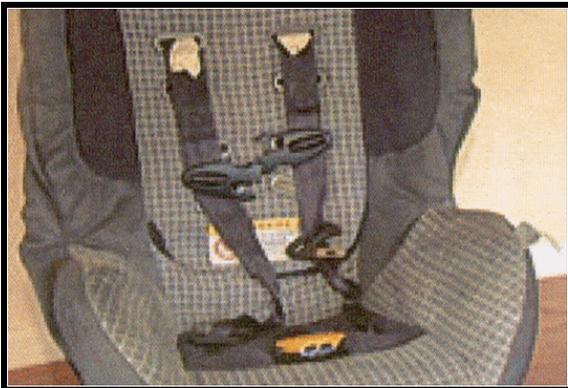
Figure 12. Evenflo Victory 5 CSS

The Evenflo Victory 5 CSS was positioned forward facing in the front right seat of the Toyota pickup. The model number was 3771346 P1 and the date of manufacture was July 8, 2003. The convertible CSS was configured with a 5-point harness and a two-piece, locking harness retainer clip (Figure 12). The harness was in the top set of harness slots at the time of the crash. The retainer clip was used at the below armpit level, according to the interviewee. A label on the CSS outlined the recommended use of the CSS as follows:

The child's weight was 21 kg (46 lbs) and his height was 107 cm (42 in) which was outside the manufacturer's recommended weight and height guidelines. After the crash, the CSS was retrieved by the wife of the driver from the police. Prior to giving CSS back to her, they cut the harness to ensure that the CSS would not be re-used (Figure 13). The CSS had been installed in the vehicle by the driver. The vehicle was equipped with ELR retractors. A locking clip was not used.
