**CALSPAN ON-SITE CHILD SAFETY SEAT CRASH INVESTIGATION
CASE NO: CA07-035**

VEHICLE: 2007 PONTIAC G6

LOCATION: OHIO

CRASH DATE: NOVEMBER 2007

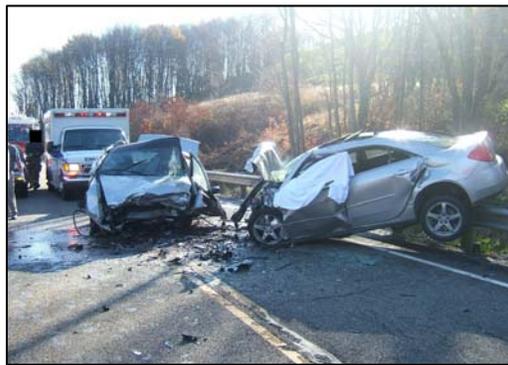
Figure 1 - On scene view of crash site.

The Pontiac was equipped with a Certified Advanced 208-Compliant (CAC) system that included dual stage frontal air bags for the driver and front right passenger. A CAC vehicle is certified by the manufacturer to be compliant to Advanced Air Bag portion of Federal Motor Vehicle Safety Standard (FMVSS 208). The frontal air bags deployed as a result of the severe frontal impact. The data from the Event Data Recorder (EDR) was recovered during the SCI investigation and is discussed in detail later in this report. The 21-year old female driver of the Buick also sustained fatal injuries and was pronounced deceased at the scene. Both vehicles were towed due to severe damage. **Figure 1** is an on-scene view of the crash site.

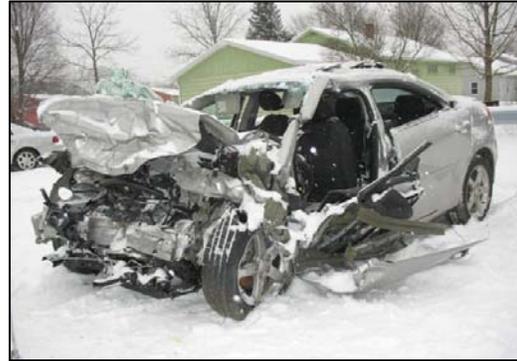
The 2007 Pontiac G6 (**Figure 4**) sustained severe frontal damage as a result of the head-on impact with the 1992 Buick Regal. The direct contact damage encompassed the full frontal width of the vehicle and measured 92 cm (36.2"). The maximum crush was located 9 cm (3.5") left of the vehicle's centerline and measured 88 cm (34.6") in depth. The front of the Buick contacted the front left alloy rim of the Pontiac resulting in a fracture to the wheel. The fracture began at the inboard bead of the rim and encompassed approximately 60 percent of the circumferential surface. The left wheelbase was compressed 33 cm (13") from this impact. The compression of the wheelbase resulted in induced damage that extended down the left side to the B-pillar. The right wheelbase was also compressed a length of 8 cm (3") and direct contact damage was present on the right fender which extended rearward 42 cm (16.5"). The left front and left rear side windows were disintegrated and the windshield sustained stress cracks from the crushed frontal components and induced damage. Six equidistant crush measurements were documented along the bumper beam of the vehicle and were as follows: C1 = 71 cm (28"), C2 = 79 cm (31"), C3 = 88 cm (34.6"), C4 = 84 cm (33"), C5 = 68 cm (26.8"), C6 = 44 cm (17.3"). The Collision Deformation Classification (CDC) for the impact with the Buick was 12-FDEW-4.

Figure 4 - Damaged frontal plane of Pontiac.

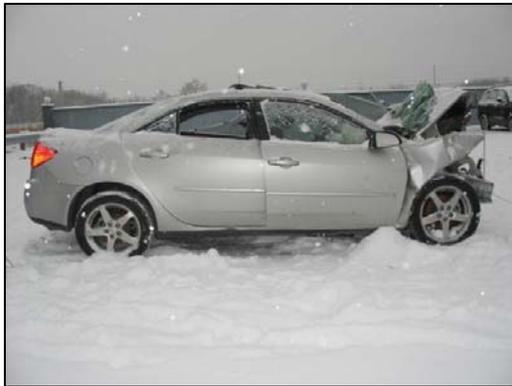
Figure 5 - Damage to right side of Pontiac.

During the impact, the front of the Pontiac pitched down and the back of the vehicle lifted off the ground. Simultaneously, the Pontiac was redirected rearward toward the south shoulder and a guardrail on the south roadside. While the back end was elevated, the vehicle mounted the guardrail, which resulted in minor damage to the vehicle's right side (**Figures 5 and 6**). The direct contact damage to the right side began 88 cm (34.6")

forward of the right rear axle and measured 16 cm (6.3”) in length. The damage was isolated to the right sill, 25 cm (9.8”) vertically from the ground. The maximum crush to the right side was 2 cm (0.8”) in depth and was located 96 cm (37.8”) forward of the rear axle. The impact was non-horizontal in orientation and the CDC was 00-RPLN-1.

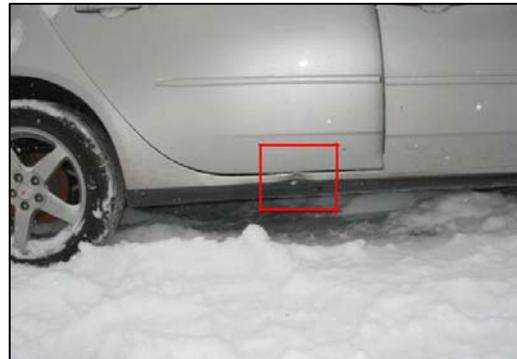
Figure 6 - Close-up view of right side damage.

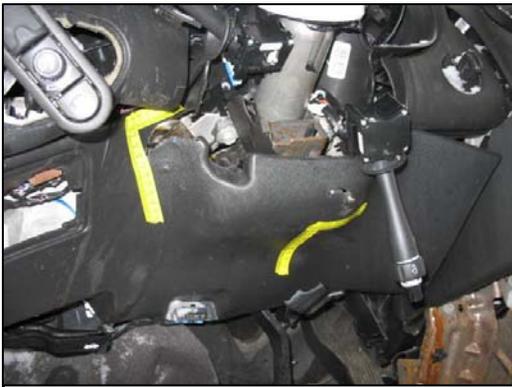
Several discernable occupant contact points were identified during the SCI vehicle inspection. The unbelted female driver of the Pontiac was displaced forward during the impact. She loaded the steering assembly and the knee bolster in two locations. As the front of Pontiac pitched down and partially underrode the Buick, the driver knees struck the padded knee bolster which resulted in pocket impressions to the bolster (**Figure 7**). The first impression was 7 cm (2.75”) in diameter and was located 20 cm (8”) inboard of the left instrument panel edge. Vertically, the impression was located 66 cm (26”) above the floor pan and was attributed to the driver’s left knee. The second impression was 5 cm (2”) in diameter and was located 47 cm (18.5”) inboard of the left instrument panel edge. Vertically, the impression was located 56 cm (22”) above the floor pan and was attributed to the driver’s right knee. As the steering assembly intruded longitudinally, the driver’s torso partially submarined the wheel, which resulted in a bent wheel rim and vertical upward deformation of the column (**Figure 8**).

Figure 7 - Knee bolster damage from driver loading.

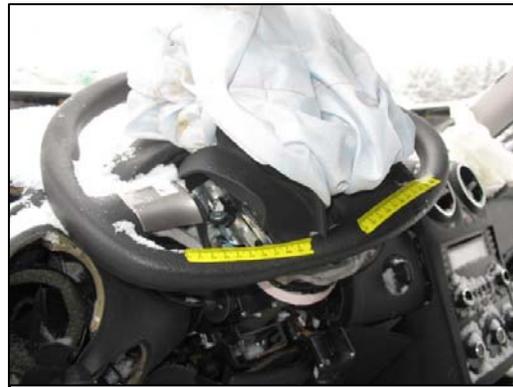
Figure 8 - Steering wheel rim damage from driver loading.

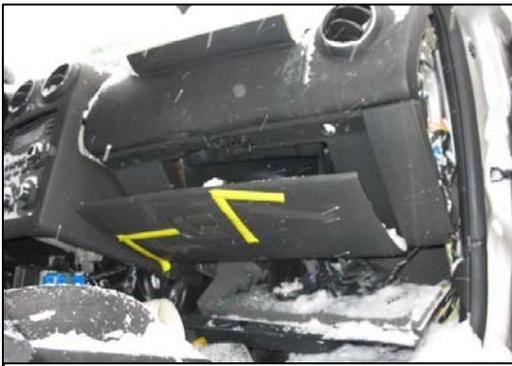
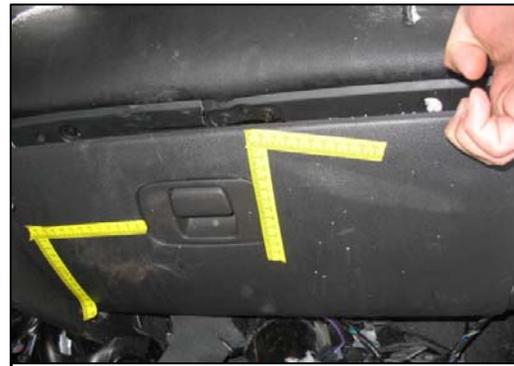
The front right female passenger was displaced slightly forward and her lower extremities loaded the glove compartment door resulting in abrasions to the cover (**Figures 9 and 10**). The left knee contact point was 10 cm (4") in diameter and was located 43–53 cm (17–21") inboard of the right edge of the instrument panel. Vertically, the abrasion was 54 cm (21") above the floor panel. The right knee contact point was 15 cm (5.9") in diameter and was located 13–28 cm (5–8") inboard of the right instrument panel edge. Vertically, the abrasion was 68 cm (27") above the floor pan. The front right passenger also loaded the belt system. This was evidenced by discernable loading evidence on the belt webbing and is discussed in greater detail later in the *Manual Restraints* section of this report.

Figure 9 - Damage to glove compartment cover from front right passenger loading.

Figure 10 - Damage to glove compartment cover from front right passenger loading.

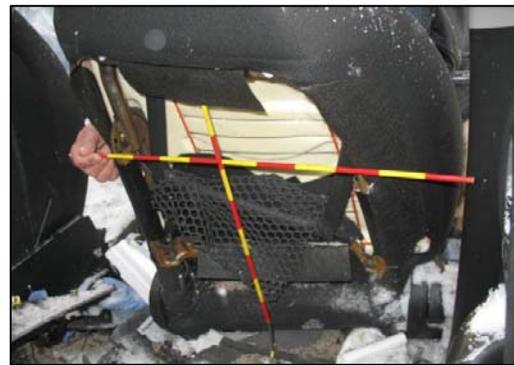
The right rear male child passenger was initially seated within a forward facing CSS. At impact, the child loaded the internal harness within the CSS and the harness splitter plate fractured. Following the fracture of the splitter plate, the child was ejected from the CSS and was displaced forward. He loaded the front right seat back which resulted in a 45 x 43 cm (18 x 17") area of damage (**Figure 11**). The child's kinematics during the crash and the fracture of the CSS's splitter plate are discussed further in the *Child Safety Seat* section of this report.

Figure 11 - Damage to front right seat back from right rear passenger loading.

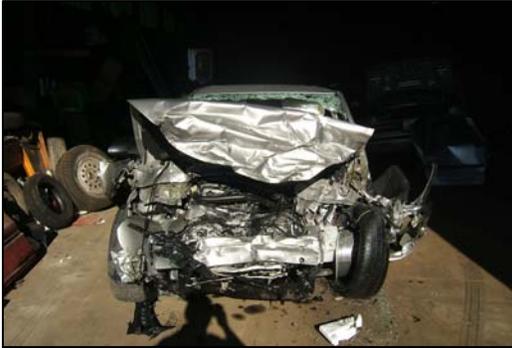
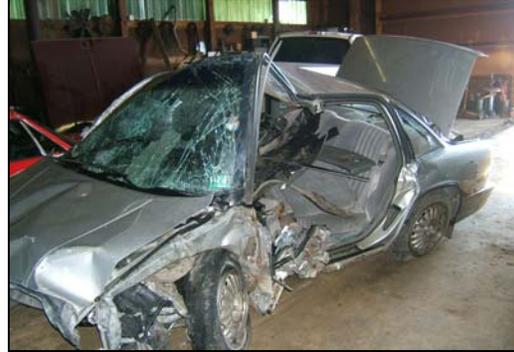
The 1992 Buick Regal sustained severe damage as a result of the head-on impact with the Pontiac (**Figures 12 and 13**). The Buick was destroyed prior to the case assignment; however, on-scene images allowed for a partial inspection of the vehicle. The direct contact damage encompassed the full frontal width of the vehicle. The force of the impact resulted in the front of the Buick shifting slightly to the right and the left A-pillar displaced upward significantly. The left wheelbase was compressed and the left front tire was restricted and flattened. The CDC for the impact with the Pontiac was 12-FDEW-4.

Figure 12 - Frontal damage to the 1992 Buick Regal.

Figure 13 - Frontal and left side damage to the Buick Regal.

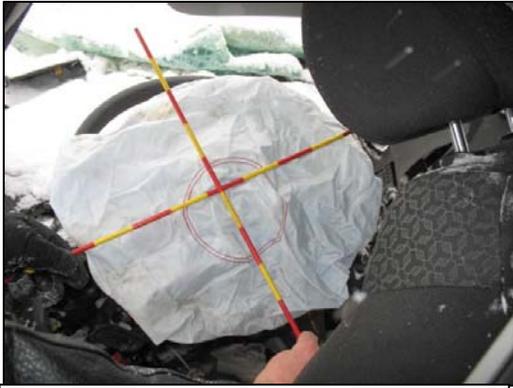
The driver's air bag (**Figure 14**) was housed within the steering wheel and was concealed by a three-piece cover flap design that was trapezoidal in shape. The top piece of the cover flap was 16 cm (6.3") horizontally and 5 cm (2") vertically. The lower side flaps were 8 cm (3") horizontally and 13 cm (5") vertically. The air bag membrane was 54 cm (21") in diameter in its deflated state and had an excursion of 25 cm (9.8"). A small tear was present on the air bag membrane (**Figure 15**). The tear was 5 cm (2") in height and was located on the vertical midpoint of the air bag 16–21 cm (6.3–8.3") above the horizontal centerline. It is probable that the tear resulted from contact with the windshield as the steering column was displaced upward.

Figure 14 – Deployed driver's air bag.

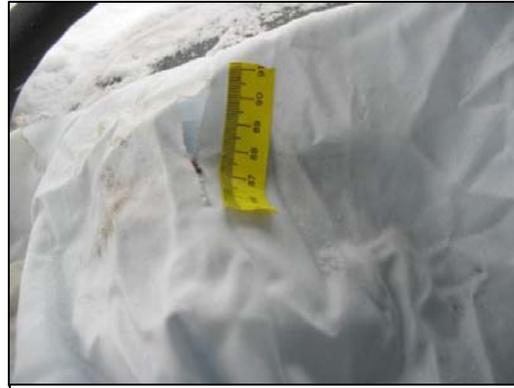
Figure 15 - Small tear in the driver's air bag membrane.

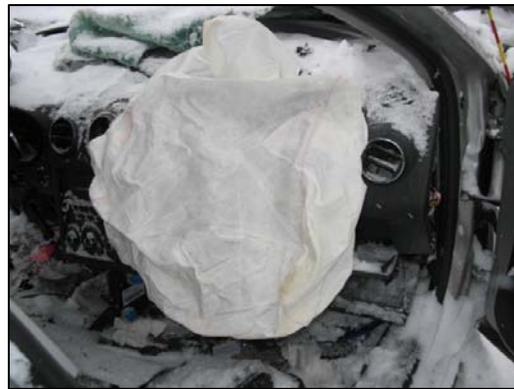
The front right passenger's air bag (**Figure 16**) deployed from a mid-mount H-configuration module configured with an asymmetrical rectangular vinyl cover flaps. The upper flap measured 30 cm (12") horizontally and 9 cm (3") vertically. The lower flap measured 30 cm (12") horizontally and 5 cm (2") vertically. The deflated air bag membrane measured 45 cm (18") horizontally and 65 cm (25.5") vertically. There was no occupant loading evidence on the front right air bag.

Figure 16 - Deployed front right passenger's air bag.

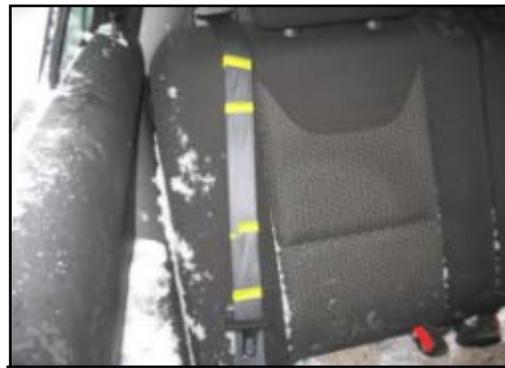
The second row right safety belt (**Figure 17**) was used to install a Forward Facing Child Safety Seat (FFCSS). The lap and shoulder belt was threaded through the forward facing belt path. The webbing exhibited loading evidence from the CSS. This evidence consisted of creasing at two locations. A 5 cm (1.9”) area of creasing that began 10 cm (3.9”) above the stop button and ended 15 cm (5.9”) above the reference point appears to have occurred from loading of the right belt path of the CSS. The second area of creasing measured 9 cm (3.5”) and was located from 37-46 cm (14.5-18.1”) above the stop button. This area of creasing occurred from the left belt path of the CSS.

Figure 17. Rear right safety belt webbing.

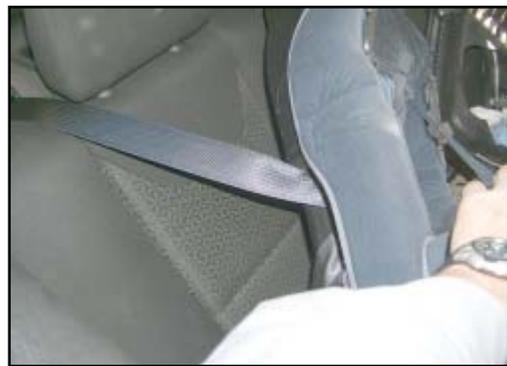
The exact installation process is not known. The tightness of the harness straps and the height location of the retainer clip could not be determined. Based on the police on-scene images, it appears that the lap and shoulder belt was routed through the forward facing belt path and the harness straps were in the top slots. Additionally, it appeared that the Automatic Locking Retractor (ALR) feature of the safety belt was not engaged during the installation.

Figure 19 depicted the police investigator moving the FFCSS forward to photograph the position of the safety belt. The slack in the safety belt was indicative that the ALR feature was not activated.

Figure 19. Police investigator moving the FFCSS post-crash.

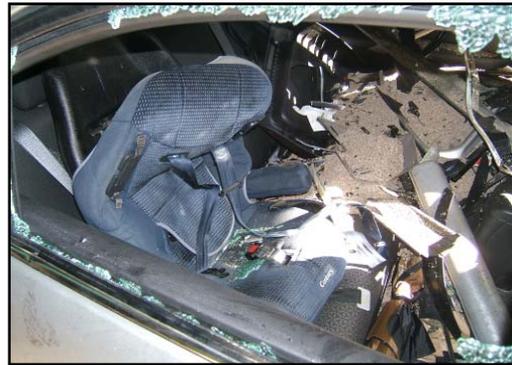
During the crash phase the child passenger loaded the internal harness system. The loading of the lower left harness strap tore the cloth and foam seat cushion (**Figure 18**). The tear began at the harness strap opening on the cushion and extended forward 17 cm (6.7"). As the 2-year-old male passenger continued loading the harness system the retainer clip unlatched. The unlatching of the harness retainer clip was supported by the tearing of the cushion from loading. This tearing probably would not have occurred if the harness clip was not latched. **Figure 20** is a police post-crash image of the FFCSS which show the harness system and the harness retainer clip prior to the removal of the FFCSS from the vehicle. No damage was evident during the SCI inspection and the retainer clip functioned as designed.

Figure 20. Post crash location of the harness and the harness retainer clips.

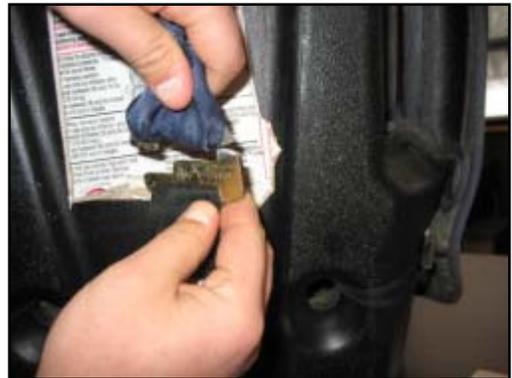
In the course of the loading, the right side (closed end) of the splitter plate fractured (**Figure 21**). The fracture occurred approximately 0.6 cm (0.25") below the apex of the top right side aspect (**Figures 22 and 23**). **Figure 24** is of the splitter plate configuration. Due to the splitter plate fracture, the harness straps partially threaded through the top slots. The movement of the harness straps against the FFCSS shell resulted in frictional abrasions on the rear of the shell. The abrasions from the left harness strap were diagonally oriented (top left to bottom right) and began at the top slot and extended 25 cm (9.8") (**Figure 25**). Frictional abrasions were present within the right harness

Figure 21. Fractured splitter plate.

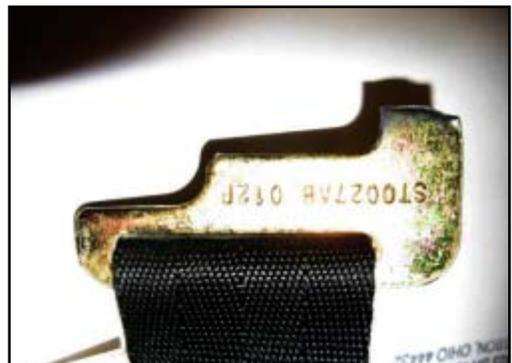
Figure 22. Bottom aspect of the splitter plate. Note the top right aspect is the area of the fracture location.

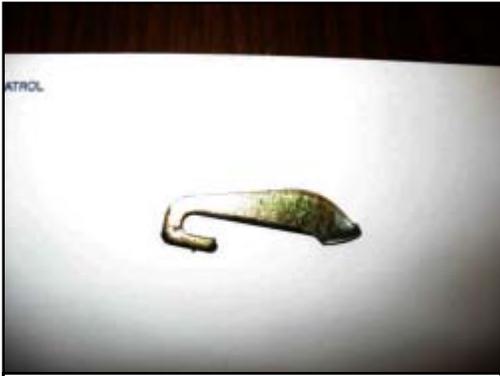
Figure 23. Top aspect of splitter plate. Note the right side attaches to the lower portion of the splitter plate.

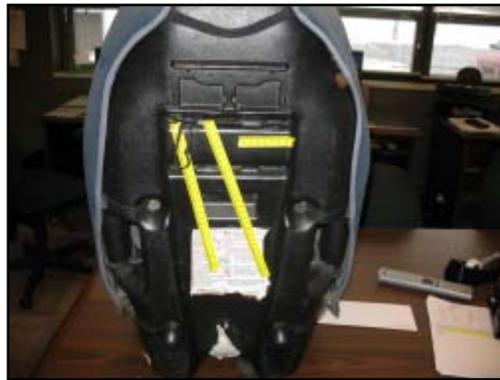
slot. In the post-crash on-scene images of the FFCSS, it did not appear that the harness straps fully threaded through the front of the safety seat. No further damage was noted to the FFCSS shell.

Figure 25. Loading abrasions from the harness straps.
