# INDIANA UNIVERSITY

## ON-SITE CHILD SAFETY SEAT INVESTIGATION

CASE NUMBER - IN07036  
LOCATION - TEXAS  
VEHICLE - 2001 CHEVROLET MALIBU  
CRASH DATE - October 2007

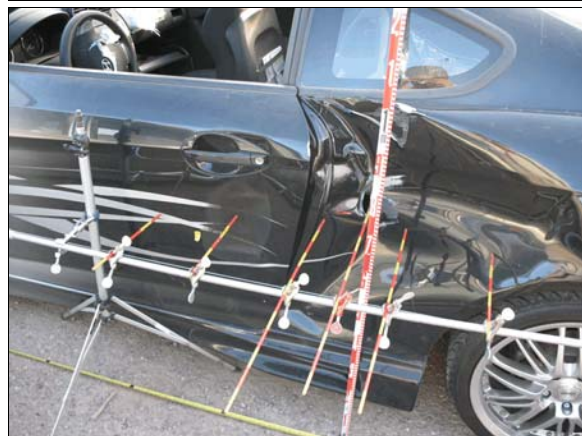
**Figure 3:** Hyundai's left side damage from the impact with the semitrailer

**Exterior Damage:** The Hyundai's impact with the tractor-semitrailer involved its left side (**Figure 17**). The vehicle's left front door and quarter panel were directly damaged. The direct damage began 5 centimeters (2 inches) forward of the left rear axle and extended 92 centimeters (36.2 inches) along the left quarter panel and door. The crush measurements were taken at the mid-door level and the residual maximum crush was 11 centimeters (4.3 inches) occurring at C<sub>3</sub>. The Hyundai's wheelbase was not changed as a result of this impact. Induced damage involved only the left front door and quarter panel. The table below shows the vehicle's left side crush profile.

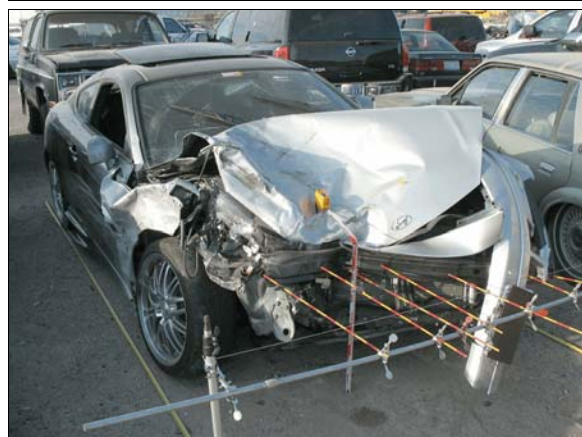
**Figure 4:** Hyundai's front damage from the impact with the back of the Chevrolet

The Hyundai's impact with the Chevrolet involved its front plane. The front bumper, bumper fascia, hood, grille, radiator, both turn signal and headlamp assemblies, the right fender and door were directly damaged. The direct damage began at the front right bumper corner and extended 63 centimeters (24.8 inches) across the front end. The crush measurements were taken on the metal bumper bar, and the residual maximum crush was 46 centimeters (18.1 inches) occurring 11 centimeters (4.3 inches) left of C<sub>5</sub>. The table below shows the vehicle's front crush profile.

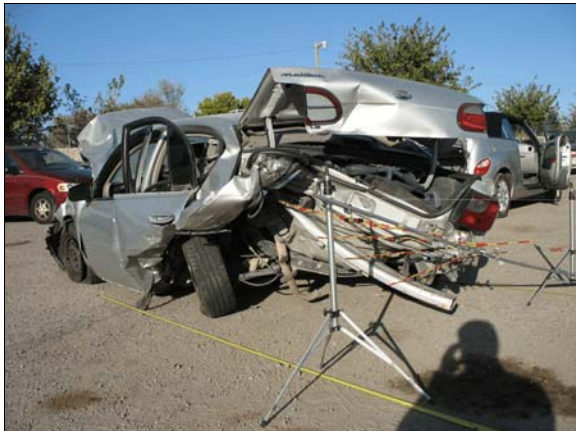
**Figure 5:** Damage to back of Chevrolet from impact with the front of the Hyundai

**Exterior Damage:** The Chevrolet’s impact with the Hyundai involved the left portion of the back end. The back bumper, trunk lid, left quarter panel, left rear door, and left rear wheel were directly damaged. The direct damage began at the back left bumper corner and extended 54 centimeters (21.3 inches) along the back bumper. The crush measurements were taken at the back bumper bar, and the residual maximum crush was 148 centimeters (58.3 inches) occurring at C<sub>1</sub> (Figure 9). The table below shows the Chevrolet’s back crush profile.

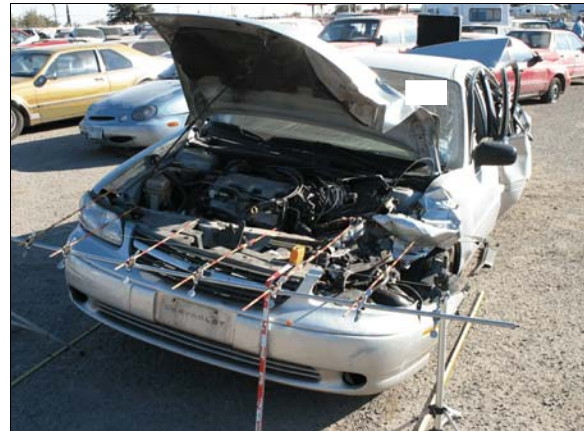
**Figure 6:** Damage to the front of the Chevrolet from impact with the back of the Ford

The Chevrolet's front impact with the back of the Ford involved the left portion of the front end. The front bumper, left headlamp/turn signal assembly, hood, left fender, and left front wheel were directly damaged. The direct damage began at the front left bumper corner and extended 31 centimeters (12.2 inches) along the bumper. Due to the Chevrolet's underride of the Ford, the crush measurements were taken at both the bumper level and the upper radiator support (**Figure 10**) and the results were averaged. The residual maximum above the bumper crush was measured as 46 centimeters (18.1 inches) and occurred at C<sub>2</sub>. The residual maximum crush at the bumper was 14 centimeters (5.5 inches) and occurred at C<sub>1</sub>. The induced damage from this impact involved the front bumper, right and left fenders, hood, and the windshield. The table below shows the final crush profile based on the crush averaging protocol; however, the maximum crush value reflects the crush above the bumper.

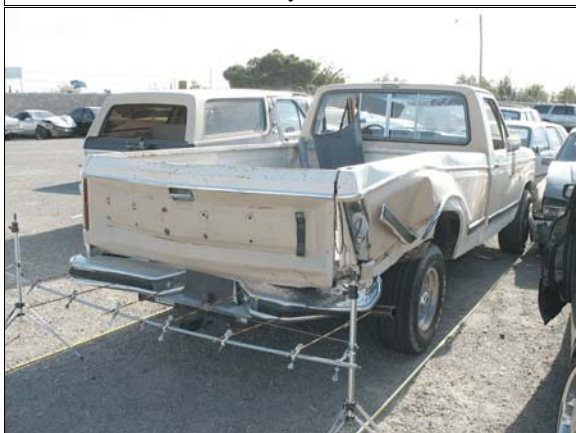
**Figure 7:** Damage to back of the Ford from the impact with the front of the Chevrolet

**Exterior Damage:** The Ford's impact with the front of the Chevrolet involved its back end. The back bumper, tailgate, and right side of the truck bed were directly damaged. The direct damage began at the back right bumper corner and extended 54 centimeters (21.3 inches) to the left along the bumper. The crush measurements were taken at the back bumper and residual maximum crush was 39 centimeters (15.4 inches) at C<sub>6</sub>. The table below shows the Ford's back crush profile.

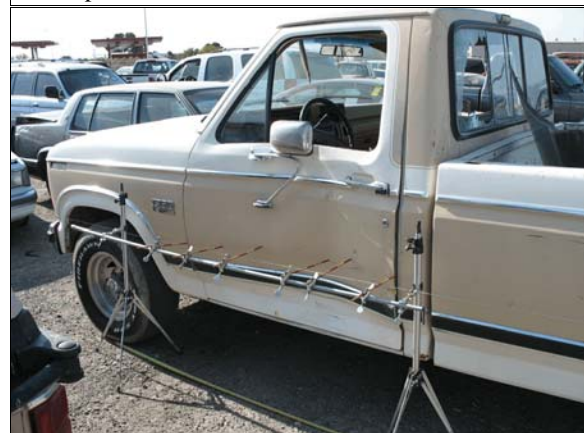
**Figure 8** Damage to the Ford's left front door from impact with the Chevrolet's left quarter panel

The Ford's left side impact with the Chevrolet involved its left front door. The direct damage began 158 centimeters (62.2 inches) forward of the left rear axle and extended 60 centimeters (23.6 inches) forward along the door. The crush measurements were taken at the mid-door level, and the residual maximum crush was 9 centimeters (3.5 inches) occurring at C<sub>3</sub>. The table below shows the Ford's left side crush profile.

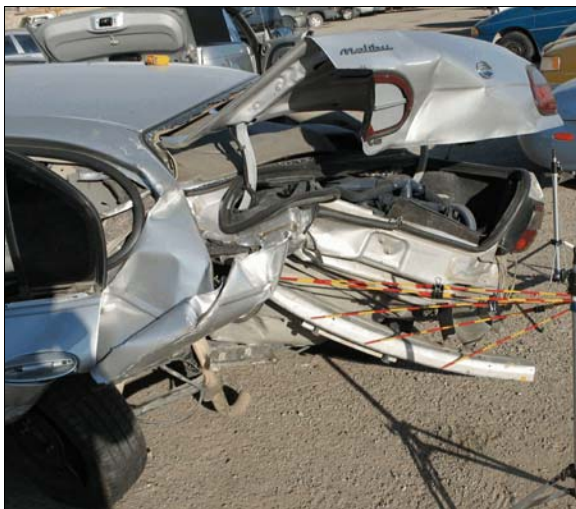
Figure 9: Left side view of the crush to the back of the Chevrolet

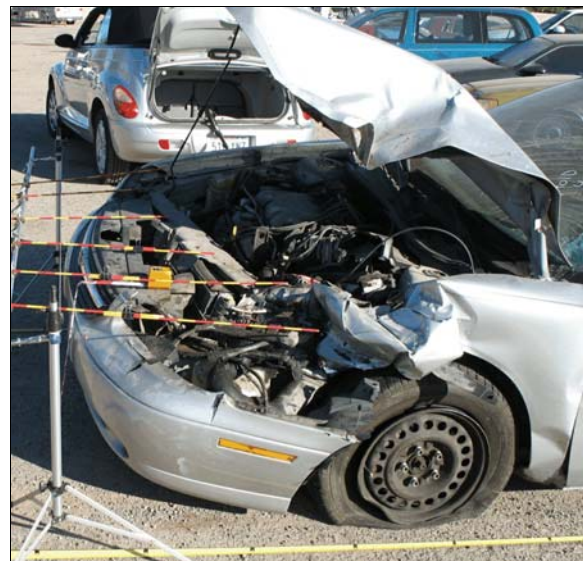
Figure 10: Left side view of the Chevrolet’s above bumper crush

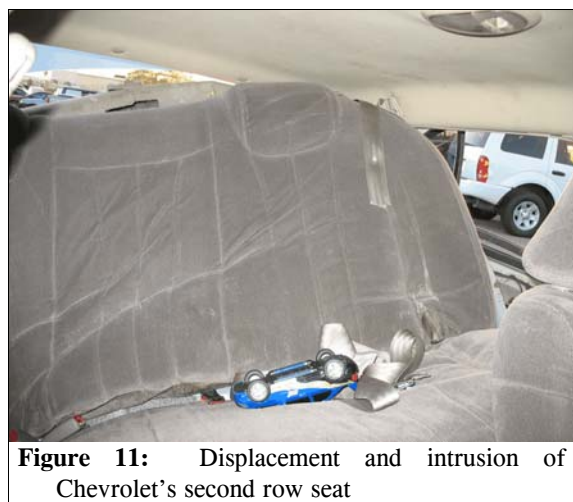
**Figure 11:** Displacement and intrusion of Chevrolet's second row seat

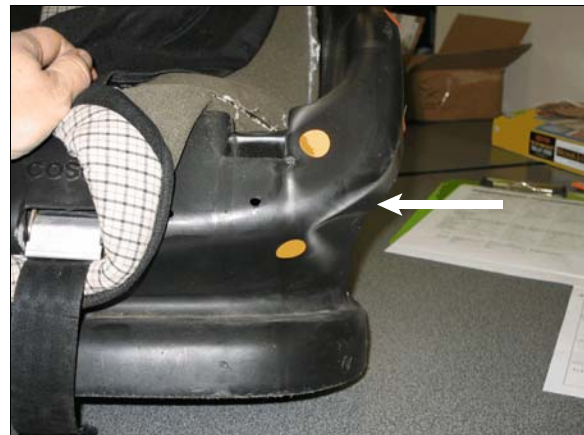
Inspection of the CSS revealed a dent and load marks in the shell at the front left corner (Figure 12). The damage was caused by the CSS loading into the left front seat back during the crash. There were also three small load marks on the inboard right side. There was no evidence of loading or damage to the remainder of the CSS and no evidence of loading to the harness.

Figure 12: Deformation of second row left CSS (arrow)

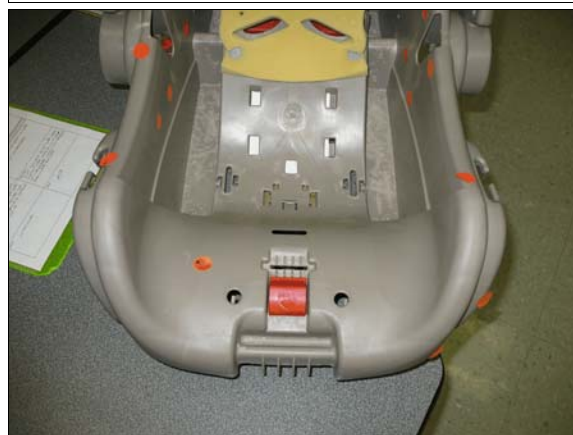
Inspection of the CSS revealed multiple load marks in the plastic on the inside of the shell (**Figure 14**). The most significant load marks were near the hubs of the carrier attachments. The load marks were probably caused by the flexing of the CSS as a result of the seat intrusion. There were also minor load marks at the right and left seat belt guides, as well as in random locations throughout the shell. There was no evidence of damage or loading on the harness webbing, buckles, and latch plate.

**Figure 14:** Orange dots show load marks in plastic shell of second row center CSS

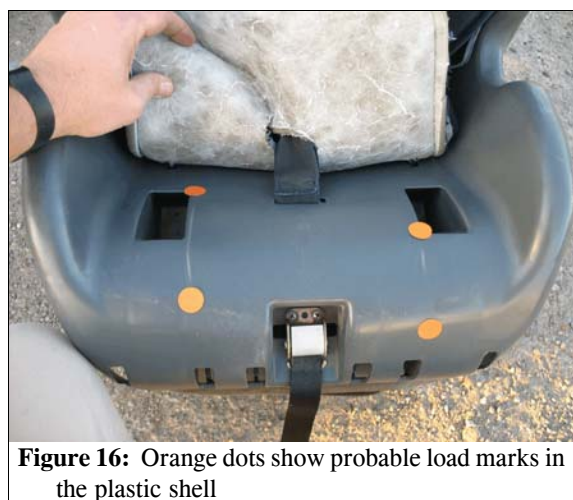
The CSS was constructed of a one-piece, plastic shell with a lightly padded cloth cover. Inspection of the CSS revealed evidence of probable loading on the bottom of the seat (**Figure 16**). The remainder of the child seat was unremarkable.

**Figure 16:** Orange dots show probable load marks in the plastic shell
