## ON-SITE AIR BAG NON-DEPLOYMENT INVESTIGATION

CASE NUMBER - IN07037

VEHICLE - 2001 MERCURY GRAND MARQUIS GS

CRASH DATE - June 2007

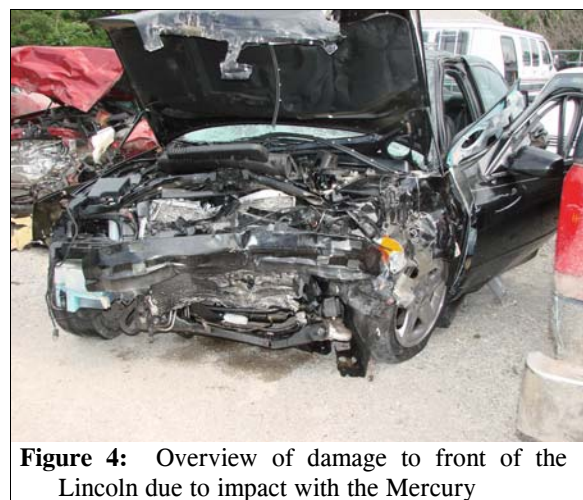
**Figure 4:** Overview of damage to front of the Lincoln due to impact with the Mercury

**Exterior Damage:** The Lincoln had been sold at auction and was not inspected. Based on the police photographs, the front of the vehicle sustained severe damage. The direct damage involved the front bumper, left fender, and left headlamp/turn signal assembly. The direct damage began at the front left bumper corner and involved approximately 60% of the front plane.

**Damage Classification:** The CDC was estimated from the photographs to be **12-FYEW-3**. The Missing Vehicle algorithm of the WinSMASH program calculated the Lincoln's total Delta V as 68.0 km/h (42.3 mph). The longitudinal and lateral velocity changes were -67.0 km/h (-41.6 mph) and -11.8 km/h (-7.3 mph), respectively. The results were based only on the Mercury's front crush profile and should be considered a borderline reconstruction of the Lincoln's Delta V.

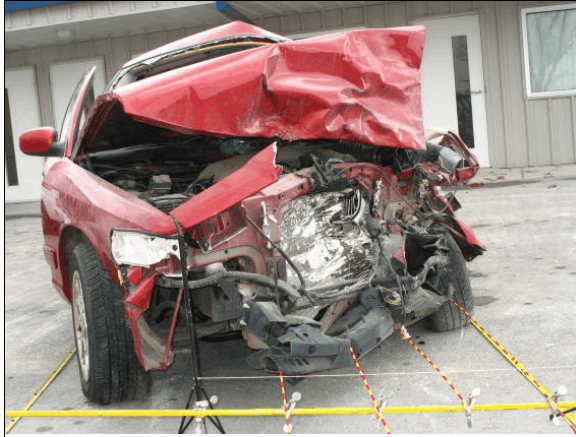
Figure 5: Overview of damage to front of Mercury from impact with front of the Lincoln

**Exterior Damage:** The Mercury's impact with the Lincoln involved the front plane. The front bumper, left headlamp/turn signal assembly, left fender and hood were directly contacted. The direct damage began at the front left bumper corner and extended 100 centimeters (39.4 inches) across the front end. The crush measurements were taken on the front bumper bar because the front bumper fascia had been torn off the vehicle. The maximum residual crush was 122 centimeters (48 inches) occurring at  $C_1$  (Figure 11). Due to the triangular-shaped crush profile, the Field L, which is projected to the baseline, was only 73 centimeters (28.7 inches). Therefore, the option to use four C-measurements as allowed by the

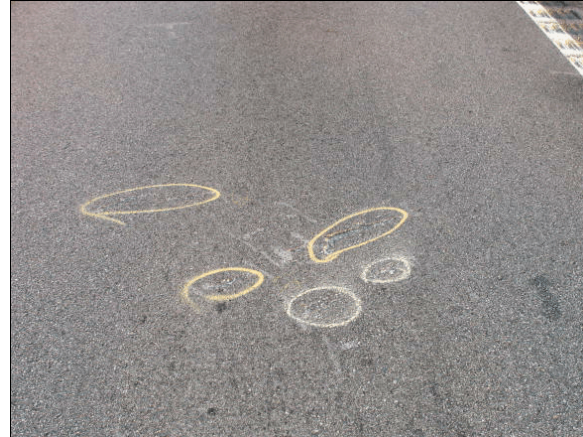
Figure 6: Impact gouges in eastbound lane

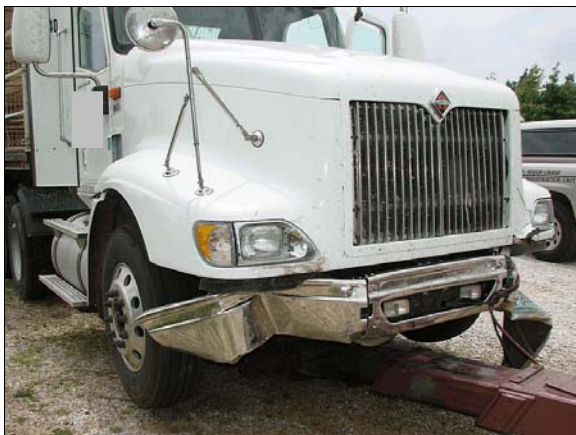
Figure 7: Police photo showing damage to front of International due to impact with left side of Mercury

The International was not inspected. A Truck Deformation Classification (TDC) was determined from the photographs to be **12-FDEW-1 (0 degrees)**.

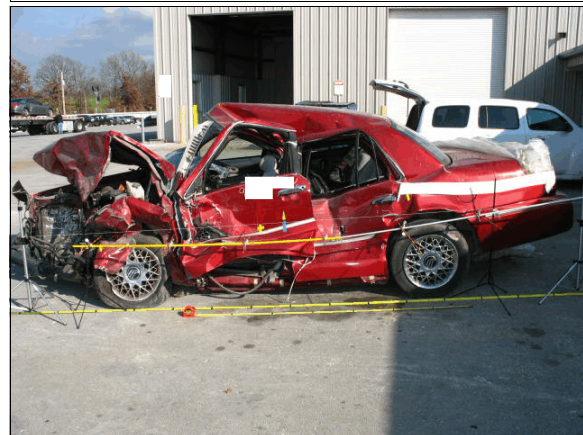
Figure 8: Damage to left side of Mercury due to impact with front of the International

The Mercury's impact with the International involved the left side plane. The left fender, left front door and left rear door sustained direct damage. The direct damage began 17 centimeters forward of the left rear axle and extended forward 239 centimeters (94.1 inches). The damage from the front impact partially overlapped the damage from this impact, and the crush at C<sub>6</sub>, C<sub>5</sub> and possibly C<sub>4</sub> represents the overlapping damage from both impacts. The maximum crush was 30 centimeters, which occurred at C<sub>3</sub> and was rear of the overlapping damage area.

The Mercury's left side wheelbase was shortened 59 centimeters (23 inches) and the right side wheelbase was extended 7 centimeters (2.8 inches). The vehicle sustained induced damage to the hood, roof, left quarter panel and right fender.

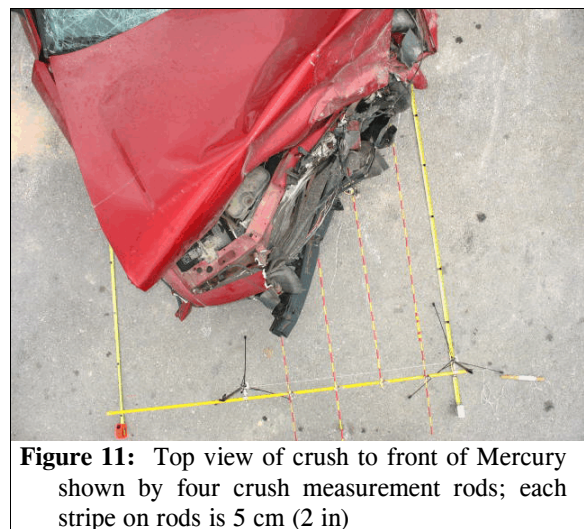
Figure 11: Top view of crush to front of Mercury shown by four crush measurement rods; each stripe on rods is 5 cm (2 in)

Vehicle Measurement Techniques document was used to document the crush profile. The table below shows the vehicle's front crush profile. The C-measurement positions for C<sub>5</sub> and C<sub>6</sub> are indicated as N/A (not applicable).

**Damage Classification:** The Collision Deformation Classification (CDC) for the Mercury's front impact with the Lincoln (event 1) was **12-FYEW-4 (0 degrees)**. The CDC for the Mercury's left side impact with the front of the International was **09-LYAW-2 (270 degrees)**. The Missing Vehicle algorithm of the WinSMASH program calculated the Mercury's total Delta V for the front impact as 61.0 km/h (37.9 mph). The longitudinal and lateral velocity changes were -61. km/h (-37.9 mph) and 0.0 km/h (0.0 mph), respectively. The results were based only on the Mercury's front crush profile because the Lincoln was not inspected. The results should be considered a borderline reconstruction of the Mercury's frontal impact Delta V.

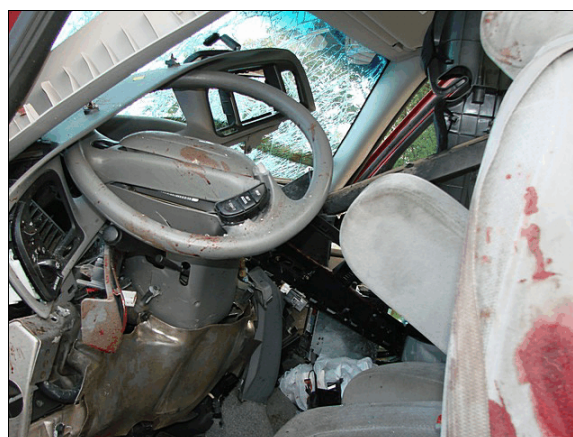
**Vehicle Interior:** The Mercury’s instrument panel and steering assembly had been extensively damaged as a result of intrusion and the police disassembly of the driver and front right passenger air bags, and the removal of the Restraint Control Module (RCM). A police photograph showed that the driver had loaded the steering assembly (**Figure 12**) and her left knee loaded the left instrument panel. A few hairs from the front right passenger were found on the broken windshield. No occupant contact evidence was discernable on the instrument panel due to its damaged condition. The left front door was jammed shut following the crash, but had been forced open by emergency responders to extricate the driver. The left rear door was jammed shut. The right front and right rear doors had remained closed and operational following the crash. The police on-scene photos showed that the windshield was in place and cracked following the crash; however, it was partially collapsed into the passenger compartment at the time of the inspection. The left front and left rear door window glazing were closed at the time of the crash and disintegrated during the crash. The right front and right rear door window glazing was closed and undamaged and the backlight glazing was undamaged.

**Figure 12:** Police photo showing deformation to Mercury’s steering wheel and steering column

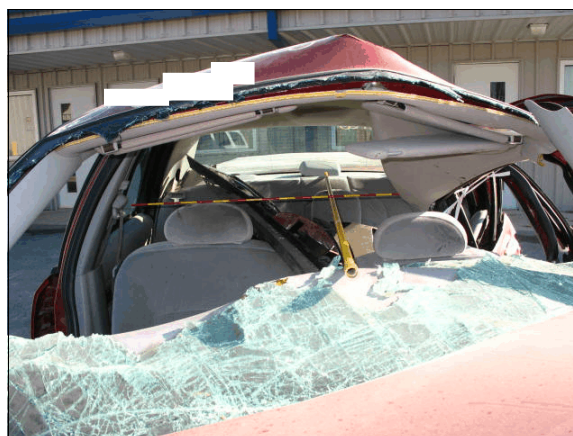
**Figure 13:** Left side intruding components into Mercury’s passenger compartment

The passenger compartment sustained numerous intrusions and the most severe involved the driver's occupant space and the second row left occupant space. The left instrument panel and toe pan intruded longitudinally 20 centimeters (7.9 inches) and 12 centimeters (4.7 inches), respectively into the driver's occupant space. The left rear door and left roof side rail intruded 29 centimeters (11.4 inches) into the second row left occupant space. The induced buckling of the roof resulted in 20 centimeters (7.8 inches) of intrusion into the second row left occupant space.

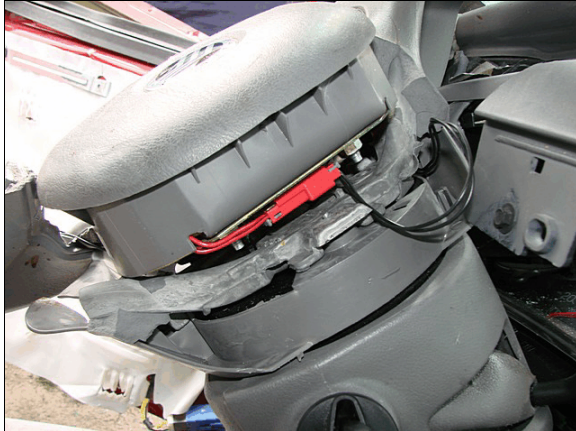
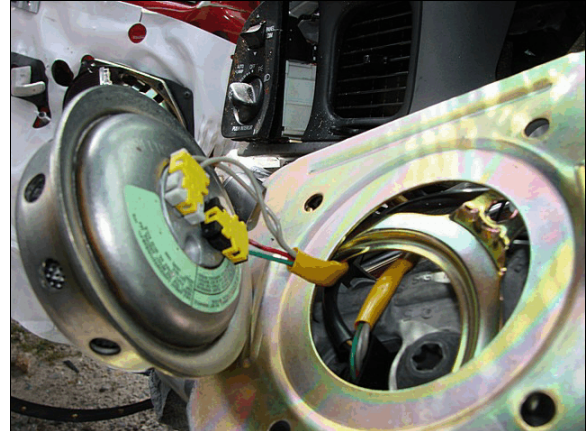
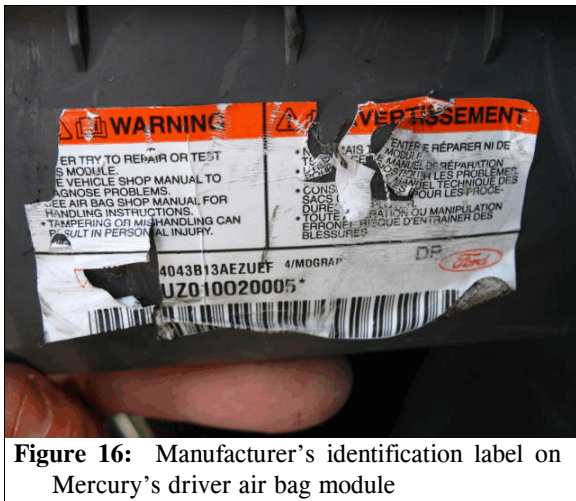
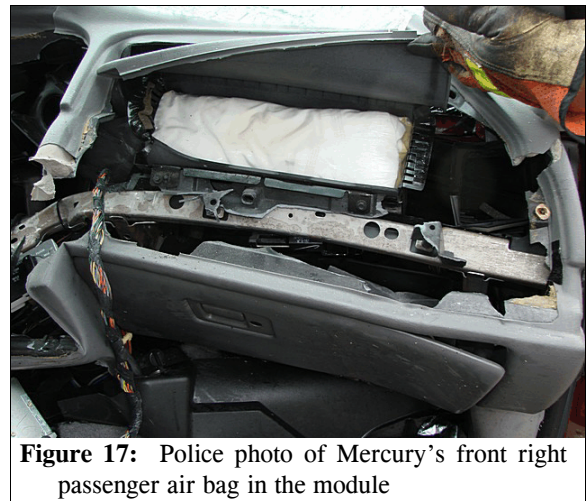
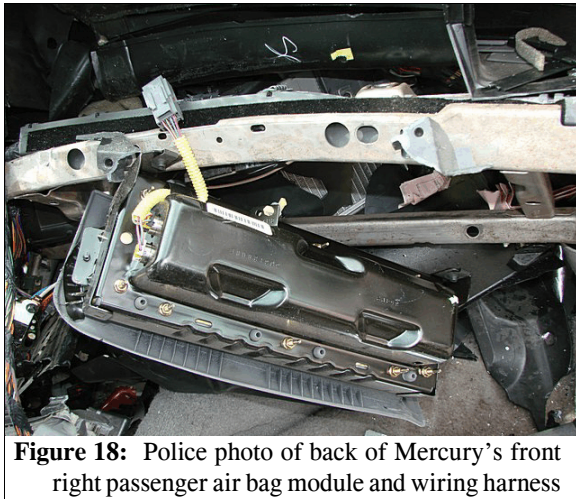
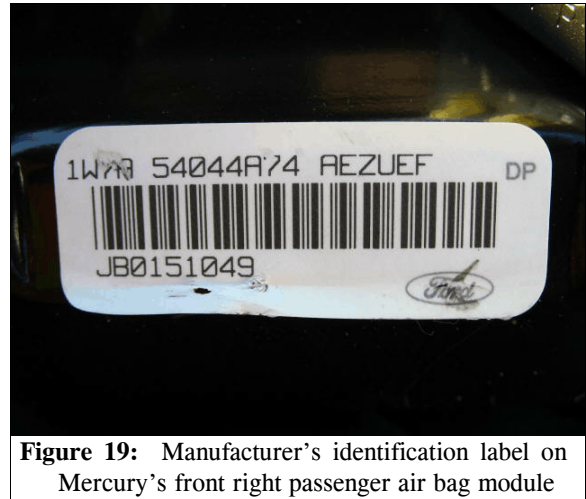
The police disassembled both driver and front right passenger air bag modules (**Figures 14-19**) and reported that an intact air bag and inflator were present within each module and the electrical connections were intact. The air bag fuse was not blown and was in operable condition. The vehicle inspection confirmed that an air bag was present within each module and that the inflators had not activated. The driver air bag module was still connected to its electrical wiring; however, the front right passenger air bag module had been disconnected, apparently during the police disassembly. The front impact sensor (**Figure 20**) was undamaged but its electrical feed wire had been severed (**Figure 21**) as a result of the impact. The sensor was located on the center of the upper radiator support. Since there was no override of the Mercury's front bumper during the impact, it is unlikely that the severed electrical feed wire was the cause of the non-deployment.

Figure 14: Police photo of Mercury's driver air bag module prior to disassembly

Figure 15: Police photo of Mercury's driver air bag inflator and wiring harness

Figure 16: Manufacturer's identification label on Mercury's driver air bag module

Figure 17: Police photo of Mercury's front right passenger air bag in the module

Figure 18: Police photo of back of Mercury's front right passenger air bag module and wiring harness

Figure 19: Manufacturer's identification label on Mercury's front right passenger air bag module

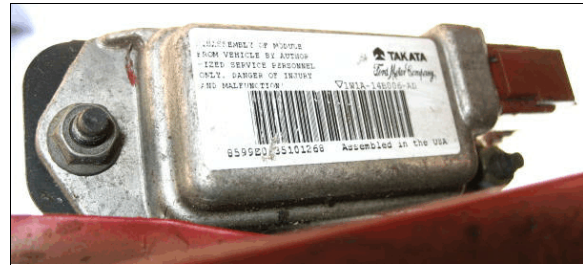
**Figure 20:** Mercury's impact sensor mounted at center of upper radiator support

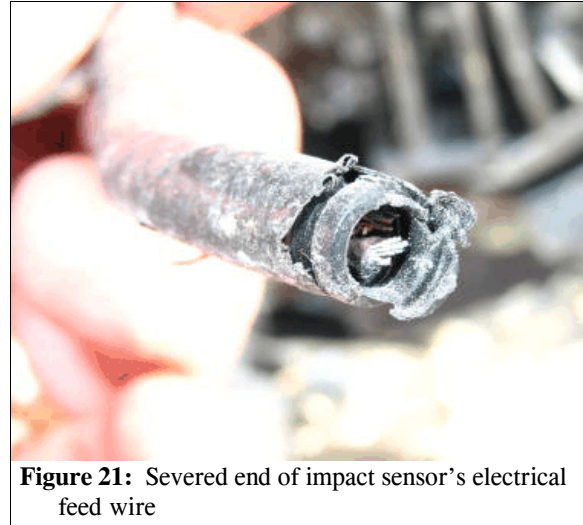
**Figure 21:** Severed end of impact sensor's electrical feed wire

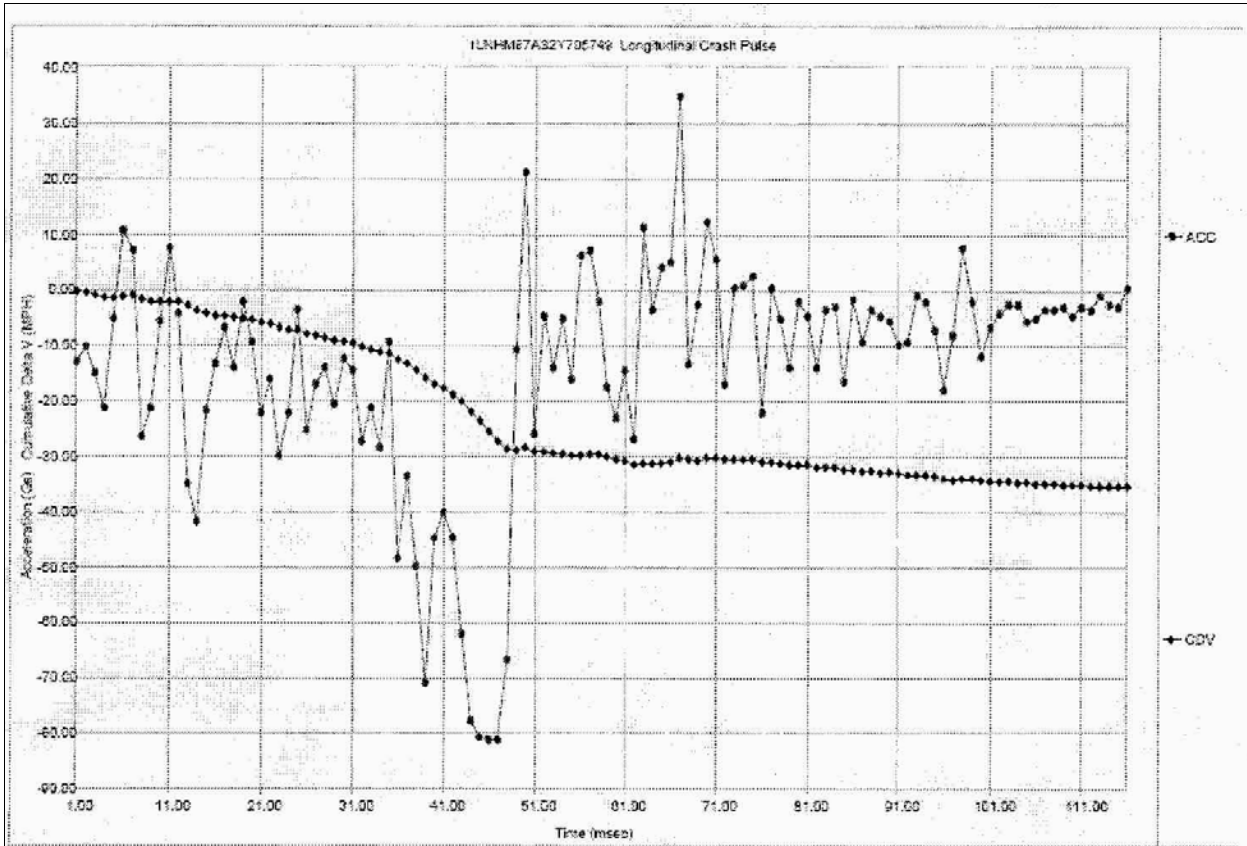
Figure 25: Lincoln's Longitudinal Crash Pulse Data graph

The police download the Lincoln's EDR and the report is presented in **Figures 22-29** beginning on page 23. The EDR recorded a deployment event and indicated that the deployment of the air bags and seat belt pretensioner occurred at 14.5 milliseconds after the recording began. The maximum recorded Delta V was -57.0 km/h (-35.41 mph), which occurred at the end of the recording, at 116 milliseconds.
