Child Safety Seat Investigation
Dynamic Science, Inc. / Case Number: DS07038
2001 Nissan Quest
California
September 2007

1. Report No. DS07038	2. Government Accession No.		3. Recipient Catalog No.	
4. Title and Subtitle Child Safety Seat Investigation		5. Report Date August 27, 2008

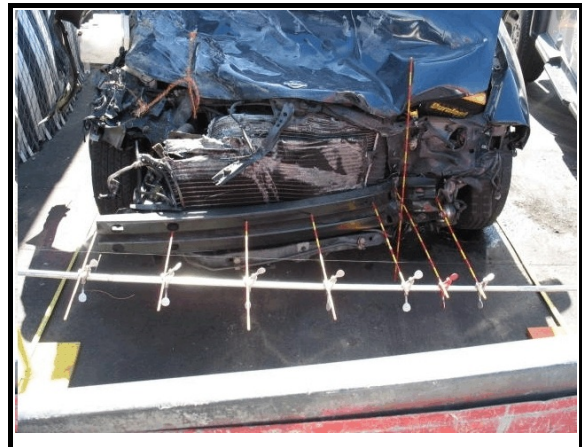
The 2001 Nissan Quest sustained moderate front end damage as a result of the impact with the Chevrolet (**Figures 4-5**). The bumper fascia and backing material, and the right front fender were displaced from the vehicle. There was direct damage to the front bumper, grille and hood. The hood was buckled and had contacted and cracked the windshield glazing.

The direct damage to the front end was distributed across the front bumper and measured 124 cm (48.8 in). There were uneven crush patterns between bumper level and above bumper level. In accordance with National Automotive Sampling System (NASS) protocols, two sets of crush measurements were taken and crush averaging was applied.

Six crush measurements were taken at bumper level as follows: C1 = 29 cm (11.4 in), C2 = 31 cm (12.2 in), C3 = 21 cm (8.3 in), C4 = 13 cm (5.1 in), C5 = 4 cm (1.6 in), C6 = 0 cm. Maximum crush at bumper level was located between C1 and C2 and measured 43 cm (16.9 in). The grille was

Figure 4. Crush gauge set a bumper level

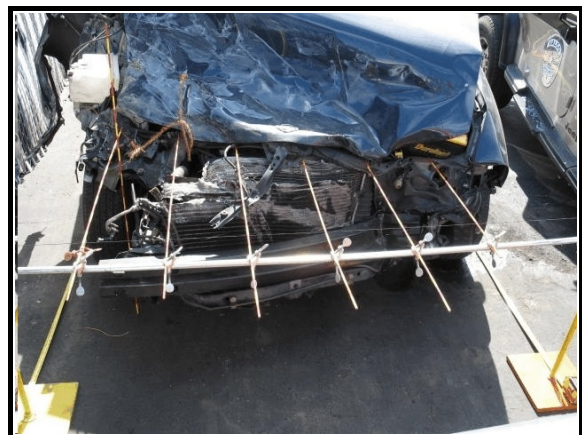
Figure 5. Gauge set at upper radiator support

completely fractured; therefore six crush measurements were taken at the upper radiator support as follows: C1 = 30 cm (11.8 in), C2 = 30 cm (11.8 in), C3 = 32 cm (12.6 in), C4 = 38 cm (15.0 in), C5 = 48 cm (18.9 in), C6 = 58 cm (22.8 in). Maximum crush at the upper radiator support level was located at C6 and measured 58 cm (22.8 in). The average crush measurements for the upper and lower measurements were as follows: C1 = 29 cm (11.4 in), C2 = 31 cm (12.2 in), C3 = 21 cm (8.3 in), C4 = 26 cm (10.2 in), C5 = 26 cm (10.2 in), C6 = 29 cm (11.4 in). The maximum crush measurement was 58 cm (22.8 in). The Collision Deformation Classification (CDC) for the frontal impact was 11FDEW3.

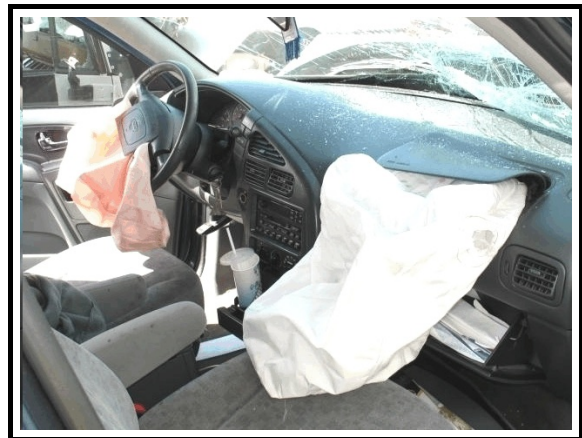
The 2001 Nissan Quest was equipped with frontal air bags. The air bags deployed as a result of the longitudinal deceleration of the Nissan during the impact with the Chevrolet (**Figure 6**).

The driver's air bag deployed from the center of the steering wheel hub through asymmetrical H-configuration module cover flaps. The top flap measured 11 cm (4.3 in) in height and 16 cm (6.3 in) in width. The bottom flap measured 3 cm (1.2 in) in height and 15 cm (5.9 in) in width. The deployed driver's air bag measured 60 cm (23.6 in) in diameter in its deflated state. The air bag was tethered by a single internal strap. There was a circular stitching pattern in the front center of the air bag that measured 16 cm (6.3 in) in diameter.

There were two vent ports, one on either side near the top cover flap. There was a reddish color stain that was a suspected occupant contact. The stain was located 18 cm (7.1 in) from the bags front center, in the upper left quadrant. There were faint black streak markings that were suspected occupant contacts. These markings were located on the front of the bag in the lower left quadrant. The driver reportedly sustained a forehead contusion which was consistent with contact with the air bag.

The front right passenger's air bag deployed from a mid-mount module with a rectangular cover flap that was hinged at the forward aspect. The module cover flap measured 37 cm (14.6 in) in width and 19 cm (7.5 in) in height. The deployed front right passenger's air bag measured 37 cm (14.6 in) in width seam to seam and 50 cm (19.7 in) in height. The air bag had two vent ports, one on each side near the upper corners. There were several black streak markings that are suspected to have been caused during the deployment. There was suspected dried blood within an area 24 cm (9.5 in) x 12 cm (4.7 in).

Figure 6. The left and right frontal air bags deployed

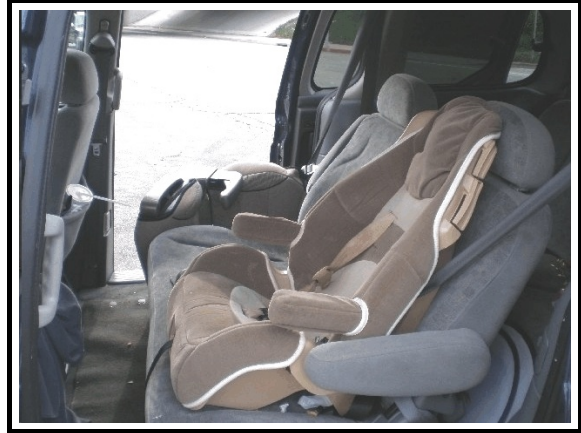
Figure 7. Dorel High Backed Booster

A forward facing child safety seat was positioned on the second row left seat (**Figure 7**). The data for this seat was obtained from police photographs, which revealed that the seat was a Dorel High Back Booster. The child seat was designed to be used forward facing only. The child seat was configured with a 5-point harness system with a retainer clip. The child seat was configured with LATCH (Lower Anchors and Tethers for Children) hardware. There were two lower anchor assemblies on the bottom and an upper tether on the back. The manufacturer recommended that the seat be used only by children more than one year of age, and weighing between 22 - 40 pounds (10.1 - 18.0 kg), and whose height is between 34 - 43 inches (85.1 - 110 cm). The manufacturer recommended that the child seat can be secured by either lap belt only, lap and shoulder belt, or LATCH only.

A 19-month-old male occupant was seated in the child safety seat. The child was 71 cm (28 in) tall and weighed 10.4 kg (23 lbs.). The child met the age and weight recommendations, but he was 15 cm (6 in) shorter than the height recommendation. The internal harness straps were routed through the top set of slots. The seat was secured using the vehicle's 3-point manual lap and shoulder belt, which was routed through forward facing ports in the seat shell. It was reported by the police that the seat was properly secured at the time of their arrival on-scene; however, the child had already been removed from the seat by that time. The mother reportedly assisted the child with the child seat restraint prior to the trip, and then started a DVD movie for the children to watch. Based on evidence obtained from the vehicle inspection, the police report, the on-scene photos, the child's injuries, and the interview, the SCI Investigator was unable to determine whether the child was properly restrained. The safety belt was switched to ALR mode when the seat was installed in the vehicle. The child seat, harness straps and safety belt were examined and did not reveal any evidence of occupant loading.

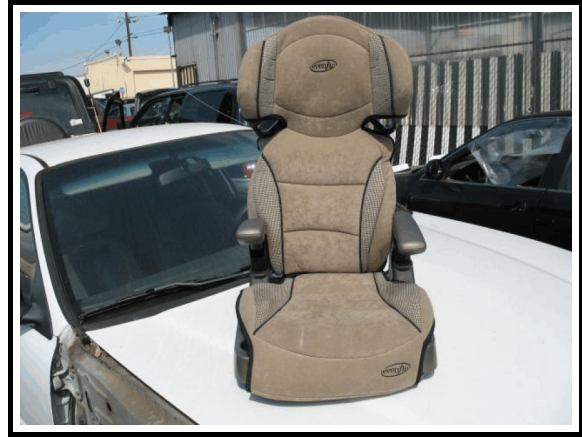
Figure 8. Evenflo Big Kid Deluxe booster seat

A forward facing child seat was positioned on the second row right seat (**Figure 8**). The seat was an Evenflo Big Kid Deluxe high back belt positioning booster seat. The model number was 3371689A and the date of manufacture was April 11, 2007. The booster seat was to be used forward facing only and was not configured with integrated harness straps. The seat was configured with pivoting armrests, retractable drink/snack holders, and 5-position height and seat depth adjustments.

A 3-year-old male child was seated in the Evenflo booster seat. The child was 76 cm (30 in) tall and weighed 18.6 kg (41 lbs.). He met the seat manufacturer's height and weight guidelines. At the time of the crash, the child was not wearing the vehicle's lap and shoulder belt. It was reported by an investigating police officer that upon her arrival, the booster seat was unoccupied and lying in the floor of the second row. The second row left safety belt was reportedly unbuckled at that time. On-scene photos show the safety belt unbuckled and latch plate routed through the right side positioning slot. The mother reportedly assisted the child with the belt restraints prior to the trip, and then started a DVD movie for the children to watch. It was reported that the 3-year-old had a habit of unbuckling his safety belt while seated in the booster seat. The booster seat was examined and did not exhibit evidence of damage or occupant contact. The safety belt webbing and latch plate were examined and did not exhibit evidence of occupant loading.

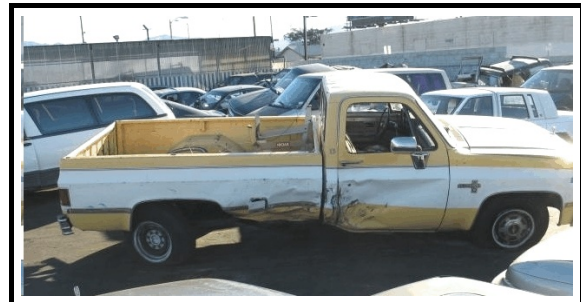
Figure 9. 1984 Chevrolet Silverado

The 1984 Chevrolet Silverado sustained moderate right side damage as a result of the impact with the Nissan (**Figure 9**). The direct damage began 126 cm (49.6 in) rearward of the right front axle, and extended 218 cm (85.8 in) rearward to the right rear tire. The combined direct and induced damage measured 300 cm (118.1 in). Six crush measurements were taken at mid-door level as follows: C1 = 0 cm, C2 = 2 cm (0.8 in), C3 = 3 cm (1.2 in), C4 = 9 cm (3.5 in), C5 = 11 cm (4.3 in), C6 = 0 cm. Maximum crush at mid-door level was located between C4 and C5 and measured 15 cm (5.9 in). The CDC for the side impact was 02RZEW2.

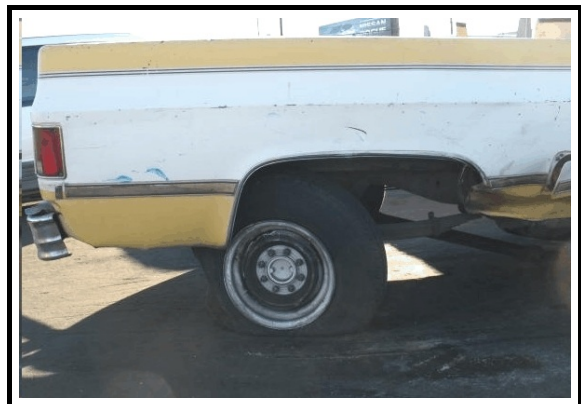
The Chevrolet sustained damage to the rear axle (**Figure 10**). The rear tires were deformed 10 degrees to the right. The drive shaft was detached at the front end. The right rear wheel was deformed approximately 28 cm (11.0 in) rearward of the original wheelbase. The right rear tire was debedded and flattened.

Figure 10. Right rear axle and wheel were moved rearward
