Child Safety Seat / Vehicle To Vehicle Investigation
Dynamic Science, Inc. / Case Number: (DS07044)
2002 Ford Expedition
California
September 2007

1. Report No. DS07044		2. Government Accession No.		3. Recipient Catalog No.	
4. Title and Subtitle Child Safety Seat Investigation			5. Report Date June 2, 2008

14. Sponsoring Agency Code		
15. Supplemental Notes					
16. Abstract This on-site investigation focused on child occupants involved in a two vehicle crash involving a 2002 Ford Explorer XLT and a 2002 Chevrolet Silverado K3500 pickup. The crash occurred within a four-leg intersection. The subject vehicle was being driven by a restrained 26-year-old female and there were three children seated in the second row. The second row left seat was occupied by a 5-year-old female seated in a forward facing booster seat. The second row middle seat was occupied by a 21-month-old male seated in a child safety seat. The second row right seat was occupied by a 3-year-old male reportedly seated in a child safety seat. The other vehicle was a 2002 Chevrolet Silverado pickup being driven by a 27-year-old male. The Ford was traveling north; the Chevrolet was traveling west. As the Ford traverse

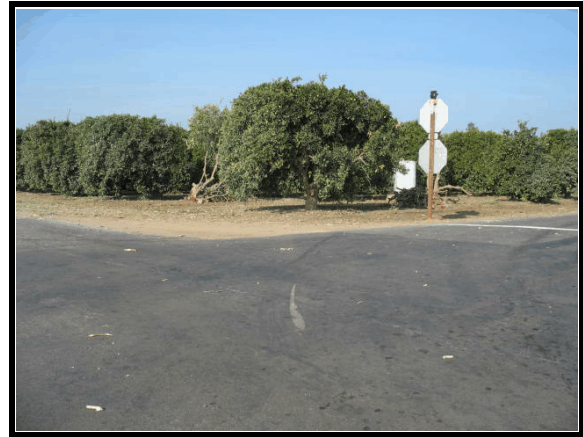
Figure 5. Point of impact; view showing gouge mark and path to northwest corner

The two vehicles entered the intersection simultaneously. The front end of the Chevrolet Silverado contacted the right side of the Ford Expedition. Each vehicle initiated a clockwise rotation and traveled toward the northwest corner of the intersection (**Figure 5**).

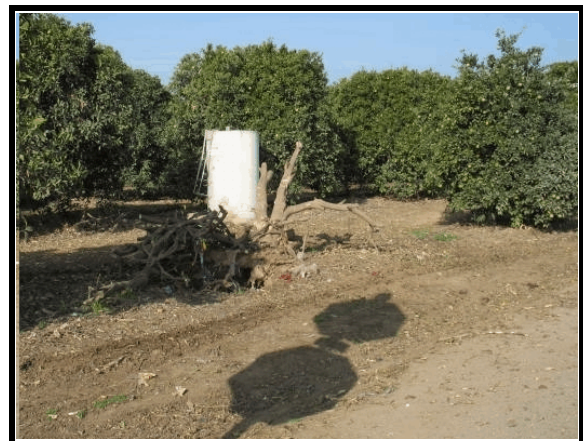
Figure 6. Approach to impact with tree, 2002 Ford Expedition

The Ford traveled off the northwest corner of the roadway and impacted a tree with its right side (**Figure 6**). The vehicle continued traveling through several rows of orange trees. The Ford traveled approximately 39.6 m (130.0 ft) from the area of the first impact to the area of final rest. The vehicle came to final rest facing southeast. The second row middle occupant was ejected from the vehicle in the area of the roadside departure. The occupant was ejected while still restrained within the Evenflo child safety seat. The police report stated that the child was found on the west shoulder of the north/south roadway.

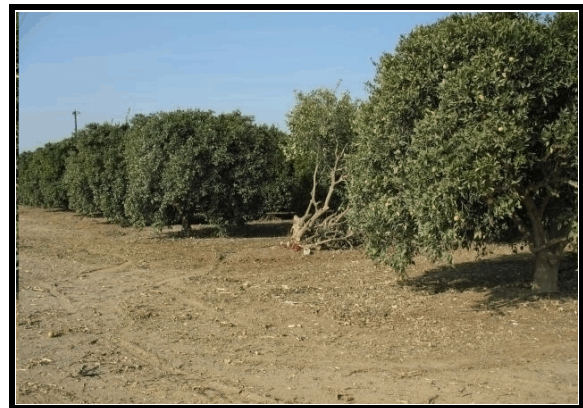
Figure 7. Approach to impact with tree, 2002 Chevrolet Silverado

The Chevrolet traveled off the northwest corner of the roadway and contacted two trees before coming to final rest (**Figure 7**). The Chevrolet traveled approximately 38.1 m (125.0 ft) from the area of the first impact to the area of final rest. The vehicle came to final rest facing generally west. The unrestrained driver of the Chevrolet was ejected near area of the first tree impact. He was found in an orange tree by emergency personnel.

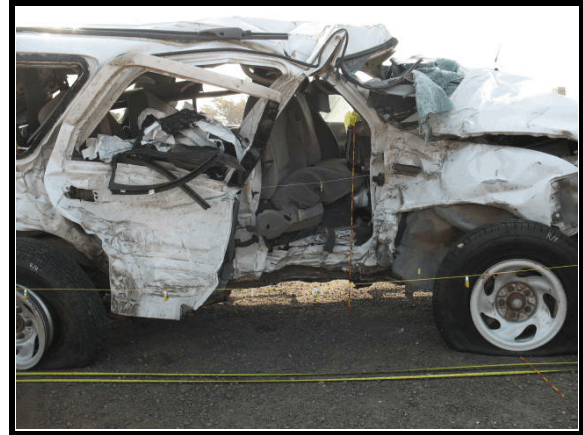
Figure 8. Subject vehicle, right side damage, middle

The 2002 Ford Expedition sustained two impacts to the right passenger area. The first impact was a vehicle to vehicle impact; the second was a tree impact. The contact damage overlapped and could not be separated by the investigator. However, based on the damage profile, the majority of the damage occurred as a result of the impact with the Chevrolet. The vehicle sustained severe right side damage as a result of the two impacts.

The first row right side door was separated from its hinges during the crash (**Figure 8**). The door panel was found in the third row seating area. The upper hinge for this door was deformed but still intact (**Figure 9**). The lower hinge was broken off near the pin (**Figure 10**). There was also hinge damage to the second row right side door. The upper and lower hinges failed at the pin slots (**Figures 11, 12, 13**). This door was jammed in place and was still attached to the vehicle.

The direct damage to the right side measured 294 cm (116.0 in) in length. The damage began 30 cm (11.8 in) rearward of the rear axle and ended 22 cm (8.7 in) forward of the front axle. There was bowing to the vehicle as a result of the right side impacts.

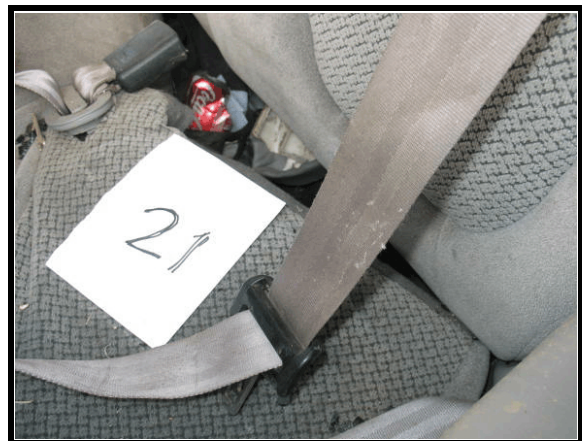
Figure 15. Second row left safety belt, showing evidence of occupant loading

The back left safety belt latch plate showed signs of usage. The belt webbing was slightly frayed and stretched, which indicated the belt was loaded by the occupant during the crash (**Figure 15**). This belt was used to restrain a child seated in a booster seat.

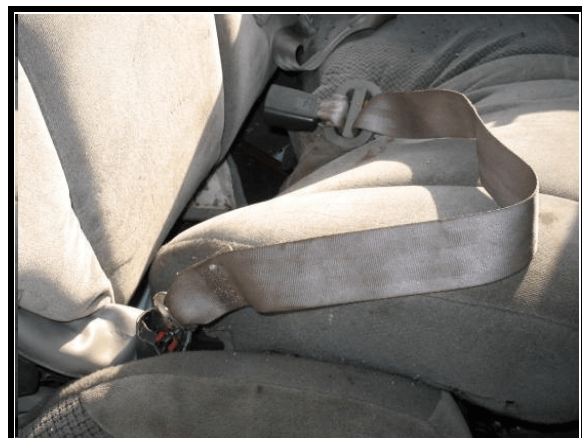
Figure 16. Second row middle lap belt, subject vehicle

The middle belt was found in its buckled position (**Figure 16**). This belt would not unbuckle. The buckle was examined and damage was noted. The plastic cover was cracked and the buckle mechanism was visible. The occupant in this seat position was ejected while seated in a child safety seat.

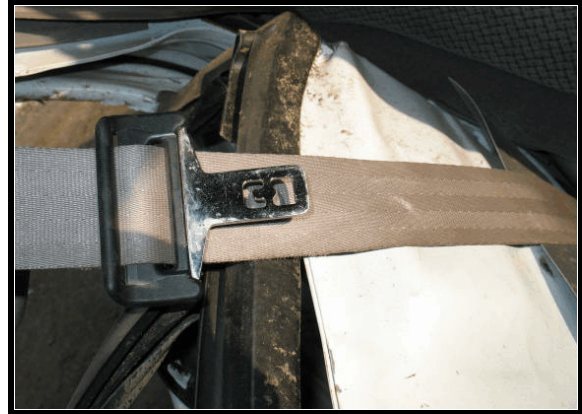
Figure 17. Second row right safety belt, showing evidence of occupant loading

The back right safety belt latch plate showed signs of usage. The webbing had stretch marks, which indicated the belt was loaded by the occupant during the crash (**Figure 17**).

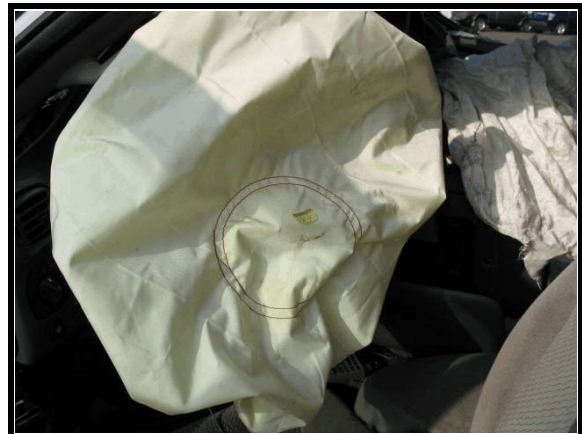
Figure 18. Driver air bag, showing suspected area of occupant contact

The 2002 Ford Expedition was equipped with first row frontal air bags for the driver and the front right occupant. The air bags deployed as a result of the longitudinal deceleration of the Ford during the impact with the Chevrolet (**Figure 18**).

The deployed driver's air bag measured 58 cm (22.8 in) in diameter in its deflated state. There was a circular stitching pattern in the front center of the air bag that measured 17 cm (6.7 in) in diameter. There were two vent ports, one on either side near the top cover flap. There was a reddish/brown stain located near the bag's front center that appeared to be the result of occupant contact. The stained area measured 3 cm x 5 cm (1.2 x 2.0 in).

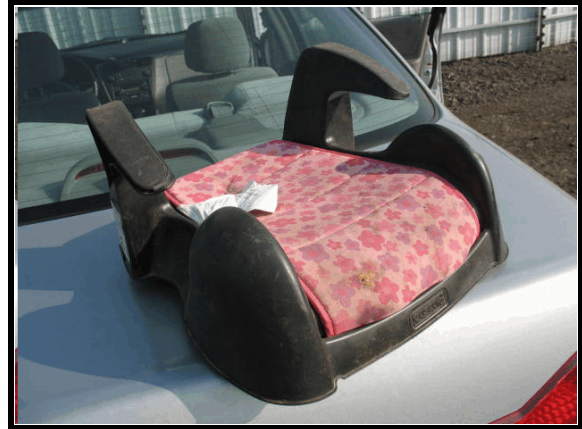
Figure 19. Cosco/Dorel Ambassador CSS

The plastic seat shell was lightly scuffed and scratched in several areas. There were dried stains on the seat cover. No structural damage to the seat was observed.

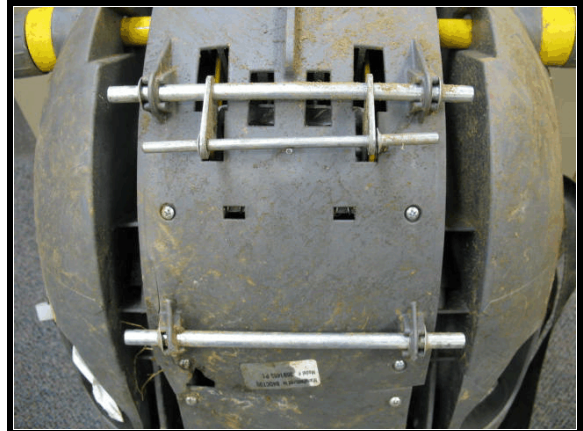
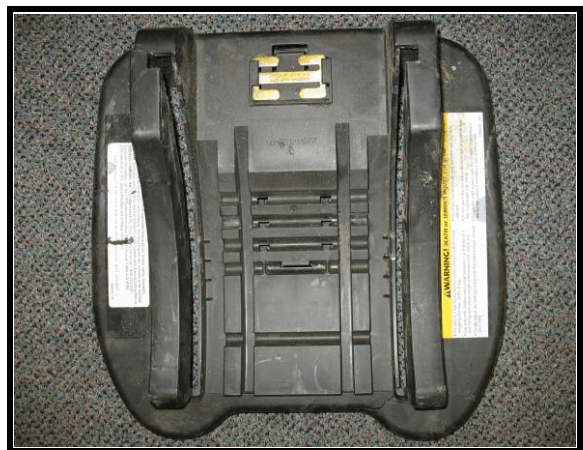
This child seat separated from its base at some point, though this model was not configured with a detachable base. The seat was configured with a recline adjustment feature. The base fit into two channels located in the bottom of the seat frame (**Figures 22- 23**). There were cracks present on the seat bottom.

It is probable that the lap belt was buckled at the time of the crash. There were no indications that the belt was routed through the forward facing slots in the back of the child seat. It appeared that the lap belt was either not used at all or was routed around the child seat base. If it were routed around the base, the belt may have contributed to the separation of the seat from the base.

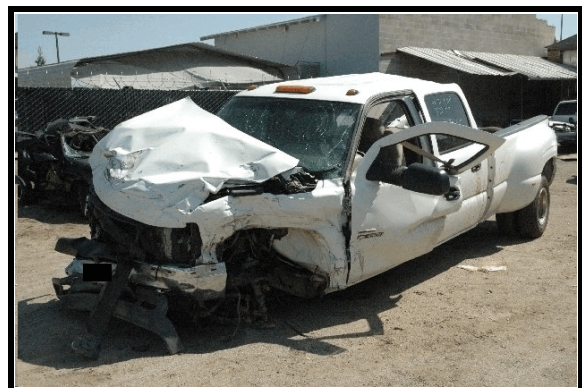
Figure 24. 2002 Chevrolet Silverado, front/left oblique view

The 2002 Chevrolet Silverado sustained moderate front end damage as a result of the impact with the Ford Explorer (**Figure 24**).

The direct damage was distributed across the front end from bumper corner to bumper corner.

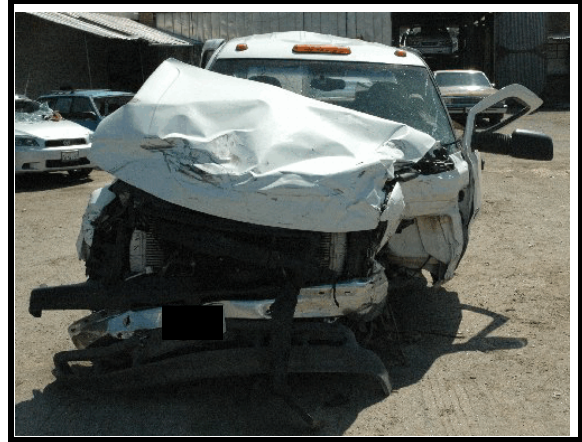
Figure 25. 2002 Chevrolet Silverado, front view

The steel bumper and fascia were partially detached from the vehicle. The front left wheel was detached from the axle and the front tires were flattened. The left engine mount and rear transmission mount were separated from the frame, and the engine and transmission were displaced rearward. The rear drive shaft U-joint cups were broken and partially missing. Based on police images, the estimated CDC for the end impact was 71FDEW3. The CDC for this impact was incremented for the frame shift to the right (**Figure 25**).

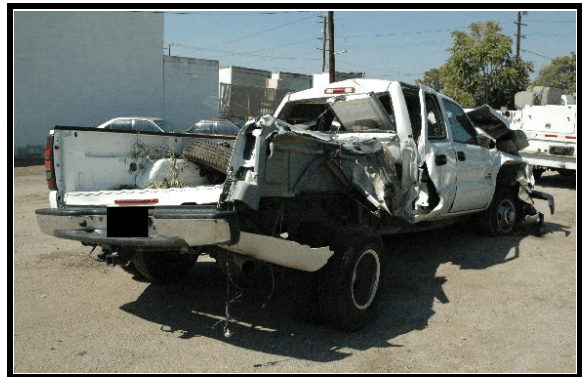
Figure 26. 2002 Chevrolet Silverado, back/right oblique view

The Chevrolet contacted a tree in a second impact. The tree impact was to the right side rear passenger compartment and cargo bed (**Figure 26**). The estimated CDC for the tree impact was 02RZEW3.
