## REMOTE CHILD AIR BAG FATALITY INVESTIGATION

CASE NUMBER - IN08004  
LOCATION - Texas  
VEHICLE - 2001 KIA SPECTRA GS  
CRASH DATE - January 2008

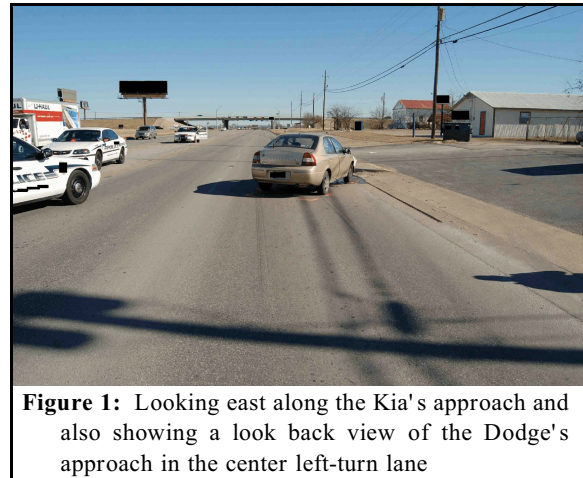
**Figure 1:** Looking east along the Kia's approach and also showing a look back view of the Dodge's approach in the center left-turn lane

The driver observed the Dodge turning across the Kia's path of travel and braked hard, depositing lock-up braking skid marks (**Figures 1 and 2**). The driver moved forward in response to the braking deceleration and the safety belt retractor probably locked. The Kia's front impacted the Dodge's right side, causing the Kia's driver and front right passenger air bags to deploy. The driver probably contacted the deployed front right air bag with her face and chest. Following the initial impact, the Kia was deflected and rotated approximately 20 degrees clockwise. The driver probably moved to the left in response to this rotational motion. The Kia came to rest a short distance from the point of impact. The driver's position at final rest is not known.

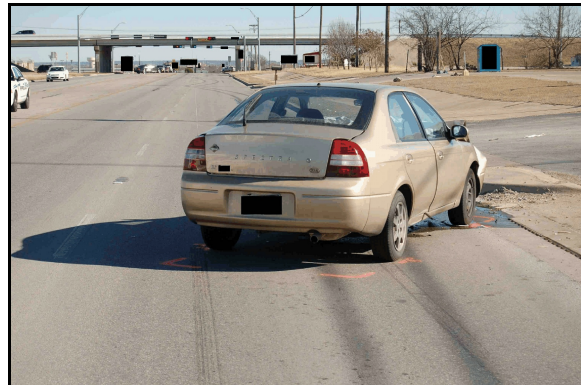
**Post-Crash:** The Kia rotated approximately 20 degrees clockwise and came to rest close to the point of impact (**Figure 2**). The Dodge's driver continued forward into a commercial parking area and brought the Dodge to a controlled stop.

**Figure 2:** Kia at final rest; note, lock-up braking skid marks (see also Fig. 1) and clockwise deflection

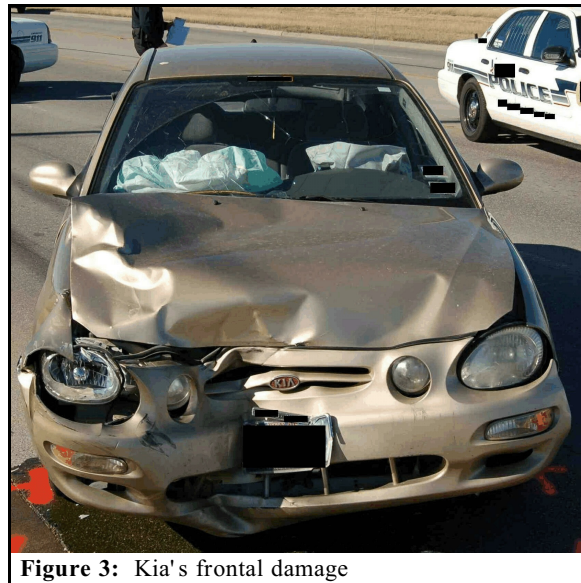
**Exterior Damage:** The Kia sustained direct contact damage on its front, beginning slightly to the right of center and extending to the right corner, with induced damage encompassing the entire front end (**Figures 3 and 4**). The flexible plastic bumper cover/cowl is distorted and displaced such that the steel bumper and other stiff frontal structures are not visible in the available photographs. The right half of the Kia's front bumper area engaged the Dodge's right rear wheel and tire, crushing the frontal structures rearward against the radiator, causing leakage of the coolant and leaving black rubber scuffs on the bumper cover near the right headlamp. The right half of the engine hood and the leading edge of the right fender engaged the Dodge's body panel forward of the right rear wheel well, causing the hood to be bent downward along its front edge and folded upward at the middle. The right headlamp lens was shattered and the right fender was distorted and displaced rearward. None of the wheels/tires were deflated or restricted. The windshield had stress cracks and there was no other glazing damage. There is an area of abrading and light denting on the rocker panel beneath the right rear door, but this appears to be prior damage. The front right wheel cover is missing and is not visible in any of the photographs.

**Damage Classification:** Based on the available photographs, the Kia's Collision Deformation Classification (CDC) code was estimated to be: **11-FZEW-01** (340 degrees). The WinSMASH

**Figure 3:** Kia's frontal damage

reconstruction program, missing vehicle algorithm based on the photo-estimated crush profile for the Dodge, was used. The total, longitudinal and lateral delta-Vs are, respectively: 15 km/h (9.3 mph), -14 km/h (-8.7 mph) and 5 km/h (3.1 mph). This is a borderline reconstruction because the crush profile was estimated from the police on-scene photos, but the results appear reasonable.

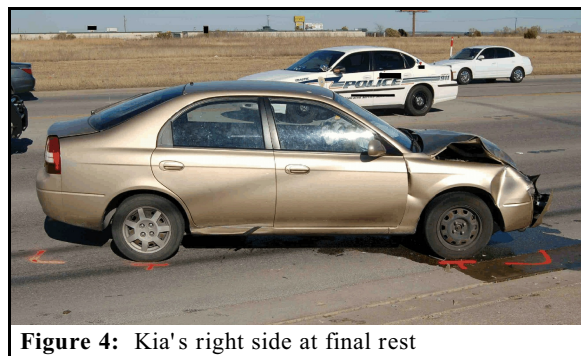
**Figure 4:** Kia's right side at final rest

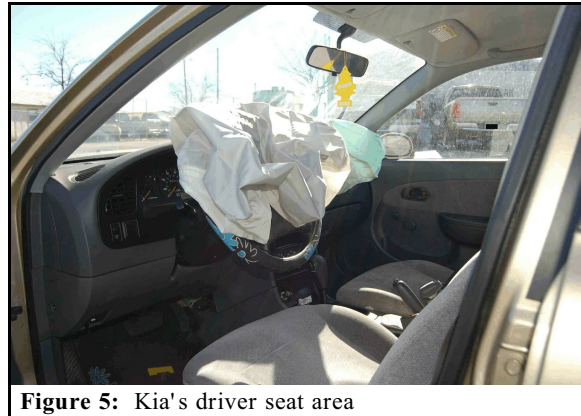
**Vehicle Interior:** The available photographs provide limited views of the driver's and front right passenger's seating area (**Figures 5 and 6**). The two front bucket seats were both adjusted with the seat track at or close to full forward and both seat backs slightly reclined. There is no visible evidence of intrusion or occupant contact in these limited views.

Figure 5: Kia's driver seat area

**Automatic Restraints:** The Kia was equipped with redesigned air bags for the driver and front right passenger seat positions and both air bags deployed (**Figures 5 and 6**). The driver's air bag was mounted in the steering wheel hub and the front right passenger's air bag was mounted in the top of the instrument panel. The available photographs do not show any obvious signs of occupant contact or damage to the air bags.

The Kia's driver (33-year-old female, height and weight unknown) was restrained by her manual lap-and-shoulder safety belt system and the steering wheel air bag deployed. The available photographs (**Figure 5**) show that her seat back was slightly reclined and her seat track was adjusted at or near the full forward position. Her posture is not known but she was probably in a normal, forward facing driving posture, with at least one hand on the steering wheel and her feet operating the foot controls.

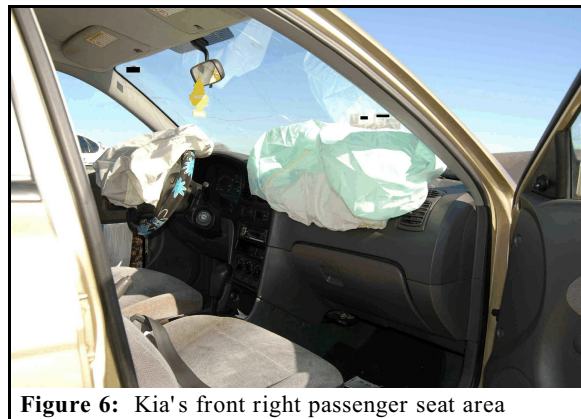
Figure 6: Kia's front right passenger seat area

The Kia's front right passenger (6-year-old female, 23 kilograms [51 pounds], height unknown) was restrained by the manual lap-and-shoulder safety belt system and the front right passenger air bag deployed. The available photographs (**Figure 6**) show that her seat back was slightly reclined and the seat track was adjusted at or near the full forward position. Her pre-crash seated posture and safety belt position are otherwise not known.

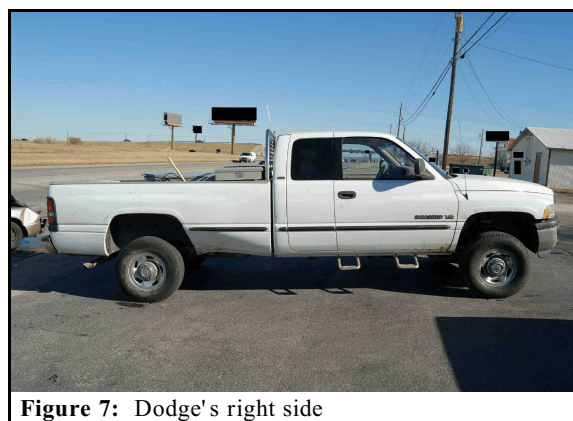
**Figure 7:** Dodge's right side

**Exterior Damage:** The Dodge sustained direct contact on the right rear wheel and tire and on the body panel immediately forward of the right rear wheel well (**Figures 7 and 8**). Scuff marks can be seen on the tire, but there is no visible damage to the wheel or suspension. The Dodge also sustained minor direct contact denting and scraping on the body panel immediately forward of the right rear wheel well.

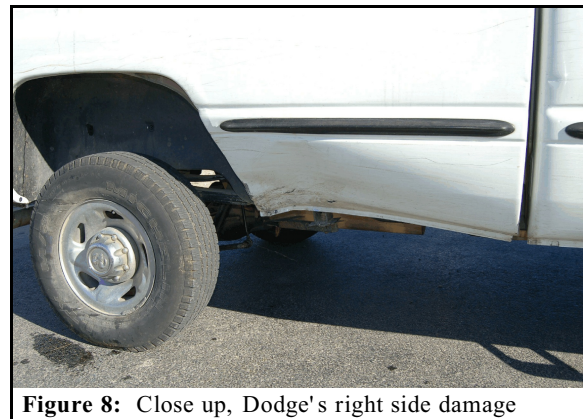
**Damage Classification:** Based on the available photographs, the Dodge's CDC was estimated to be **02-RBLW-2 (60 degrees)**. The WinSMASH reconstruction program, missing vehicle algorithm based on the photo-estimated crush profile for the Dodge, was used. The total, longitudinal and lateral delta-Vs are, respectively: 7.0 km/h (4.3 mph), -3.5 km/h (-2.2 mph) and -6.1 km/h (-3.8 mph). This is a borderline reconstruction because the crush profile was estimated from police on-scene photographs, but the results appear reasonable.

**Figure 8:** Close up, Dodge's right side damage
