On Site Child Safety Seat / Vehicle To Object Investigation
Dynamic Science, Inc. (DSI), Case Number DS08004
1998 Mitsubishi Montero Sport
California
January 2008

1. Report No. DS08004		2. Government Accession No.		3. Recipient Catalog No.	
4. Title and Subtitle Child Safety Seat Investigation			5. Report Date December 11, 2008

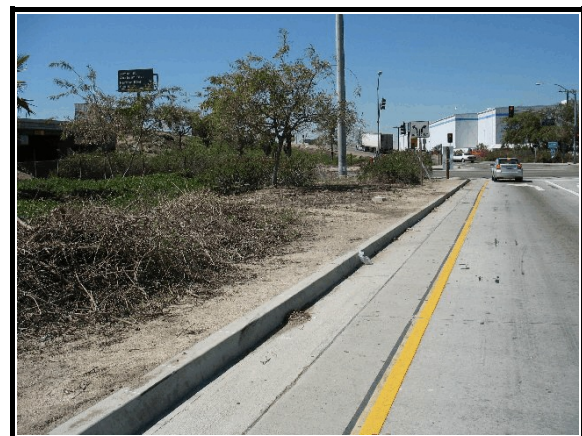
Figure 3. Scene, left roadside departure

The 1998 Mitsubishi Montero was traveling northwest on the exit ramp. On the straight, concrete section of the exit ramp, the driver of the Mitsubishi lost control of the vehicle. Tire marks observed at the scene indicated the Mitsubishi initiated a left side roadway departure 42.2 m (138.6 ft) east of the intersection (**Figure 3**). At 40.5 m (132.8 ft) east of the intersection, the Mitsubishi traveled over the curb and onto the unpaved ground on the southeast corner of the intersection. The Mitsubishi traveled off the roadway for a distance of 27.1 m (88.9 ft) and contacted a chain link fence which stood approximately 1.5 m (5.0 ft) high (**Figure 4**) The front left bumper of the Mitsubishi sustained minor contact damage as a result of the impact. The Mitsubishi then traveled another 8.5 m (28.0 ft) where the right side of the Mitsubishi contacted a steel utility pole (**Figure 5**). The Mitsubishi began a clockwise rotation and traveled a short distance

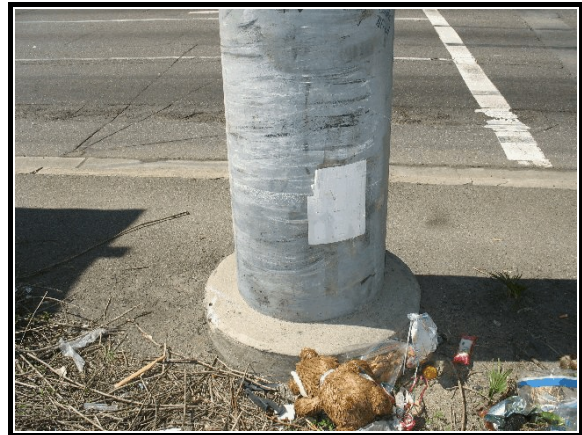
Figure 5. Point of impact with steel utility pole

Inspection of the steel pole revealed contact evidence which included paint transfers, tire marks, scrapes and gouges. Inspection of the concrete base revealed contact evidence which included gouge marks and chipped areas of concrete.

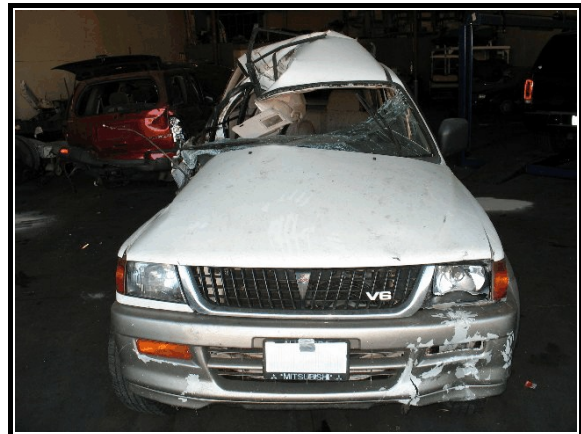
There were three events during the crash sequence. The first event was a front end impact with a chain link fence (**Figure 6**). The fence impact was a low Delta V event; the fence posts were bent and the fence yielded as the vehicle continued to travel forward. The direct damage began at the left front bumper corner and extended 160 cm (63.0 in) to the right front bumper corner. Much of the direct damage was limited to surface scratches and chipped paint. There was denting to the front left bumper, the left front headlamp was broken, and there was minor denting to the left front of the hood. The field L for the frontal impact began at the left front bumper corner and extended 49 cm (19.3 in) to the right. There was no crush to the front bumper. The Collision Deformation Classification (CDC) for the first impact was 12FDEW1.

Figure 6. Frontal view showing damage from fence impact

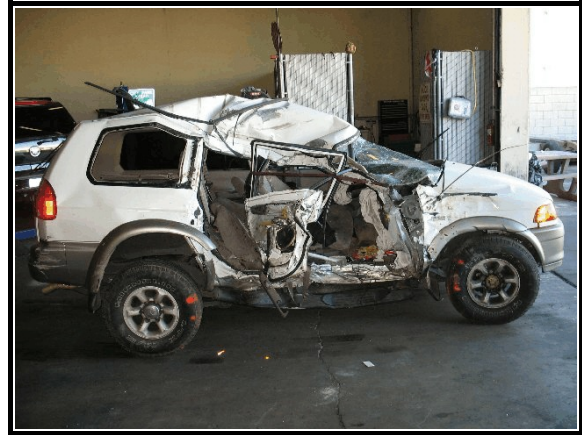
The second event was a right side impact with a steel utility pole (**Figure 7**). The pole measured 62 cm (24.4 in) in diameter and 194 cm (77.2 in) in circumference. At the base of the pole, there was a concrete skirt that measured 15 cm (5.9 in) in height and 94 cm (37.0 in) in diameter.

The pole impact resulted in moderate crush to the right side of the vehicle. There was direct damage to the A, B and C pillars, the right side doors, the sill, and the roof rail. The roof was buckled. The direct damage to the right side began at the right rear bumper corner and extended 405 cm (159.4 in) to the right front bumper corner. The Field L began 20 cm (7.9 in) rearward of the rear axle, extended forward 293 cm (115.4 in) and ended 8 cm (3.2 in) forward of the front axle. The CDC for the second impact was 01RDAW3. Stands were set using the vehicle half-width method. Six crush measurements were taken at mid-door level as follows: C1 = 0 cm, C2 = 9 cm (3.5 in), C3 = 31 cm (12.2 in), C4 = 18 cm (7.1 in), C5 = 9 cm (3.5 in), C6 = 0 cm. Maximum crush at mid-door level was located between C2 and C3, 74 cm (29.1 in) forward of the rear axle, and measured 38 cm (15 in).

Figure 7. Right side view showing damage from utility pole impact

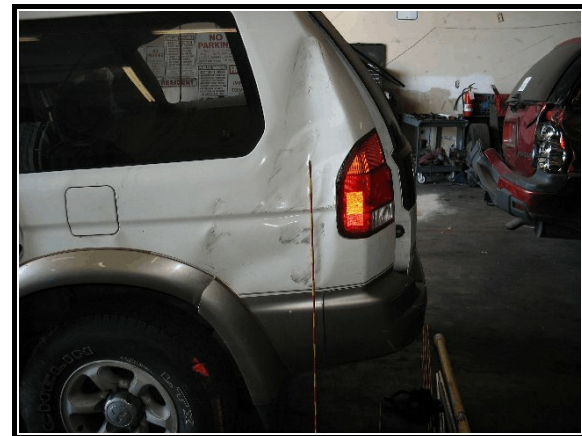
The third event was a left side impact with a wooden sign post (**Figure 8**). The direct damage began 20 cm (7.9 in) forward of the left rear bumper corner and extended 45 cm (17.7 in) forward. The vertical measurement of the damage began at bumper level and extended 90 cm (35.4 in) up the D pillar. The CDC for the second impact was 10LBAW2.

Figure 8. Left side view showing damage from sign post impact

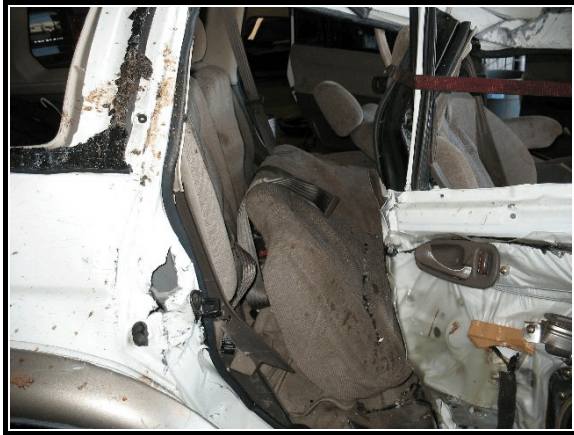
The 1998 Mitsubishi Montero sustained moderate interior damage as a result of passenger compartment intrusion. The windshield was out of place and holed. All the right side glazing was disintegrated. There was hinge damage to the right side doors and the front row right door panel was displaced from the vehicle. There was lateral intrusion to the middle seat positions of the front and second rows. The front row seats intruded longitudinally into the second row, and deformed and displaced the seat cushion (**Figures 9-10**).

Figure 9. Second row intrusion, seat deformation

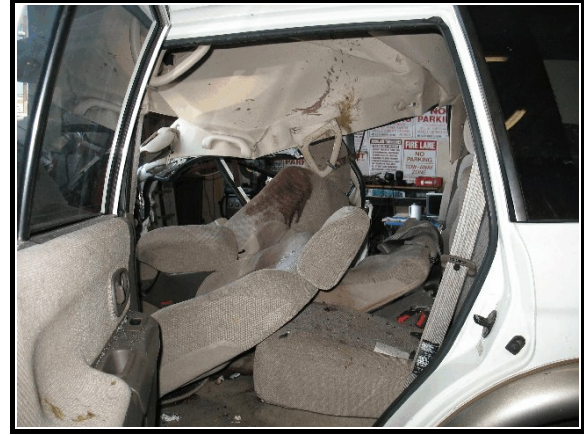
Figure 10. First and second row intrusions

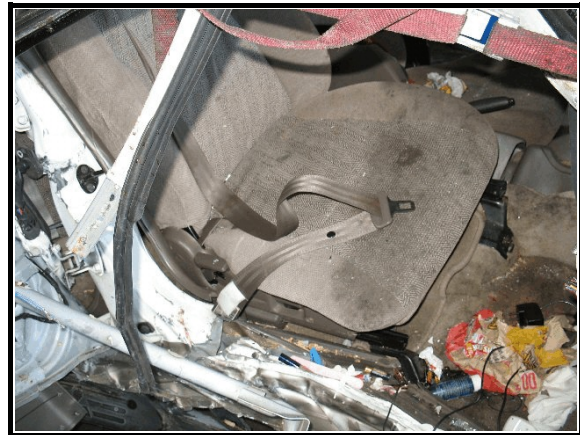
Figure 11. Front row right safety belt

The front row right passenger safety belt was configured with a switchable ELR/automatic locking retractor (ALR). The D-ring was adjusted to the full up position. The right B-pillar had been cut above the D-ring by rescue personnel. The safety belt webbing was unspooled from the retractor (**Figure 11**). The belt webbing was slack and the retractor was in an unknown mode. The lower B-pillar was deformed as a result of the pole impact and it was probable that the retractor mechanism was compromised. The belt webbing and latch plate were examined and no evidence of occupant loading of the belt restraint was found. The latch plate exhibited scratches that indicated historical usage.

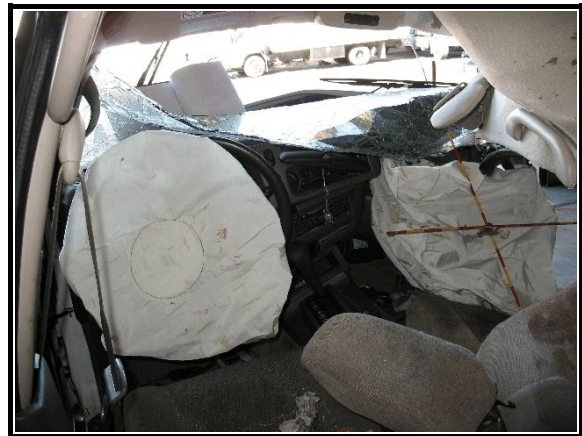
Figure 12. First row frontal air bags

The 1998 Mitsubishi Montero was equipped with front row air bags for the left and right occupants. The air bags deployed as a result of the impact with the utility pole (**Figure 12**).

The driver's air bag deployed from the center of the steering wheel hub through a single module cover flap. The flap measured 12 cm (4.7 in) in height and 17 cm (6.7 in) in width. The deployed driver's air bag measured 50 cm (19.7 in) in diameter in its deflated state. There were two vent ports, one on either side near the top cover flap. There were a few small deposits of suspected dried blood on the front of the bag.

The front right passenger's air bag deployed from a top-mount module with a rectangular cover flap that was hinged at the forward aspect. The flap measured 15 cm (5.9 in) in height and 32 cm (12.6 in) in width. The air bag measured 46 cm (18.1 in) across the seams. There were deposits of suspected dried blood on the front of the bag.

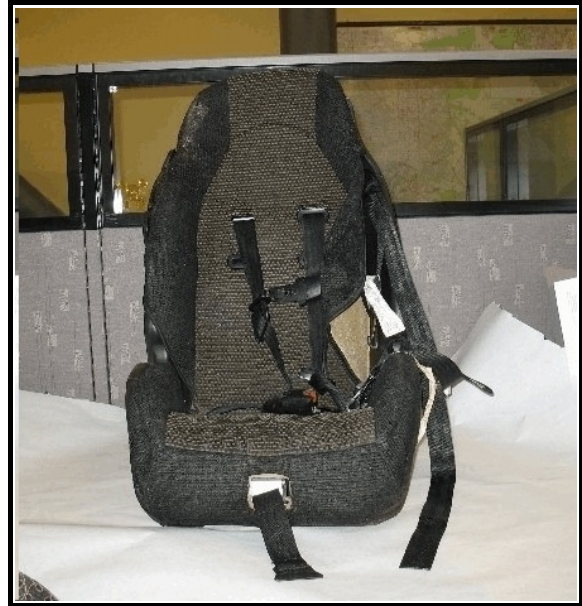
Figure 13. Cosco/Dorel High Back Booster Seat

harness shoulder straps; the straps were routed through the upper slots (**Figure 13**). The plastic grommet for the upper right slot was displaced from the slot and had slid down to the retainer clip. The grommet from the lower center slot on the seat cushion was also displaced from the slot.

The CSS shell exhibited a large area of scuffing on the headrest. There was crazing along the top edge of the shell and on the right side. The damage was a result of intrusion during the pole impact. The child was decapitated during the impact and there was a considerable amount of dried body tissue on the right side of the CSS cover, contiguous to the headrest. There were traces of dried body tissue and fluid on the harness straps and retainer clip.
