**CALSPAN ON-SITE CHILD SAFETY SEAT
CRASH INVESTIGATION**

CASE NO: CA08005

VEHICLE: 2002 SATURN VUE

CRASH DATE: JANUARY 2008

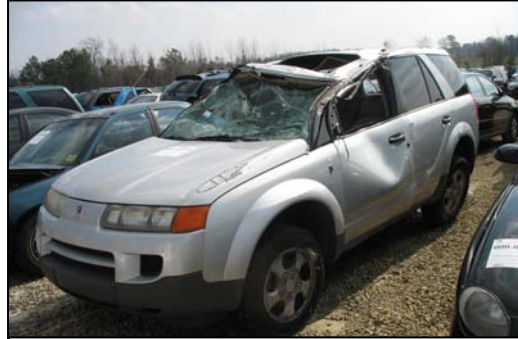
Figure 1 - Damaged 2002 Saturn Vue.

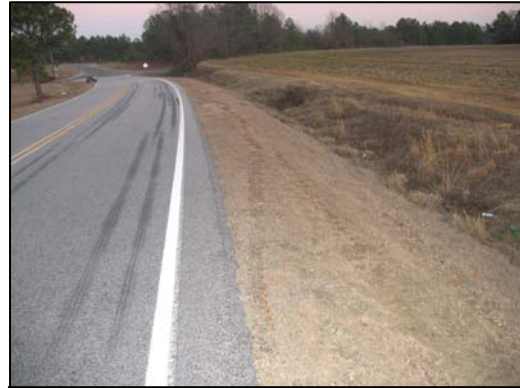
pick up an unspecified object. In doing so, she allowed the vehicle to drift off the right side of the roadway (**Figure 3**). The driver responded by steering the vehicle to the left in an attempt to regain directional control of the Saturn.

Figure 3 - Area of roadside departure.

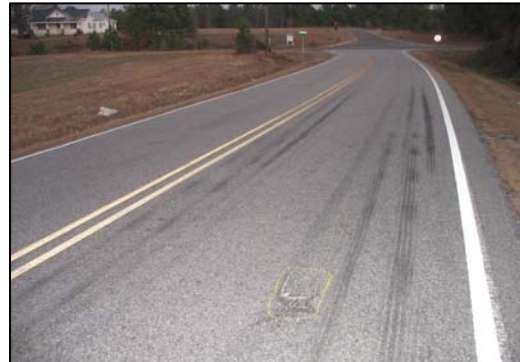
The vehicle began to rotate counterclockwise (CCW), reentered the roadway, and traveled in a northeast direction. The weight of the vehicle was transferred onto the right side tires. A yaw mark, attributed to the front right tire, was located in the eastbound travel lane, 4 m (13 ft) beyond the end of the roadside furrow (**Figure 4**). It was the probable trip point of the vehicle as evidenced by four gouges on the roadway further east.

Figure 4 - Location of trip-over.

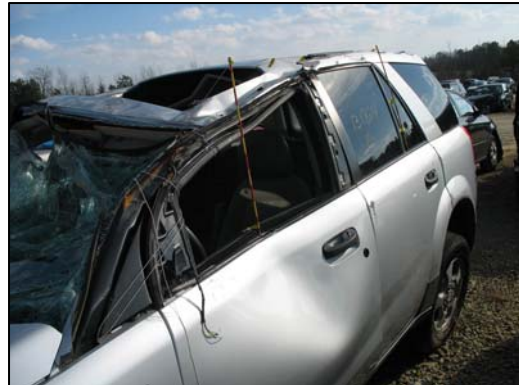
The top of the Saturn sustained moderate damage to its top plane consistent with a rollover crash type. The direct contact and induced damage to the roof began 112 cm (44”) aft of the front left axle and extended rearward 117 cm (46”). The maximum vertical and lateral crush was at the left A-pillar area and measured 20 cm (8”) and 18 cm (7”), respectively (**Figure 5**). The left A-pillar was crushed downward and the driver’s window shattered.

Figure 5 - Crush to A-pillar area of the Saturn.

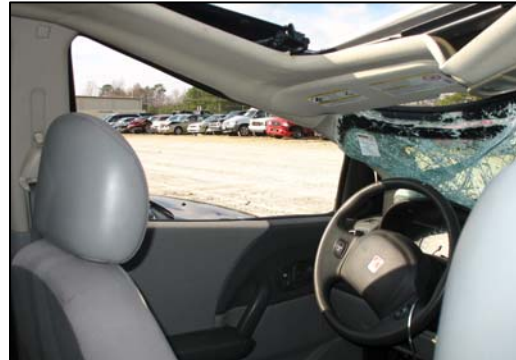
The 2002 Saturn Vue sustained moderate damage due to passenger compartment intrusion. The largest intrusion was to the front left roof side rail, which intruded vertically 20 cm (8”). There was no occupant contact evidence identified during the SCI inspection.

Figure 6 is a view of the intrusion into the driver’s area of the vehicle.

Figure 6 - Intrusion of the left A-pillar and roof side rail.

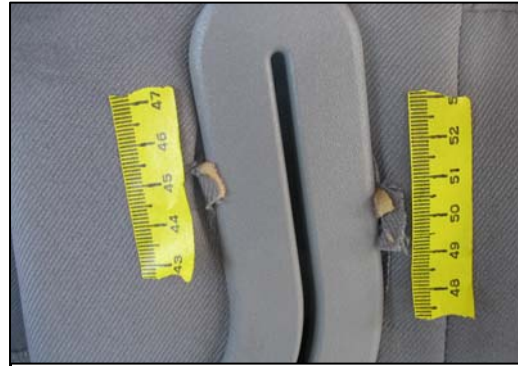
The booster seat was positioned in a forward facing orientation in the second row center seat. Inspection of the vehicle belt system revealed usage evidence in the form of rippling, creasing, and a subtle discoloration of the webbing, as well as historical usage evidence on the latch plate. The crease and discoloration were located 20 – 25 cm (8 – 10”) and 36 – 43 cm (14 – 17”) above the belt’s anchor point, respectively. At these locations, this area of the webbing would have engaged the child and BSS during the crash sequence. The historical usage on the rear center latch plate was more pronounced than on the remaining latch plates, which was indicative of regular usage of the belt system. The seatback contained a shoulder belt plastic belt-webbing guide that routed the webbing through the seatback. At impact, the belt webbing loaded the plastic guide and partially tore the component from the seatback and shifted it slightly to the left (**Figure 7**). After examining the restraint system and associated parts of the seatback, it was determined that the belt was engaged during the impact.

Figure 7 - Damaged guide path for second row center shoulder restraint.
