Not in Traffic Surveillance Back Over Investigation / Vehicle to Non-Motorist
Dynamic Science, Inc. / Case Number: DS08006
2004 Volvo XC90
California
October 2007

| 4. Title and Subtitle Not in Traffic Surveillance Back Over Investigation | | | 5. Report Date April 30, 2008 | |

Dynamic Science, Inc.
Crash Investigation
Case Number: DS08006
TABLE OF CONTENTS

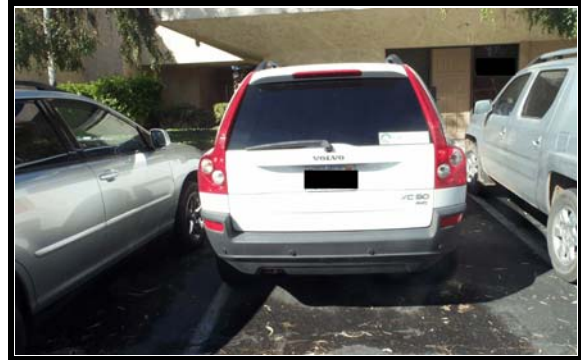
Figure 1. 2004 Volvo XC90 at area of impact (looking west)

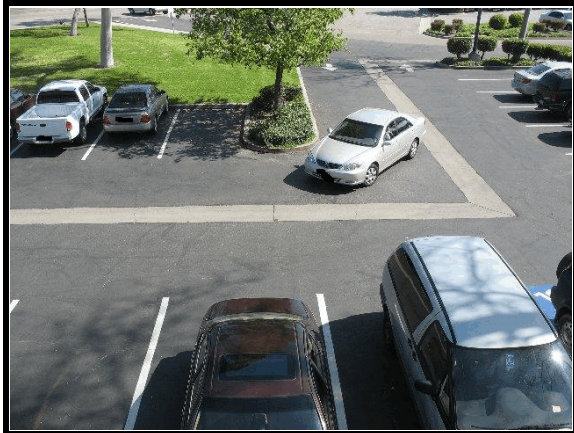
This incident took place in a parking lot adjacent to a number of commercial buildings (**Figure 2**).

Figure 2. Overview of incident site (looking east)

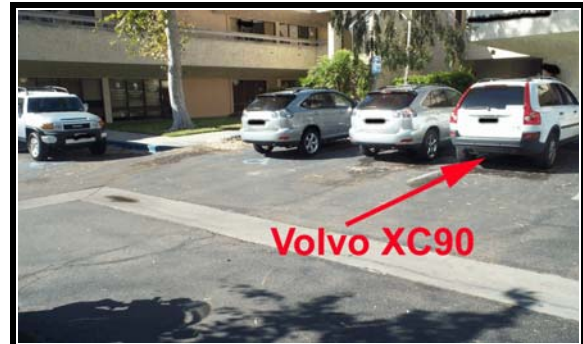
The parking lot is configured with parking stalls along the west side of the lot, the east side of the lot, and on the south side of the lot. All the stalls are marked by painted white lines. The lines are generally 5.5 m (18.0 ft) long and are marked 2.7 m (9.0 ft) apart. There is a -4% grade in the eastern direction for vehicles parked to the west. The grade decreases to -3.1% as one moves eastward. The parking lot is of asphalt construction with concrete gutter strips for drainage. There is no posted speed limit. The weather was clear and the parking lot was dry. The temperature at the nearest reporting station was 18 degrees C (64 degrees F). The Volvo was parked in the third stall from the left on the row of parking stalls to the west. It was parked between two other sport utility vehicles (**Figure 3**).

Figure 3. Volvo XC90 in parking stall (police photo)

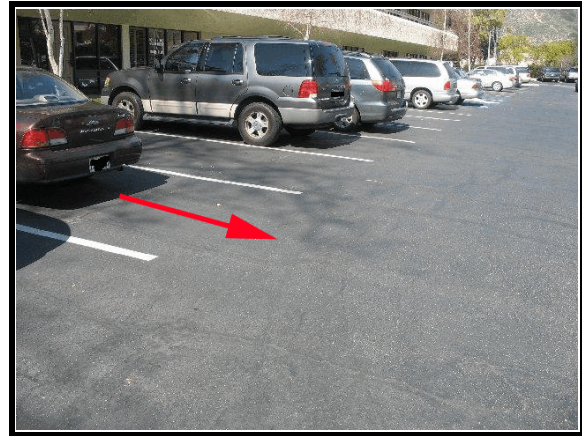
Figure 4. Area of impact (north). Arrow shows path of XC90.

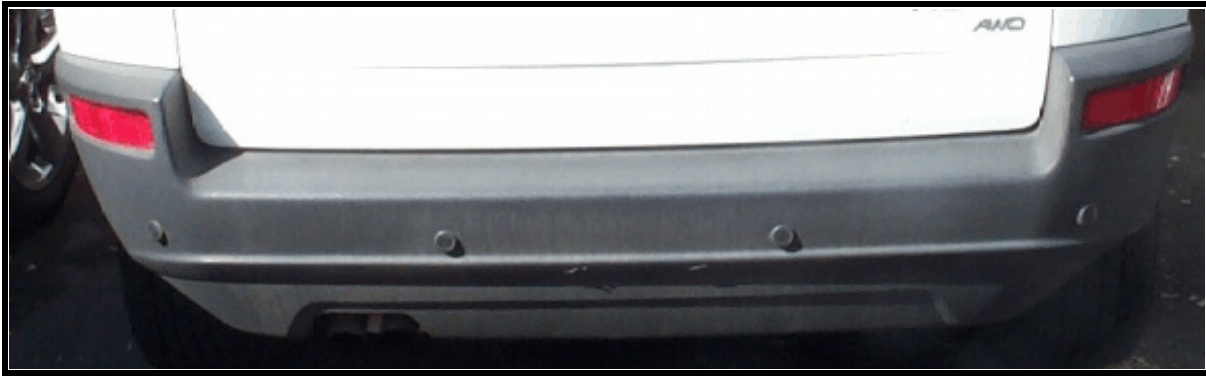
The Volvo was equipped with a rear parking assistance system that consisted of four ultrasound rear bumper mounted sensors linked to the in-vehicle sound system (**Figure 5**). The system is automatically activated when the reverse gear is selected. When the system is active, the audio system's volume is reduced and an intermittent signal is audible from the audio system's speakers. The signals begin at a distance of approximately 1.5 m (5.0 ft) from an object/person, etc. At a distance of approximately 30.0 cm (12.0 in), the signal will become constant. There are four sensors mounted horizontally along the rear bumper. The sensors are mounted 59.0 cm (23.2 in) above the ground. The driver had owned the vehicle for four years and was familiar with the parking assistance system. The system was active at the time of the incident. Based on the driver's statements, it appears that the system performed as designed. The driver was initially notified of the non-motorist with an intermittent signal. After stopping and looking in her rear view mirrors, she continued backing and the system responded with a constant signal as she got closer to the non-motorist.

Figure 5. Rear parking assistance system sensors (subject vehicle)

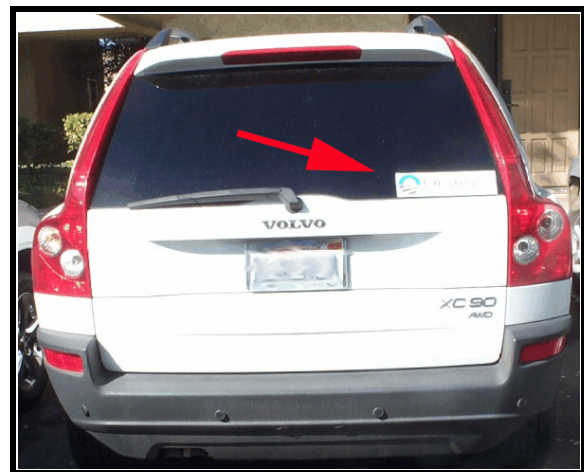
Figure 6. View of sticker on subject vehicle's backlight

For the involved subject vehicle, vision to the right was blocked somewhat by a small sticker affixed to the lower right backlight (Figure 6).

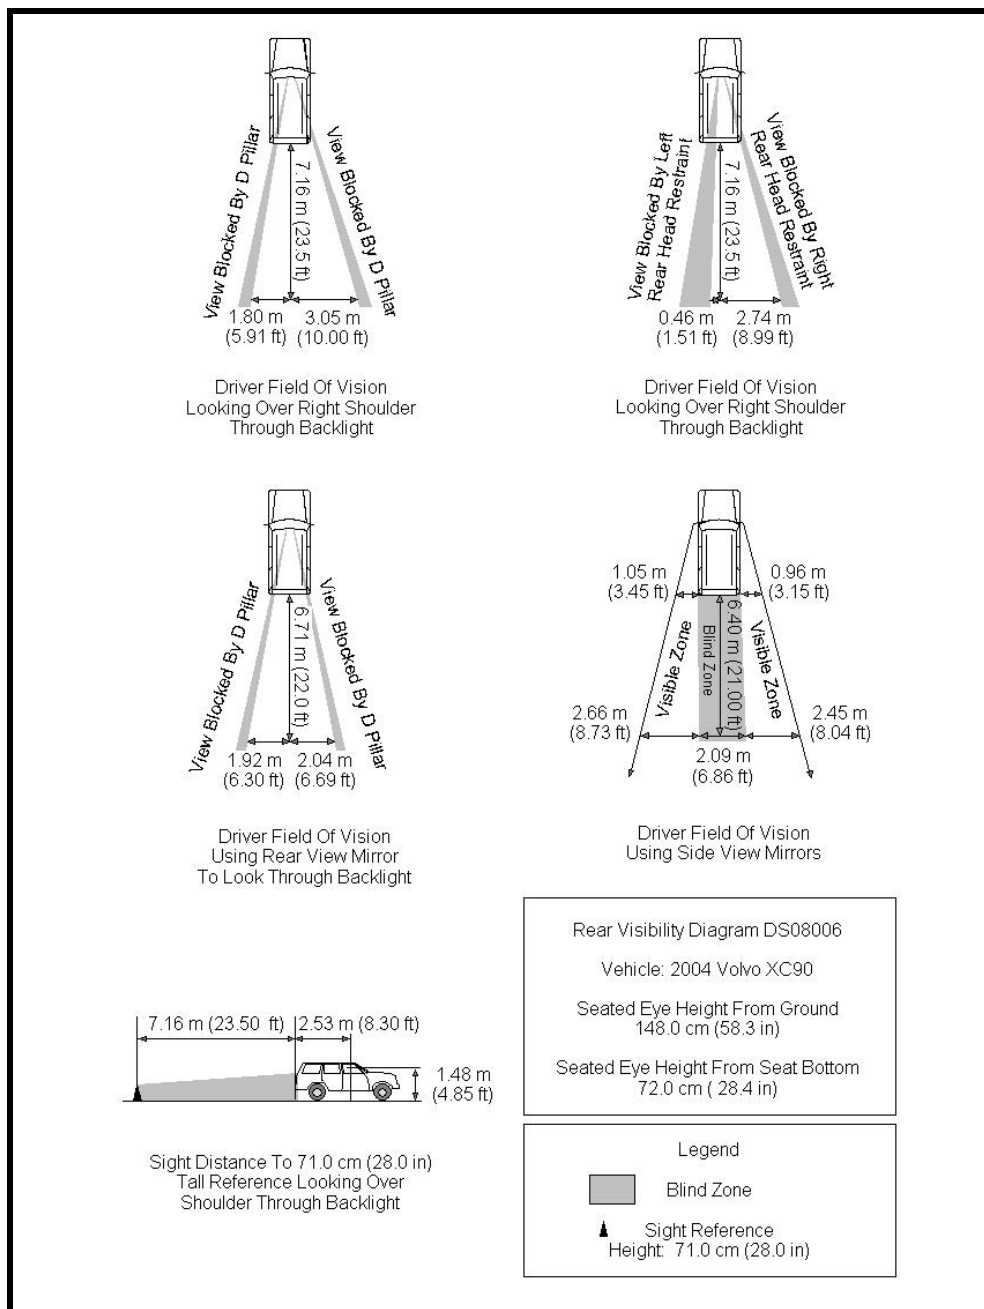
visibility zones resulted in a blind zone. Directly behind the rear bumper, the blind zone measured 1.85 m (6.07 ft) in width. The overall width of the vehicle was 1.90 m (6.23 ft). The target was then placed at 6.40 m (21.00 ft) rearward of the rear bumper. Lateral measurements were taken to the left and right at the points at which the investigator could view the target through the side view mirrors. The area between the two visible points resulted in a blind zone. At 6.40 m (21.00 ft) rearward of the rear bumper, the blind zone was approximately 2.09 m (6.86 ft) in width. The target was then moved further to the left and right until it could no longer be viewed through the rear view mirrors. The areas to the left and right in which the target could be viewed resulted in side view visibility zones.

Figure 7. Nominal visibility diagram (exemplar vehicle)

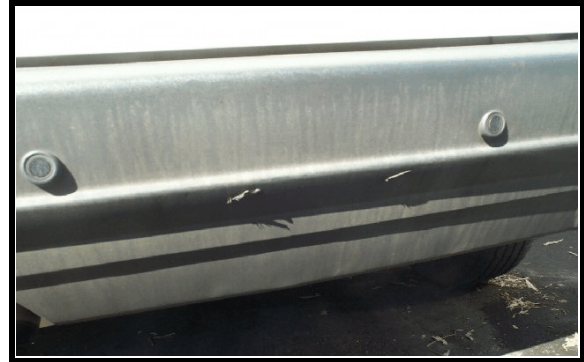
There was no exterior damage to the vehicle from this incident. There were several gouge marks to the rear bumper, but these do not appear to be related to this incident.

Figure 12. Gouges located on rear bumper
