**CALSPAN ON-SITE CERTIFIED ADVANCED 208-COMPLIANT VEHICLE
CRASH INVESTIGATION**

SCI CASE NO.: CA08008

VEHICLE: 2007 TOYOTA COROLLA

CRASH DATE: DECEMBER 2007

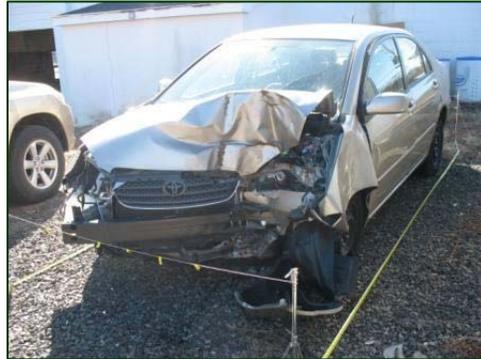
Figure 1. Frontal view of the damage to the 2007 Toyota Corolla.

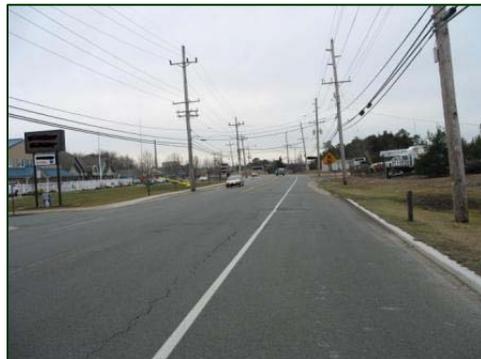
The crash occurred on a two-lane road during nighttime hours. The asphalt travel lanes were 3.8 m (12.5') in width and were separated by a painted yellow centerline that permitted passing in the eastbound direction. Paved shoulders were adjacent to the travel lanes and were 2.7 and 2.6 m (8.9 and 8.5') in width for the south and north shoulders respectively. Concrete barrier curbs bordered the shoulders. The posted speed limit

Figure 2. Overall view of the crash site.

was 72 km/h (45 mph). At the time of the crash, the pavement was dry. **Figure 2** is an overall view of the crash site.

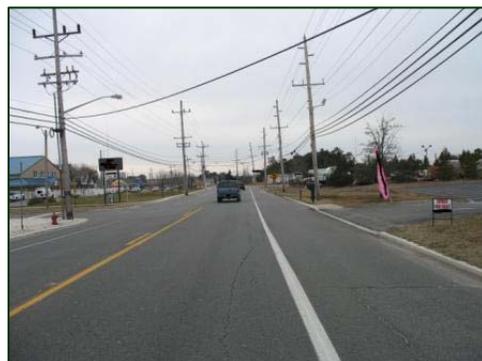
Figure 3. Pre-crash trajectory of the Toyota Corolla.

intersection, the driver relinquished control of the vehicle. It appeared that the driver fell asleep due to alcohol intoxication. The Toyota crossed the centerline of the road and the opposing travel lane in a tracking orientation. The vehicle traversed the east shoulder and the front overhang cleared the barrier curb. There was no supportive physical evidence to indicate avoidance actions by the driver. **Figure 3** is the pre-crash trajectory of the Toyota.

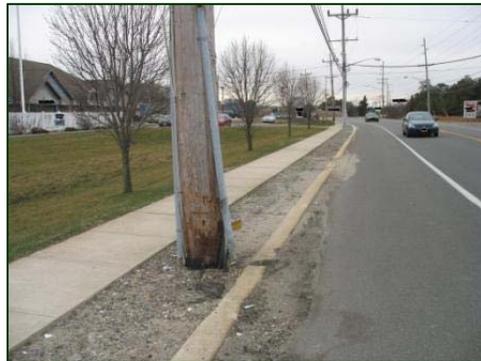
The front left area of the Toyota impacted the large diameter utility pole (**Figure 4**) that was located 0.6 m (2') outboard of the referenced curb line. The direction of force was 12 o'clock. The front left corner of the bumper crushed to a depth of 67 cm (26.5"). The Trajectory Algorithm of the WinSMASH program was utilized to compute an impact speed of 49 km/h (30.4 mph) with a total delta V of 49 km/h (30.4 mph). The longitudinal and lateral components were 49 km/h (30.4 mph) and 0 km/h respectively. It should be noted that the computed delta V appeared to be high based on SCI experience.

Figure 4. Struck utility pole.

The impact deployed the front left air bag and actuated the driver's retractor pretensioner. As the Toyota crushed to maximum engagement, the off-set left impact resulted in an estimated 20 degrees of counterclockwise rotation. The vehicle came to rest fully engaged against the struck pole. The large diameter pole did not fracture or yield to the crash forces.

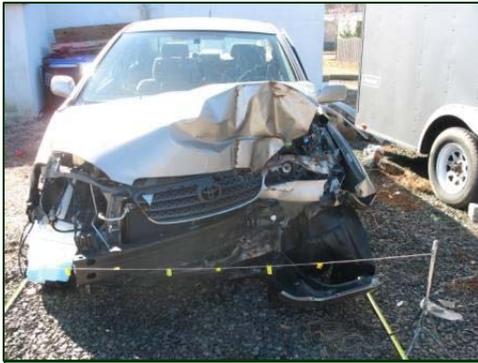
The 2007 Toyota Corolla sustained moderate damage to the front left area as a result of the impact with the utility pole. The direct contact damage began 25 cm (10") left of the vehicle's centerline and extended 46 cm (18") to the left bumper corner. The maximum crush was 67 cm (26.5") located at the left corner of the bumper beam. The vertically oriented crush profile involved the bumper and the upper radiator support. The crush depth was greater at the bumper level and was documented as follows: C1 = 67 cm (26.5"), C2 = 62 cm (24.5"), C3 = 46 cm (18"), C4 = 30 cm (12"), C5 = 14 cm (5.5"), C6 = 0 cm.

Figure 5. Frontal view of the damage to the Toyota Corolla.

The bumper fascia was removed during the tow process of the vehicle. The damage involved the fascia, bumper beam, hood, left headlight assembly, radiator, air conditioner condenser, upper radiator support, the inner structure and shock tower, the left front fender, and the left front suspension. The left front axle position was displaced rearward 16 cm (6.4") that resulted in a restriction of the tire. The Collision Deformation Classification (CDC) for the pole impact was 12-FLEW-3.

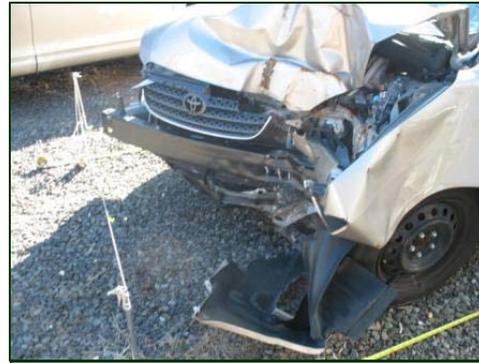
Figure 6. Lateral view of the depth of frontal crush.

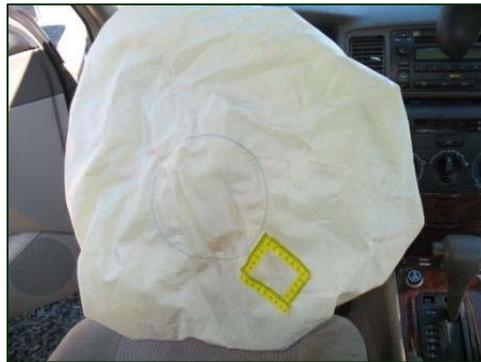
Figure 5. Deployed driver's air bag with make-up transfer.

The driver's face contacted the lower right quadrant of the air bag. A subtle make-up transfer was located 11-19 cm (4.5-7.5") right of center and 0-5 cm (0-2") below the horizontal centerline.

The driver’s face contacted the deployed driver’s air bag, evidenced by a subtle make-up transfer to the lower right quadrant of the air bag membrane. There was no damage or deflection of the steering wheel rim or column.

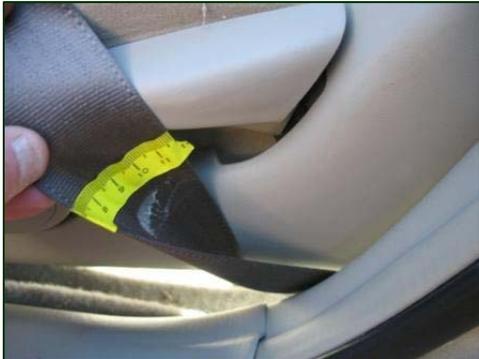
Figure 8. Lap belt transfer from recline lever.

The lap belt webbing engaged the recline lever for the driver’s seat back resulting in a pronounced frictional abrasion/plastic transfer to the inside surface of the webbing and an abrasion to the lever (**Figure 8**). The belt abrasion/transfer was located 27-28 cm (10.5-11”) above the lower anchor point. The latch plate was abraded full width; however, there were no matching transfers on the belt webbing.

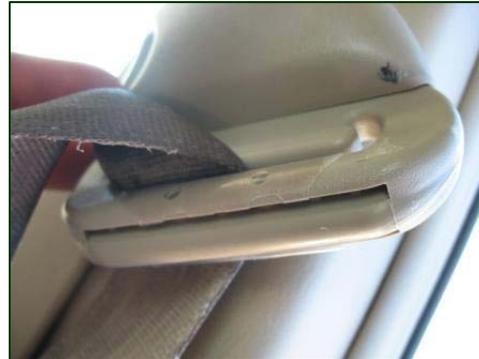
Figure 9. D-ring abrasion and belt evidence.

The D-ring was abraded and a 15 cm (6”) long frictional abrasion/transfer was present on the belt webbing (**Figure 9**) from driver loading, actuation of the retractor pretensioner, and spool-out due to the load limiter retractor. There was no damage to the hardware components of the belt system.

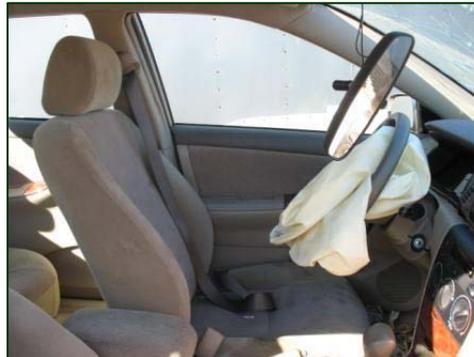
The 27-year old female driver of the Toyota Corolla was seated in a forward track position with the seat back reclined 20 degrees and the head restraint adjusted to the full-down position (**Figure 10**). The seat track was adjusted 8 cm (3”) aft of full-forward and 15 cm (6”) forward of the full rear position. She was restrained by the manual safety belt system. Belt usage was supported by the actuated status of the retractor pretensioner and the loading evidence on the system’s components.

Figure 10. Right lateral view of the driver’s seated position.

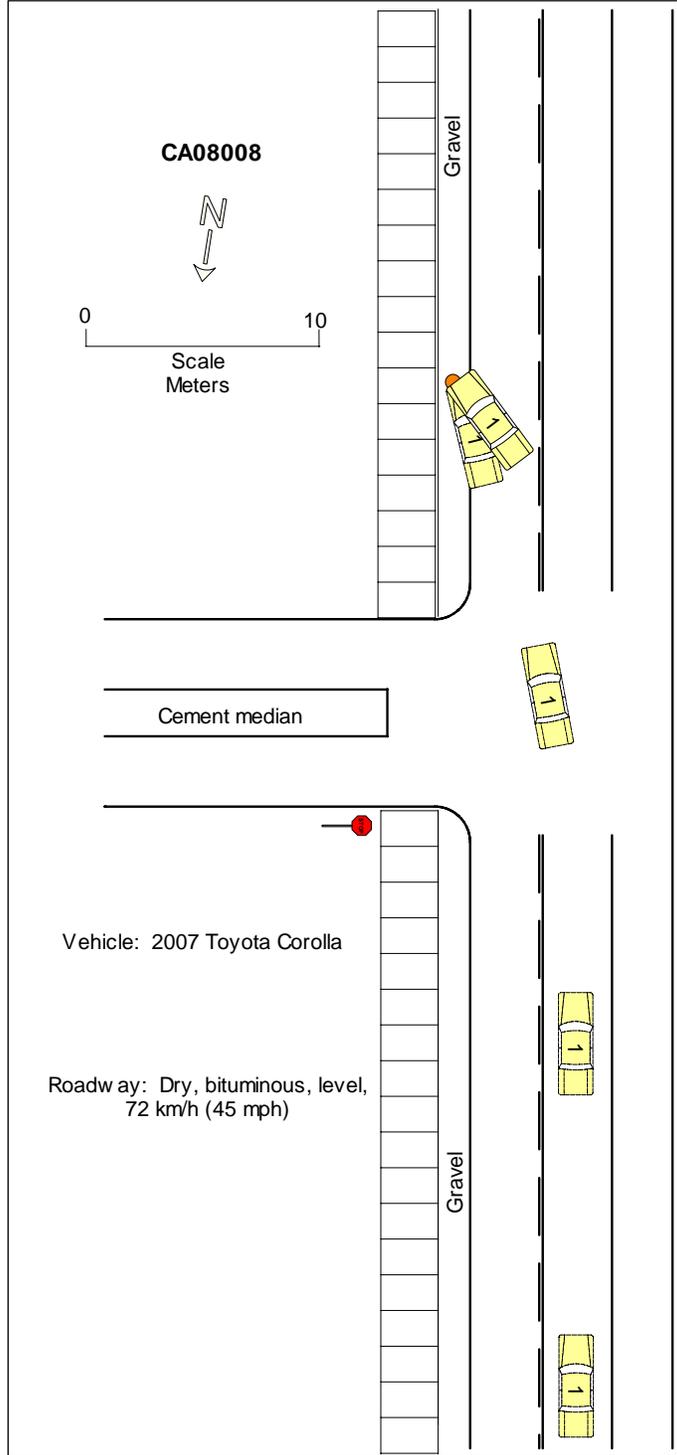
Figure 11 – Crash Schematic

The Toyota departed the south roadside and impacted a wooden utility pole. The pole was 50 cm (19.7”) in diameter and was located 0.6 m (2’) outboard of the south curbline. Two vertically positioned 5 cm (2”) diameter galvanized conduits were affixed to the pole to conceal ground wires and were 180 degrees opposed. The outboard conduit was struck by the vehicle. Damage to the pole consisted of superficial gouges. The Crash Schematic is attached as **Figure 11** of this report.
