**CALSPAN ON-SITE OFFICE OF DEFECTS CRASH INVESTIGATION**

**CASE NO: CA08009**

**VEHICLE: 1999 FORD EXPLORER XLT**

**CRASH DATE: FEBRUARY 2008**

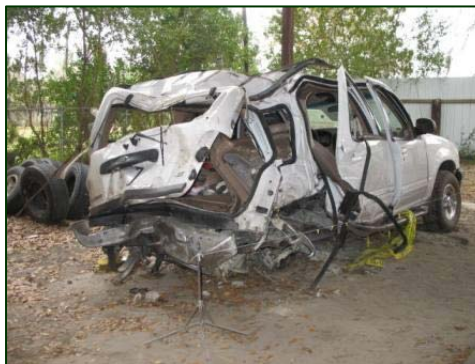
**Figure 1. Rear view of the damage to the 1999 Ford Explorer.**

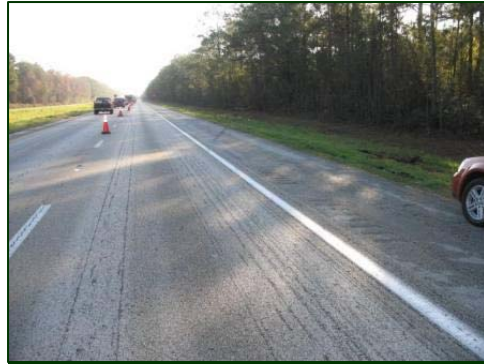
The crash occurred on the road side of the eastbound lanes of an interstate roadway during daylight conditions. The interstate consisted of two lanes in the east and westbound directions that were separated by a depressed grass median. The eastbound travel lanes were surfaced with asphalt and were 3.6 m (11.9') in width and bordered by a

**Figure 2. Overall view of the crash site.**

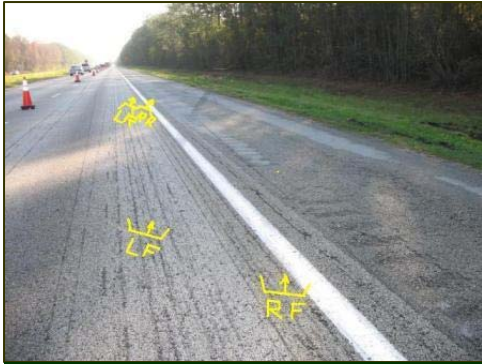
The driver had successfully negotiated a long gradual right curve that transitioned onto a straight and level section of roadway. While traveling eastbound, the left rear tire experienced a tread separation. The entire tread of the Firestone Wilderness AT radial tire separated from the steel belts of the tire, resulting in instability of the vehicle. The driver apparently applied a clockwise steering input as he attempted to maintain directional control of the Ford Explorer. The steering input induced a CW yaw as the Explorer crossed the lane line and entered the outboard travel lane. As it crossed the lane line, the CW rotation was estimated at approximately 30 degrees. It should be noted that the SCI inspection of the scene was conducted two weeks following the crash. Visible tire yaw marks were present from all four tires, beginning in the center of the outboard lane (**Figure 4**).

**Figure 4. Yaw marks on the outboard travel lane.**

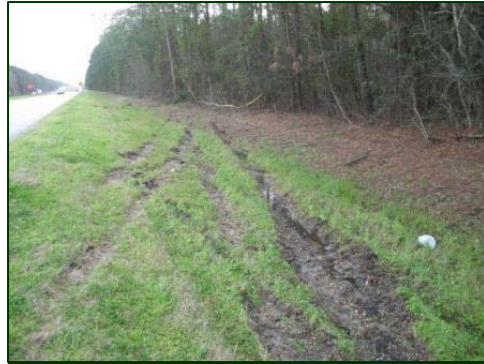
**Figure 5. CW rotational yaw marks across the grassy roadside.**

The Explorer continued to yaw CW across the outboard travel lane onto the south shoulder. As the Explorer departed the south shoulder, the front tire yaw marks crossed indicating 90 degrees of CW rotation. The rear tire marks crossed on the rumble strips, 0.6 m (2') outboard of the south fog line.

The Explorer entered the grassy roadside in a broadside orientation. The ground was soft from previous rain as the tires scuffed the grass and furrowed into the soft ground. The Explorer's center of gravity continued on a southeasterly trajectory as it traversed the shallow ditch at the midpoint of the grassy roadside. The CW yaw marks remained pronounced in the off-road surface (**Figure 5**). The right front tire mark crossed the left rear yaw mark 40 m (131') east of the front crossover point where the vehicle departed the south shoulder. At this point of the Explorer's trajectory, the vehicle had rotated approximately 150 degrees CW.

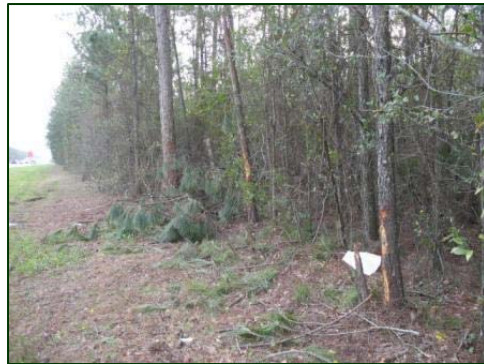
**Figure 6. Struck trees.**

The WinSMASH program computed a velocity change of 30 km/h (18.6 mph) with respective longitudinal and lateral components of 0 km/h (0 mph) and -30 km/h (-18.6 mph). This delta V estimate is conservative as it does not include the additional stiffness of the axle position of the vehicle. **Figure 6** is a view of the struck trees.

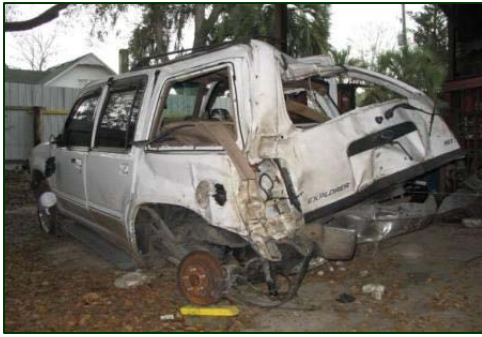
The initial impact (Event 1) involved the left corner area of the rear bumper, the left taillight assembly, the lift gate, and the surrounding sheet metal of the quarter panel. The corner-type impact scuffed the corner of the steel bumper, shattered the plastic taillamp lens, crushed the lift gate above and below the beltline, crushed the quarter panel, and probably shattered the left quarter window (**Figure 7**). The Collision Deformation Classification (CDC) for this event was 06-BLAE-3.

**Figure 7. Event #1 damage to the back left corner area.**

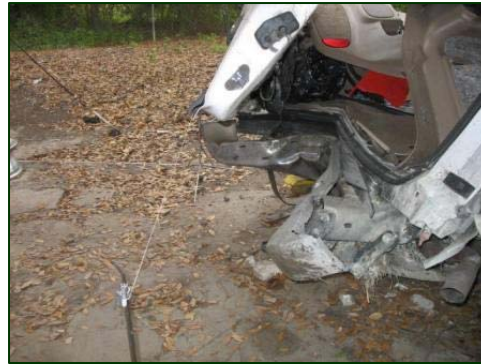
**Figure 8. Lateral view of the depth of crush to the back of Ford Explorer.**

The second event (Event 2) involved the rear impact into the 14 cm (5.5”) diameter pine tree. The direct contact damage began 5 cm (2”) left of the vehicle’s centerline and extended 15 cm (6”) to the left. The impact deformed the full width of the steel bumper and crushed the bumper, tailgate and the floor of the cargo area. The maximum crush was 64 cm (25”), located on the bumper 10 cm (4”) left of the centerline. The tailgate latch released and the backlight glass shattered. The combined induced and direct contact damage was 100 cm (39.5”) that extended from bumper corner to bumper corner. A crush profile was documented at the level of the bumper. A reference line was established at 396 cm (156”) rearward of the front axle that represented the original wheelbase and the rear overhang. Six equidistant crush measurements were documented along the damage profile. These values were as follows: C1 = 25 cm (10”), C2 = 64 cm (25”), C3 = 57 cm (22.6”), C4 = 50 cm (19.5”), C5 = 37 cm (14.6 “), C6 = 29 cm (11.6”). The CDC for this event was 06-BCAN-3. **Figure 8** is a lateral view of the crush depth.

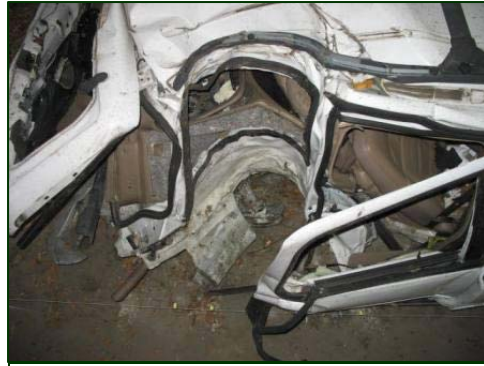
The most severe event of this crash was the right side impact into the 38 cm (15”) diameter tree. The direct contact damage began on the lower aspect of the right rear door at a point that was 261 cm (102.75”) aft of the right front axle position and extended 58 cm (23”) rearward to the corner of the quarter panel. The maximum crush was 65 cm

(25.5") that was located at the mid point of the quarter panel, 51 cm (20") aft of the right C-pillar (**Figure 9**). The combined induced and direct contact damage for this event began on the right sill, 227 cm (89.5") rearward of the right front axle and extended 92 cm (36.25") rearward to the right corner of the D-pillar. A crush profile was documented and was as follows: C1 = 28 cm (11"), C2 = 56 cm (22"), C3 = 65 cm (25.5"), C4 = 62 cm (24.5"), C5 = 36 cm (14"), C6 = 0 cm.

**Figure 9. Overhead view of the lateral impact damage to the right rear quarter panel.**

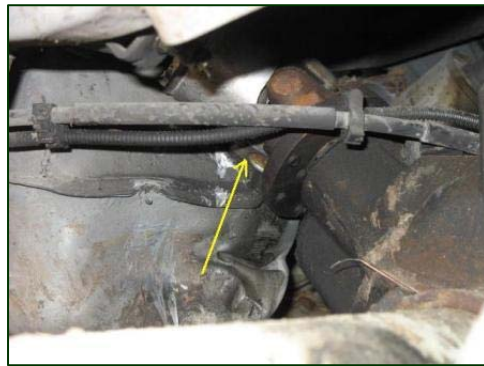
The right side impact was centered on the right rear axle position. The impact fractured the axle at the flange and resulted in complete separation of the tire and wheel assembly. The lateral forces exerted on the axle displaced the solid axle laterally left. Both lower shock mounts fractured at the axle. The left leaf spring fractured immediately aft of the forward eye and the axle displacement bent the rear aspect of the main leaf to approximately 75 degrees. The lateral displacement of the axle fractured the aluminum drive shaft approximately 8 cm (3") forward of the rear yoke. The yoke and differential contacted

**Figure 10. Differential yoke engagement into the fuel tank.**

the back inboard corner of the steel fuel tank that was mounted along the inboard aspect of the left frame rail (**Figure 10**). The contact dented and punctured the upper aspect of the fuel tank resulting in minimal fuel leakage at final rest.

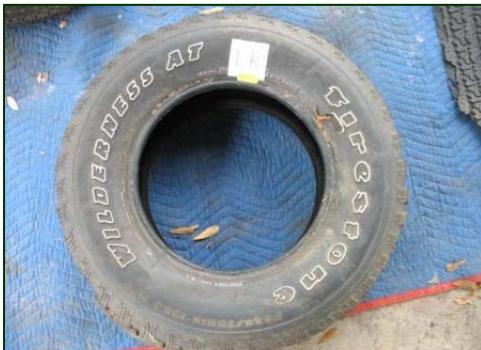
The left rear tire was a Firestone Wilderness AT radial tire that was outside (manufactured after recall scope) the recall population (**Figure 11**). The TIN was W2HL 1PY 189 with a manufacture date of the 18<sup>th</sup> week of 1999. The load index and speed rating for this P235/75R15 tire was 105S. The tread depth was 6 mm (8/32") across the full width of the tread. The full circumference of the tire tread separated from the tire. A single length of tread that measured 122 cm (48") in length was recovered by the police at the scene of the crash and was stored with the vehicle. Three smaller tread sections were recovered; however, these did not equal the full length of the tread. **Figure 12** is a view of the separated tire tread and the ply surface of the tire.

**Figure 11. Left rear tire of the Ford Explorer.**

The SCI inspection of the tire occurred two weeks following the crash. There were no punctures or repairs through the tread plies or sidewall surfaces of the tire. Despite the known age, the sidewall of the Firestone tire was in good condition with no visible checking or cracks. It's unknown if this tire was on the vehicle at the time of purchase by the driver or when the tire was placed in service. The history of this tire is unknown.

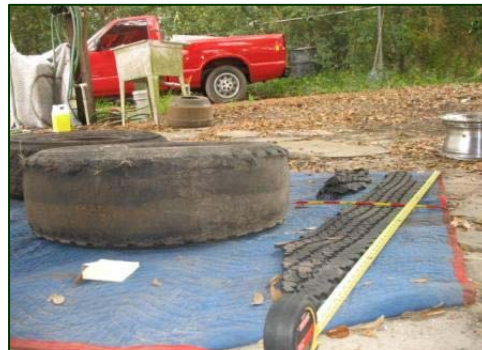
**Figure 12. Separated tire tread and the tire ply surface.**

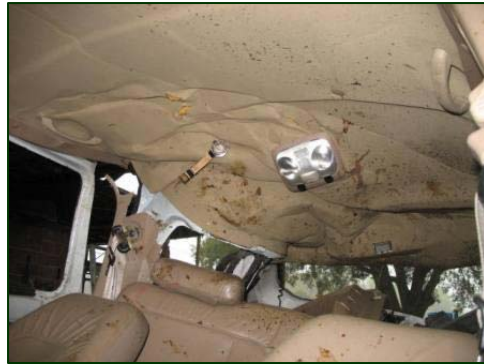
The rear seat area was reduced in size by intrusion of numerous components, inclusive of the rearward deflection of the front seat backs (**Figure 13**). The front seats appeared to be adjusted to rear track positions at the time of the SCI inspection. The driver loaded the seatback during the initial rear impact event and deflected the seat back rearward to a measured angle of 37 degrees aft of vertical. Although the seat back frame did not appear to be deformed, the deflection occurred at the recline hinge point. The front right seat back was deformed to a measured angle of 42 degrees aft of vertical.

**Figure 13. Intrusion and occupant contact points within the interior of the Explorer.**

Maximum intrusion involved 43 cm (17") of forward displacement of the rear right seat back and the right lower C-pillar. The right C-pillar intruded longitudinally and laterally into the rear right position. The intrusions are depicted in the following table:

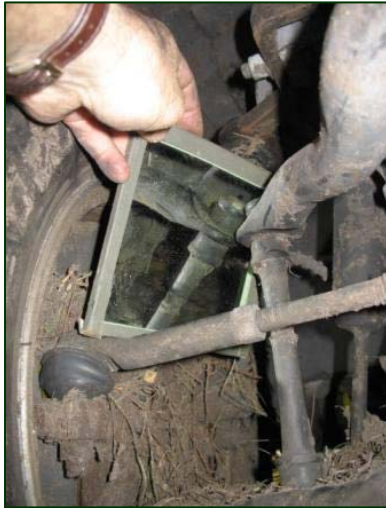
The right front stabilizer bar link was inspected following the removal of mud and grass debris from the undercarriage. The link was intact with all nylon standoff bushings, washers, spacer, and the bottom nut in place (**Figure 14**). The assembly, as with all of the undercarriage components, was free of rust and corrosion. With the vehicle resting on the front wheels and the front suspension minimally compressed by the weight of the Explorer, the right stabilizer bar link could be moved laterally with minimal force applied by hand. There was no vertical movement or gaps between the standoff bushings and stabilizer bar or lower control arm.

**Figure 14. Right front stabilizer link with standoff bushings intact.**

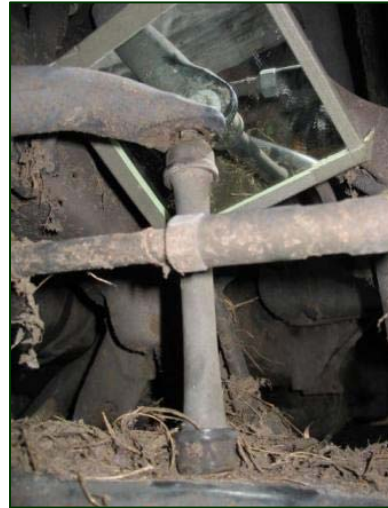
impede the inspection of the front undercarriage. A first observation of the left front stabilizer bar link revealed a gap between the upper standoff bushing and the bottom of the stabilizer bar. The upper end of the stabilizer bar link could be moved freely in a lateral direction with 9 mm (0.375") of vertical travel. An inspection mirror was positioned above the outboard end of the stabilizer bar and it was noted that the head of the bolt was intact, with the top washer; however, the top nylon standoff bushing was absent from the component (**Figure 15**). The remaining standoff bushings were in place. There was no rust or corrosion to the steel components and the bolt was intact.

**Figure 15. Left front stabilizer link with top bushing absent.**
