ON-SITE CERTIFIED ADVANCED 208-COMPLIANT VEHICLE INVESTIGATION

CASE NUMBER - IN08010

VEHICLE - 2007 CHEVROLET SILVERADO C1500 CREW CAB

CRASH DATE - February 2008

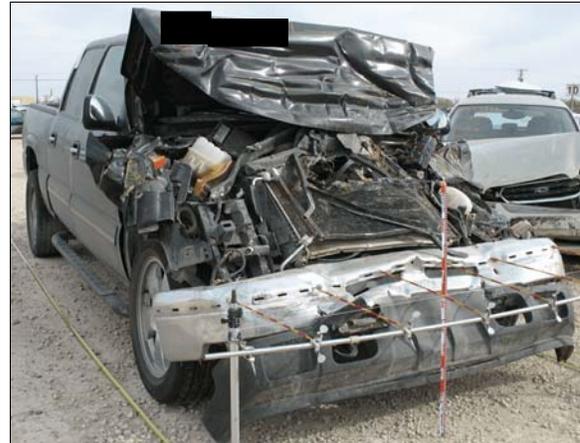
Figure 1: The damaged 2007 Chevrolet Silverado C1500 Crew Cab pickup truck

Crash: The front of the Chevrolet (**Figures 1 and 4**) impacted and underrode the Bluebird's right side, just behind its bi-fold door (event 1, **Figure 5**). The Chevrolet's direction of principal force was within the 11 o'clock sector and the impact force was sufficient to trigger a stage 2 deployment of the driver's frontal air bag. The Chevrolet's front right passenger air bag did not deploy because no front right passenger was present within the vehicle. The impact caused both vehicles to rotate clockwise and they were redirected to the north. The Chevrolet rotated clockwise approximately 20 degrees and came to final rest in the mouth of the northeast roadway heading north (**Figure 6**). The Bluebird rotated clockwise and rolled over one quarter turn onto its left side (event 2). It came to final rest on the northeast roadway heading northeast (**Figure 6**).

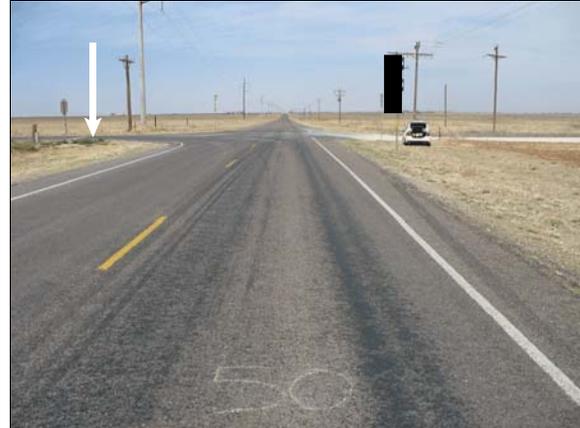
Pre-Crash: The Chevrolet's unrestrained 73-year-old male driver was traveling northwest (**Figure 2**) and the driver intended to continue straight through the intersection. The Chevrolet's EDR data indicated that the vehicle was traveling 151 km/h (94 mph) at 5 and 4 seconds prior to Algorithm Enable (AE). The brake switch circuit was recorded as on from 3 to 1 seconds prior to AE and the speed decreased to 100 km/h (62 mph) at 1 second prior to AE. The Bluebird was occupied by a restrained 53-year-old male driver and was initially stopped at the stop sign heading northeast (**Figure 3**). The driver told police that he did not see the approaching Chevrolet. He proceeded into the intersection and intended to continue northeast.

Figure 2: Chevrolet's approach to impact; number on pavement shows meters to impact area; arrow shows area where Bluebird was reportedly stopped prior to the crash

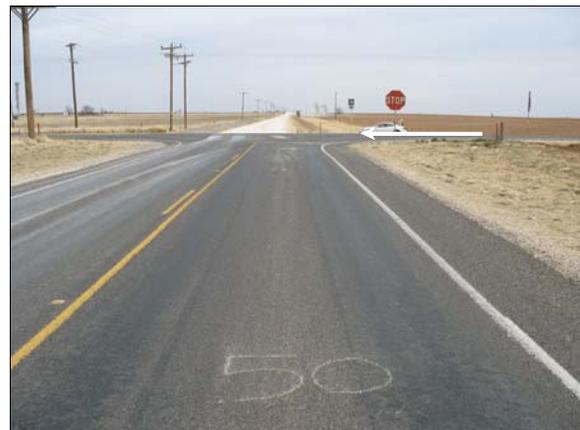
Figure 3: Approach of the Bluebird to the intersection; arrow shows approach of the Chevrolet

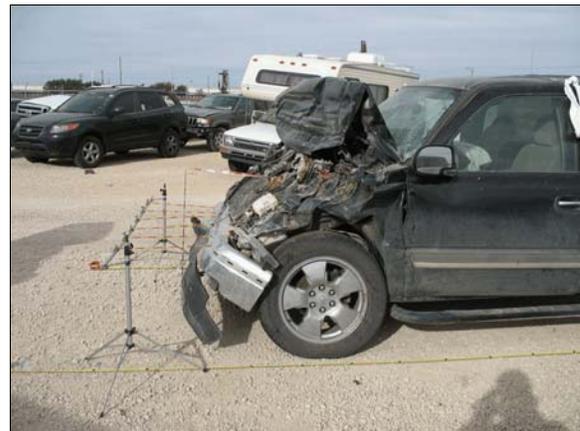
Figure 4: Profile of frontal damage measured at bumper level

Exterior Damage: The Chevrolet's impact with the Bluebird involved the front plane. The bumper, grille, hood, headlamp/turn light assemblies, and fenders were all directly damaged. The direct damage began at the front left bumper corner and extended 164 cm (64.6 in) across the bumper. The crush measurements were taken at the bumper level and due to the underride, a second set of crush measurements were taken at the upper radiator support (**Figures 4 and 7**). The maximum residual crush at the bumper level was 45 cm (17.7 in) occurring at C₄. The maximum residual crush at the upper radiator support level was 71 cm (28 in) occurring at C₃. The table below shows the crush profile based on the average of the crush at the two levels.

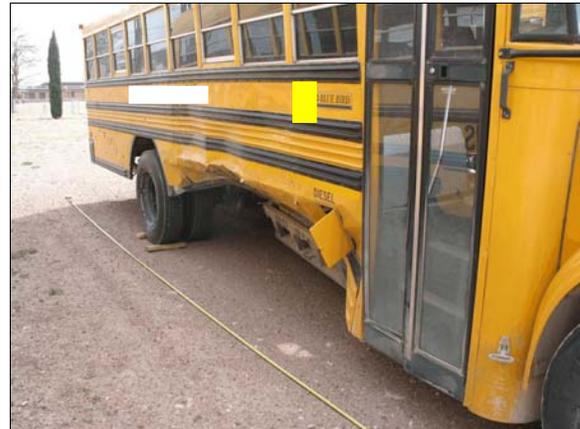
Figure 5: Damage to right side of Bluebird from impact with the Chevrolet

Exterior Damage: The Bluebird's impact with the Chevrolet involved the right side of the vehicle (**Figure 5**). The direct damage started just behind the bi-fold door and measured 245 centimeters (96.5 inches) in width. The Bluebird's fuel tank was located directly in the area of the impact (**Figure 12**). The fuel tank was protected by a steel frame and the fuel tank and frame were displaced inward by the impact. The fuel tank's protective frame loaded the bus's right frame member and bent it and the left frame member. The fuel tank was not damaged and there was no fuel leakage.

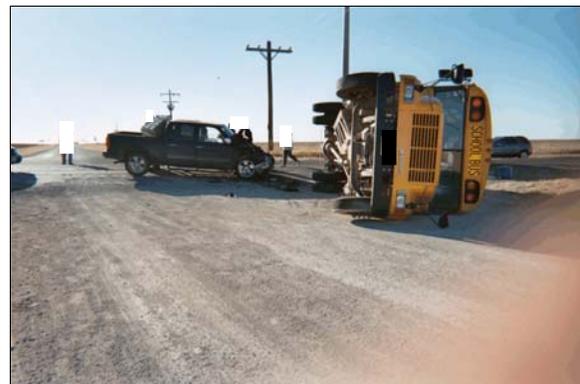
Figure 6: Police on-scene photo showing the Chevrolet and Bluebird at final rest

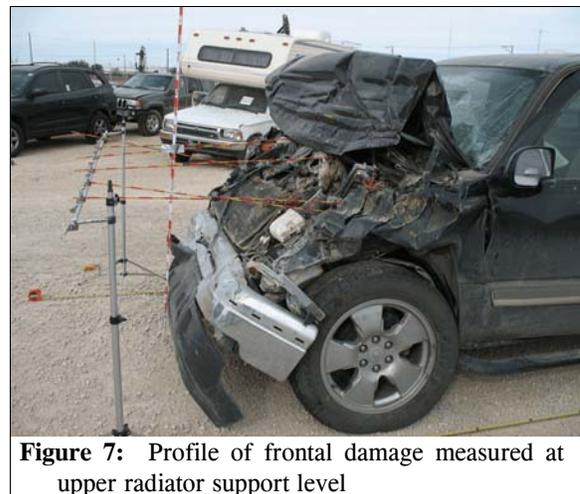
Figure 7: Profile of frontal damage measured at upper radiator support level

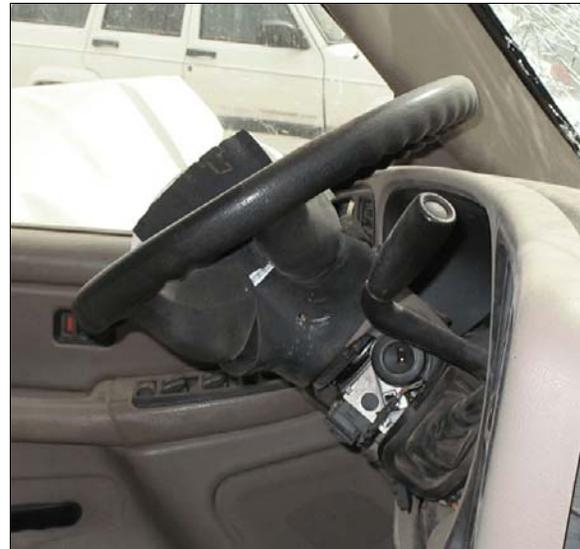
Vehicle Interior: The inspection of the Chevrolet's interior revealed occupant contact to the steering wheel, driver's knee bolster, the driver's sunvisor swivel post, and the adjacent front header. The top half of the steering wheel rim was deformed forward 3 cm (1.2 in) and the energy absorbing steering column was compressed 3 cm (1.2 in) due to occupant loading (**Figure 8**). The steering column was also displaced upward an unknown amount (the pre-crash tilt position of the steering column could not be determined due to the damage) and to the left 2 cm (0.8 in). The driver's knee bolster was scuffed due to contact by the driver's knees. Hair was found in the sunvisor swivel post bracket (**Figure 9**) and the adjacent front header was scuffed due to contact by the driver's head. All the doors remained closed and operational during the crash

Figure 8: Deformation of the steering wheel and compression loading of the steering column due to occupant loading

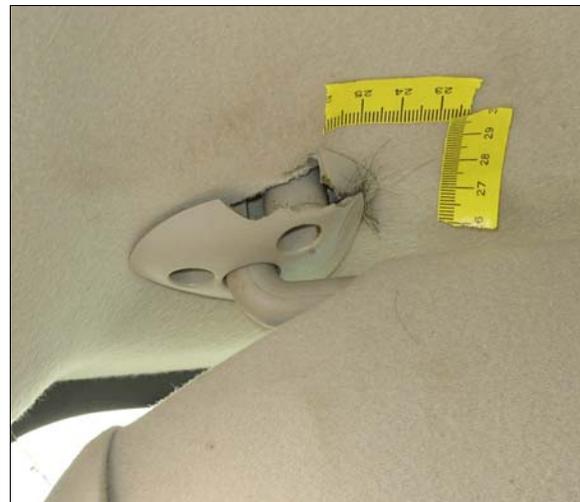
Figure 9: Hair embedded in the driver's sunvisor swivel post bracket and contact to the front header

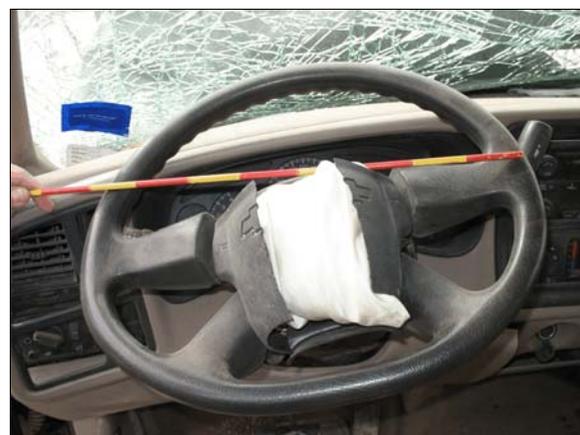
The driver's air bag was located in the steering wheel hub. An inspection of the air bag module revealed that the cover flaps opened at the designated tear points (**Figure 10**). The cover flaps were constructed of vinyl and the tear seams were configured across the top, bottom and vertically down the middle. The module flaps were 15 cm (5.9 in) in width at the top, 10 cm (3.9 inches) in width at the bottom and 13 cm (5.1 in) in height at the vertical tear seam. The deployed air bag (**Figure 11**) was round with a diameter of 65 centimeters (25.6 inches), and two vent ports were located on the back of the air bag at the 11 and 1 clock positions. The damage to

Figure 10: Steering wheel damage and air bag flaps

the steering assembly indicated that the driver had loaded and ridden down the air bag during the crash, but there was no discernable evidence of occupant contact on the air bag material and no damage to the air bag.

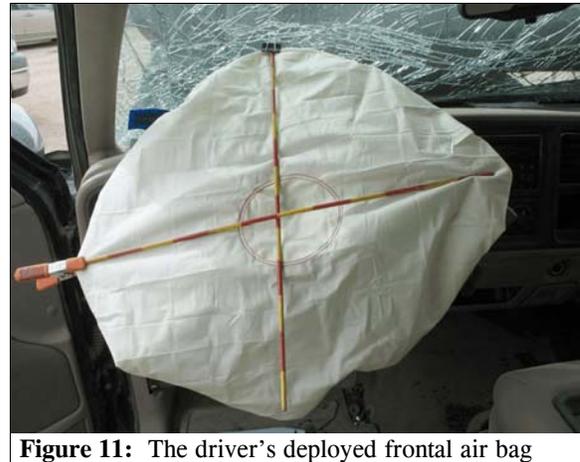
Figure 11: The driver's deployed frontal air bag

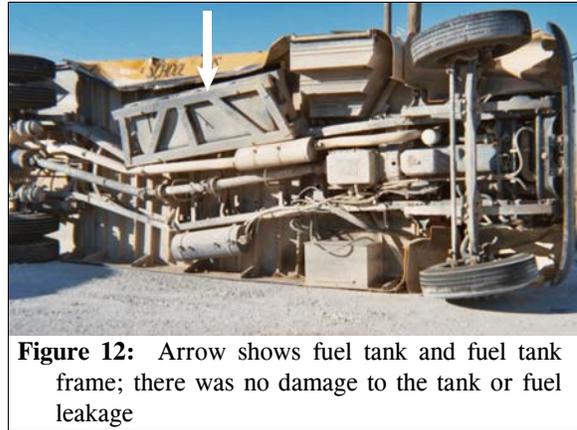
Figure 12: Arrow shows fuel tank and fuel tank frame; there was no damage to the tank or fuel leakage
