ON-SITE CERTIFIED ADVANCED 208- COMPLIANT VEHICLE INVESTIGATION

CASE NUMBER - IN08011
LOCATION - TEXAS
VEHICLE - 2006 CHEVROLET COBALT LS
CRASH DATE - December 2007

1. <i>Report No.</i> IN08011		2. <i>Government Accession No.</i>		3. <i>Recipient's Catalog No.</i>	
4. <i>Title and Subtitle</i> On-Site Certified Advanced 208-Compliant Vehicle Investigation Vehicle - 2006 Chevrolet Cobalt LS Level 1 Location - Texas			5. <i>Report Date:</i> December 22, 2008

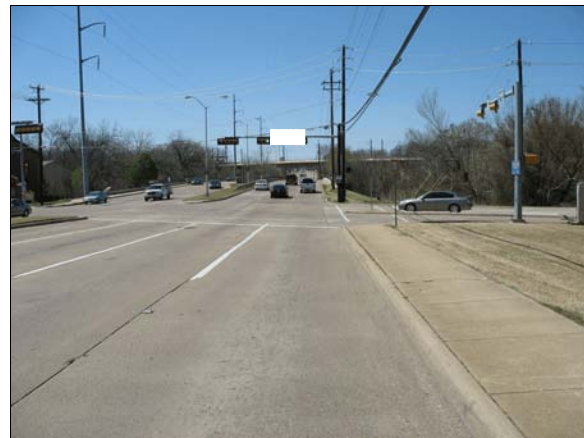
Figure 1: Chevrolet's westbound approach to the intersection

Pre-Crash: The Chevrolet was traveling west in the outside lane (**Figure 1**), and the driver intended to continue straight through the intersection. The Chevrolet's EDR data indicated that the Chevrolet was traveling 69 km/h (43 mph) approximately 1 second prior to algorithm enable (AE). The Lexus was traveling east in the left turn lane, and the driver was intending to turn left and travel northbound (**Figure 2**). The police crash report indicated that the Lexus was proceeding on a green turn arrow. The police report indicated that the Chevrolet's driver did not stop for the red signal light. It is unknown if the Chevrolet's driver took any actions to avoid the crash. The crash occurred within the 4-leg intersection of the 2 trafficways (**Figure 3**).

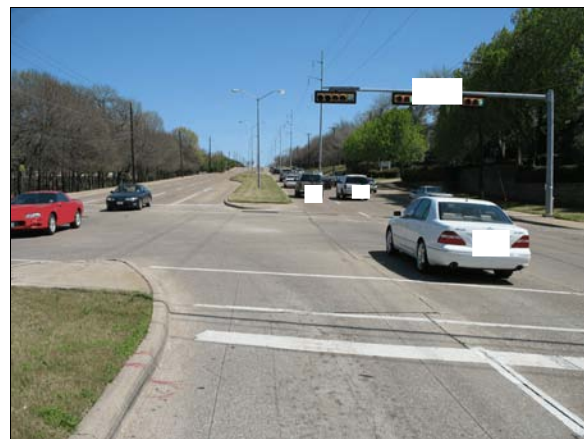
Figure 2: Lexus' approach in left turn lane to area of the crash

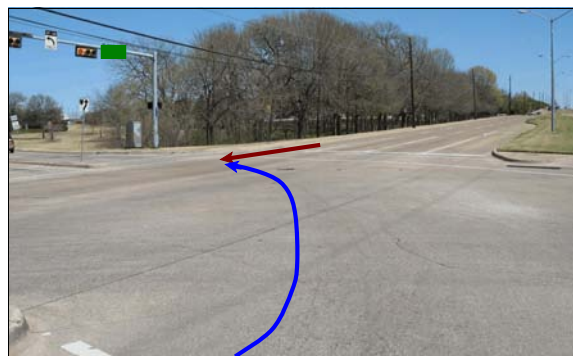
Figure 3: Impact area and converging trajectories of Chevrolet (straight arrow) and Lexus (curvilinear arrow)

indicated that both vehicles probably came to final rest in the mouth of the intersection's north leg (Figure 3) and were probably facing in a west-northwesterly direction.

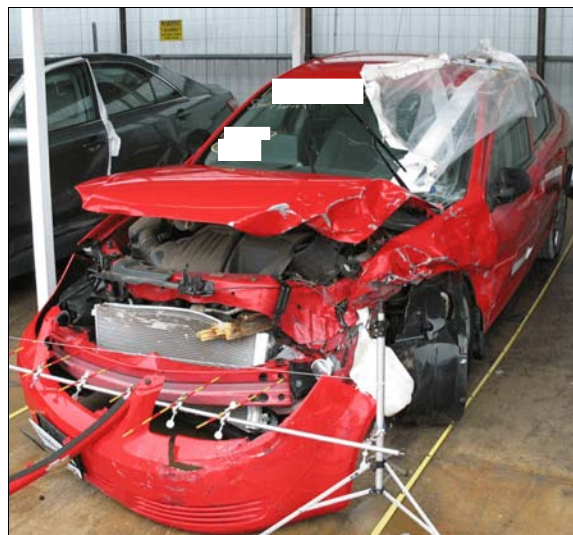
Crash: The front left corner of the Chevrolet (**Figure 4**) impacted the front of the Lexus, causing the Chevrolet's driver and front right passenger air bags to deploy. Based on the downloaded EDR data, both the first and second stages of the multi-stage air bags were activated. As a result of the impact, the Chevrolet rotated clockwise and the Lexus to rotated counterclockwise. As both vehicle's rotated, the left quarter panel of the Chevrolet (**Figure 5**) side slapped the right quarter panel of the Lexus. The scene inspection revealed no evidence of either vehicle's final rest position. The police crash schematic did not depict the final rest positions of either vehicle. The impact location and impact configuration

Figure 4: Damage to Chevrolet's front left corner from impact with the Lexus

Exterior Damage: The Chevrolet's first impact with the Lexus involved the front left corner. The front bumper, bumper fascia, grille, radiator, hood, left fender, left headlight and turn signal assemblies, left front rim, left front door, and side view mirror all sustained direct contact. The direct damage began at the front left bumper

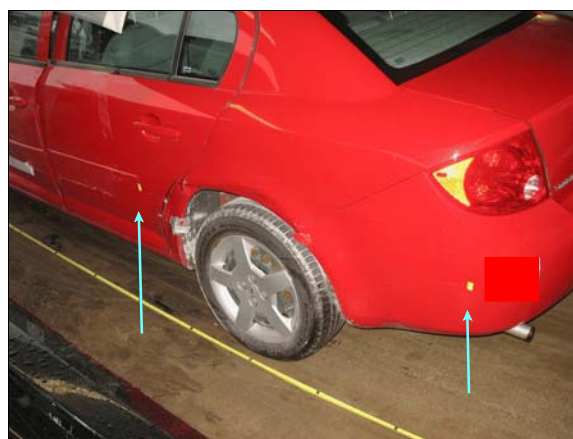
Figure 5: Damage to Chevrolet's left rear door and quarter panel, as a result of side-slap impact with Lexus; Note: arrows show yellow incremented tape which indicates damage length

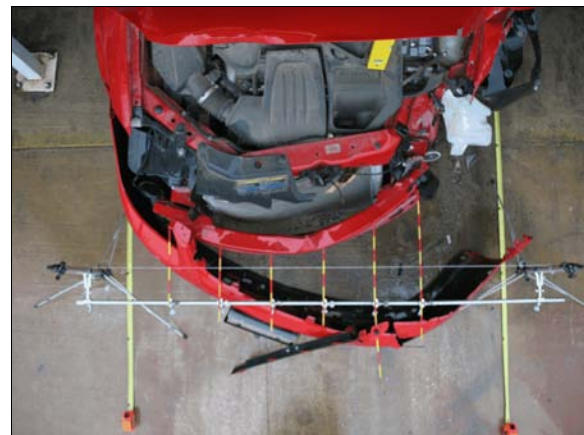
Figure 6: Overhead view of Chevrolet's frontal crush; each increment on rods is 5 cm (2 in)

corner and extended 27 centimeters (10.6 inches) along the front of the vehicle. Crush measurements were taken on the front bumper bar, and the residual maximum crush was measured as 18 centimeters (7.1 inches) occurring at C₁ (**Figure 6**). The side slap impact involved the Chevrolet's left side. The left rear door, quarter panel, and rim sustained direct contact (**Figure 5**). The direct damage began 50 centimeters (19.7 inches) forward of the left rear axle and extended rearward 121 centimeters (47.6 inches) to the left rear bumper corner. The maximum residual crush was estimated from photographs to be 3 centimeters (1.2 inches) occurring at C₅. The table below shows the Chevrolet's crush profile for each event.

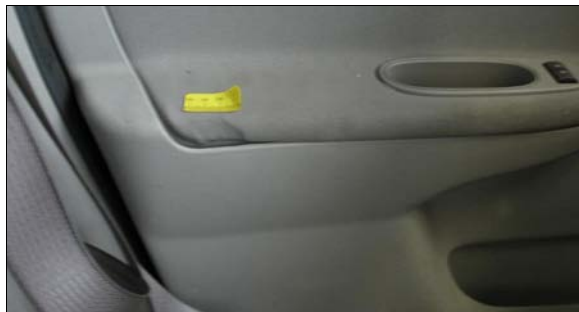
Figure 8: Close-up of dent in arm rest of Chevrolet’s driver door from driver contact

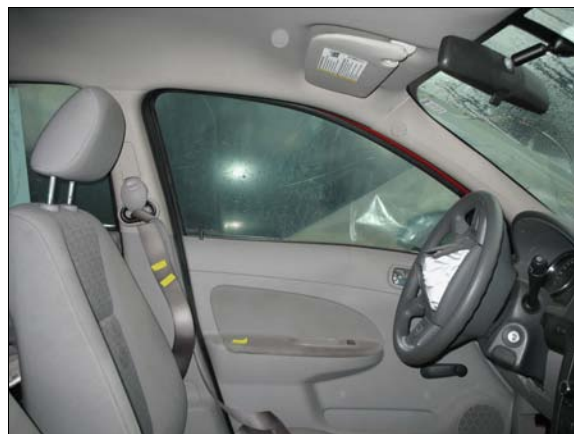
Interior Damage: Inspection of the Chevrolet's interior (**Figure 7**) revealed a slight deformation of the driver's left arm rest, indicating probable driver contact during the crash (**Figure 8**). Furthermore, no contact evidence was observed on the front right instrument panel, glove box door, or greenhouse area. There was no evidence of steering rim deformation or compression of

Figure 7: Chevrolet’s driver seating area showing deployed driver air bag, steering wheel, greenhouse, driver’s safety belt—with evidence of loading, and contact on interior door surface

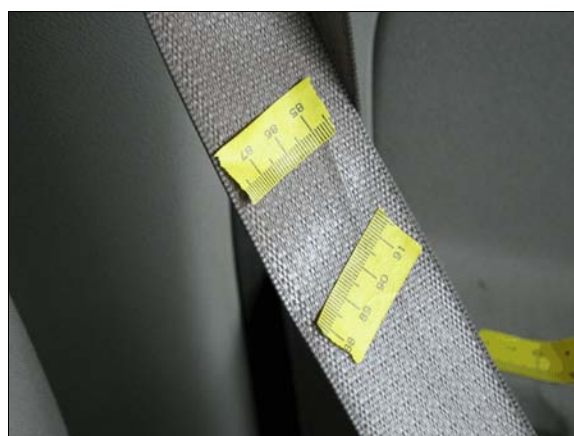
Both front row seat belts exhibited indications of historical usage. The inspection of the driver’s safety belt webbing, D-ring, and latch plate revealed that a length of belt extended out of the retractor. The retractor was jammed, indicating that the pretensioner had actuated, and the webbing was firm (i.e., the webbing would not spool or re-spool). Furthermore, there was a slight stress mark on the driver’s shoulder belt webbing from occupant loading on the D-ring (**Figure 9**).

Figure 9: Load mark on Chevrolet’s driver shoulder belt webbing

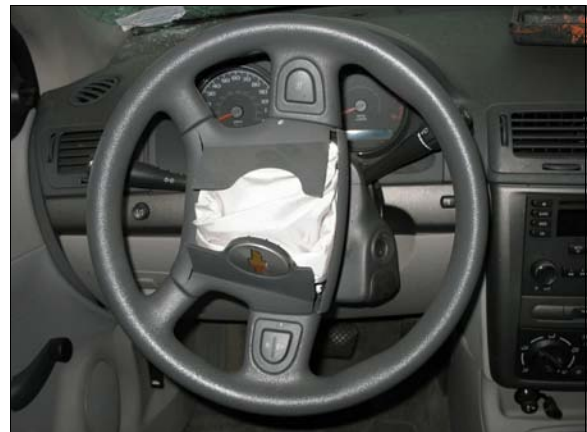
Figure 10: Chevrolet’s steering wheel with driver air bag module and flaps; steering wheel rotated clockwise approximately 90 degrees

The Chevrolet’s driver air bag was located in the steering wheel hub (**Figure 10**). An inspection of the air bag module cover flaps and the air bag fabric revealed that the cover flaps opened at the designated tear points, and there was no evidence of damage during the deployment to the air bag fabric or the module cover flaps. The deployed driver’s air bag was round with a diameter of approximately 60 centimeters (23.6 inches). An inspection of the driver’s air bag revealed no discernable contact evidence on the air bag’s fabric (**Figure 11**).

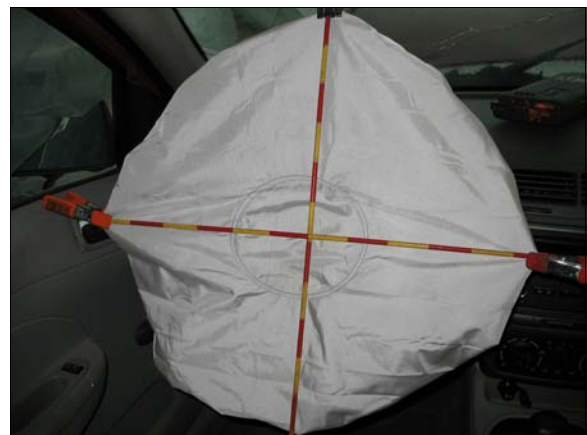
Figure 11: Chevrolet’s deployed driver air bag showing no obvious evidence of occupant contact

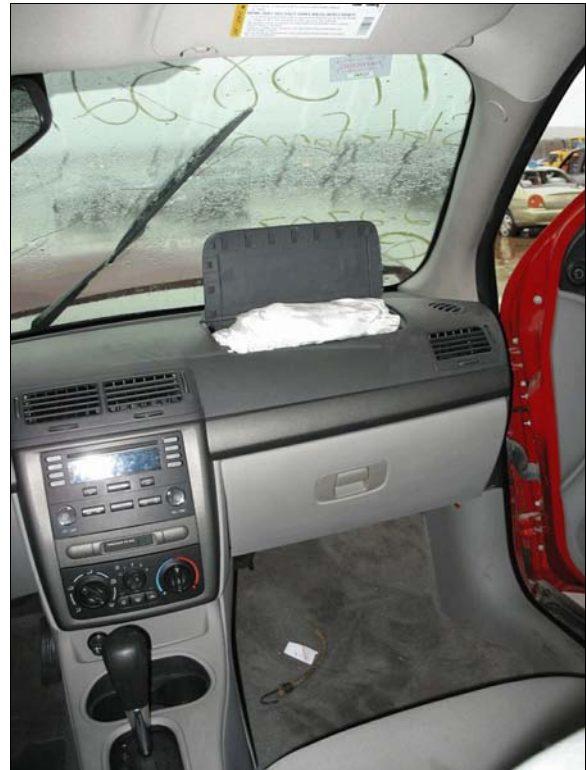
The front right passenger front air bag was located on the top of the instrument panel (**Figure 12**). An inspection of the air bag module cover flap and air bag fabric revealed the cover flap opened at the designated tear points, and there was no evidence of damage during the deployment to the air bag fabric or the module cover flap. The deployed front right air bag was rectangular with a height of approximately 58 centimeters (22.8 inches) and a width of approximately 44 centimeters (17.3 inches). An inspection of the front right passenger's air bag revealed no discernable contact evidence on the air bag's fabric (**Figure 13**).

Figure 12: Chevrolet's front right seating area showing deployed front right air bag, center and right instrument panels, center console, and greenhouse area; no occupant contacts evident

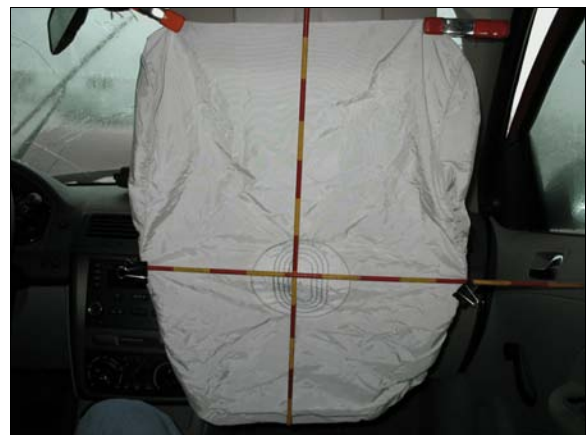
Figure 13: Chevrolet's deployed front right passenger air bag showing no occupant contact evidence
