Remote School Bus Investigation  
Dynamic Science, Inc. (DSI), Case Number DS08012  
1999 Blue Bird TC2000 School Bus  
Montana  
April 2008

1. Report No. DS08012	2. Government Accession No.		3. Recipient Catalog No.	
4. Title and Subtitle Remote School Bus Investigation		5. Report Date June 30, 2009

14. Sponsoring Agency Code		
15. Supplemental Notes				
16. Abstract This remote investigation focused on the ejection of a child occupant of a Blue Bird school bus during a vehicle-to-vehicle crash. The crash occurred April 2008 at 1810 hours within a four-leg intersection. The subject vehicle was a 1999 Blue Bird full-size yellow school bus that was being driven by a restrained 44-year-old female. There were 10 unrestrained children on board the bus at the time of the crash. The children were returning home from an after-school program. The other vehicle was 2004 Dodge pickup that was being driven by a 64-year-old female. There was one additional occupant in the Dodge, a 63-year-old male. The Dodge pickup was towing a gooseneck trailer loaded with gravel. The school bus was initially traveling south. The school bus stopped at a stop sign at the intersection, and then initiated a le

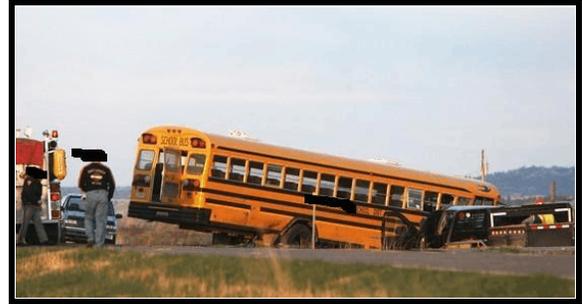
**Figure 1.** On scene view of school bus.

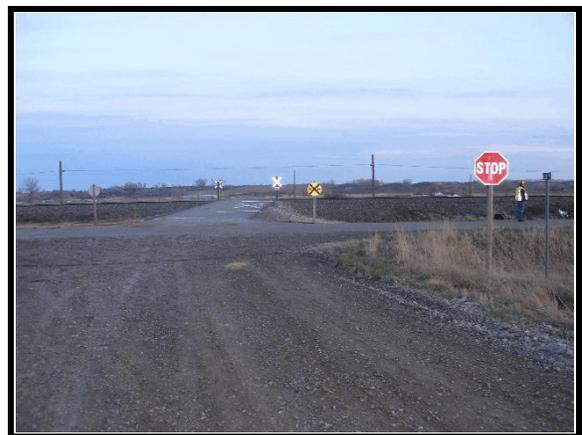
**Figure 2.** Southbound approach for 1999 Bluebird bus

(**Figure 2**). The roadway was controlled by stop signs in each direction. The southbound leg of the intersection was gravel covered and had a slight uphill grade of approximately 2 percent. The east/west roadway was configured with one lane in each direction that were separated by a solid yellow center line in the eastern direction and a dashed yellow center line in the western direction (**Figure 3**). The roadway was level, and bordered on both sides by solid white fog lines, asphalt shoulders, and sloping grass covered embankments. There was no stop sign for eastbound traffic. The posted speed limit was 113 km/h (70 mph).

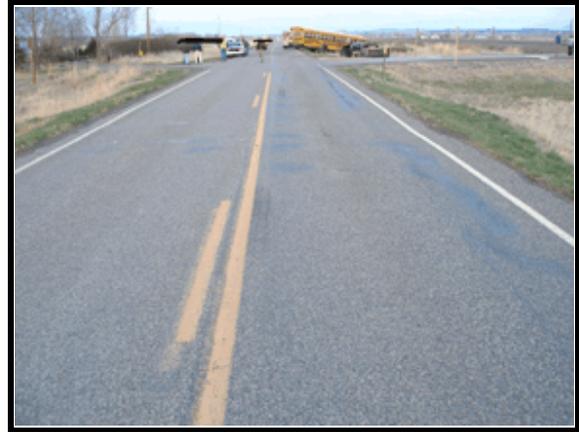
**Figure 3.** Eastbound approach for 2004 Dodge Ram

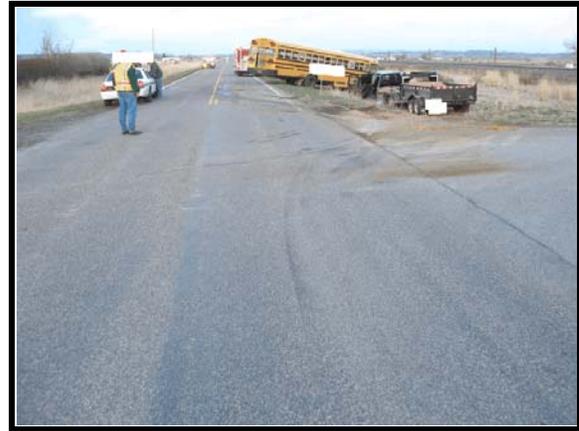
**Figure 4.** Area of impact and final rest (east).

where it came to rest on its wheels facing southeast with most of the length of the bus off the south side of the roadway (**Figure 4**). The pickup and trailer remained connected via the safety chain, though the goose-neck trailer hitch had disconnected. The Dodge came to rest off the roadway and slightly west of the bus facing east, roughly parallel with the south side of the roadway

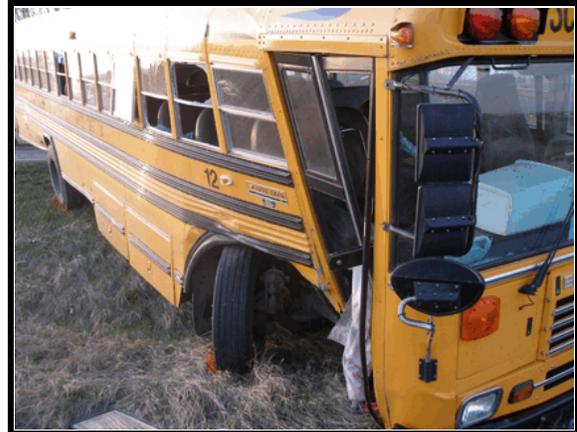
The 1999 Blue Bird school bus sustained moderate right side damage as a result of the initial impact with the Dodge truck (**Figure 5**). The direct damage began at the double outward folding doors and extended rearward to the right front wheel well. The damage extended vertically from the frame to the bottom of the rub rail. There was a small fracture to the right lower aspect of the windshield and a star-shaped fracture in front of the driver's position. The right front tire was rotated clockwise at a 45 degree clockwise angle. A police investigator checked the front suspension and reported that the shaft from the steering gear to the pitman arm was broken off. There was minor contact damage as a result of the impact with the striking vehicle's trailer (**Figure 6**). The damage was located aft of the rear tires and beneath the rub rail.

**Figure 5.** Right side damage (Event 1)

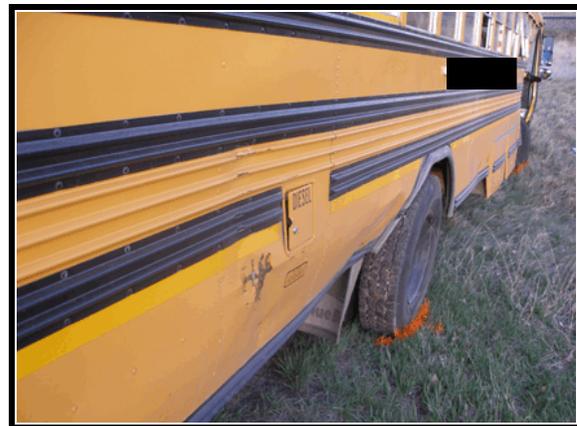
**Figure 6.** Right side damage (Event 2)

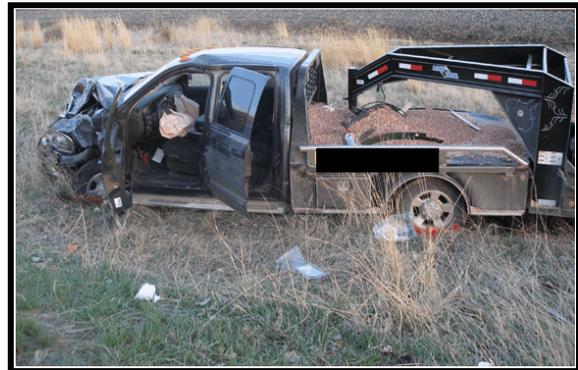
**Figure 7.** 2004 Dodge pickup

occupants on board. At impact with the right side of the bus, the Dodge sustained moderate front end damage. As the vehicle rotated, the Dodge sustained minor left side sideslap type damage to the trailer. As the vehicle continued forward, it ran over and bent a metal delineator on the roadside. The Collision Deformation Classification (CDC) for the initial bus impact was 12FDEW2.

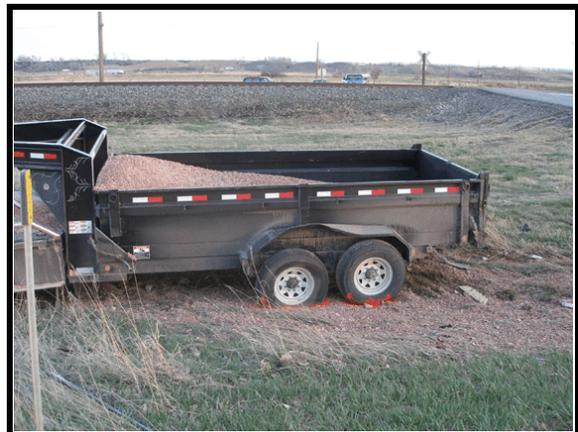
**Figure 8.** Load Trail trailer

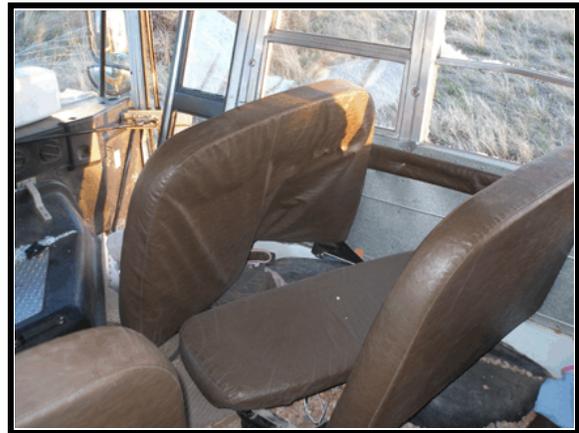
The 7-year-old female second row right occupant was seated in an unknown posture and was unrestrained (**Figure 9**). She was 135 cm (53 in) in height and weighed 39 kg (85 lbs). She was wearing a short-sleeve pullover shirt, lightweight sweat pants, and socks. She may have also been wearing a maroon jacket that was removed post-crash. At impact, she initiated a right lateral and slightly rearward trajectory and was ejected through the side window. The window sash was deformed outward (**Figure 10**). She sustained multiple contusions along the right side of her body from contact to the side interior surface and multiple abrasions from the side window frame as she was ejected. She impacted the ground and came to rest in the eastbound travel lane. She sustained left side rib fractures, a left lung contusion, a splenic laceration, and multiple contusions and abrasions from the ground impact. She was conscious for a short time after the crash. Fire and ambulance personnel began CPR efforts upon their arrival. Shortly after the arrival of the police, the CPR efforts were discontinued.

**Figure 9.** Second row right occupant seating position

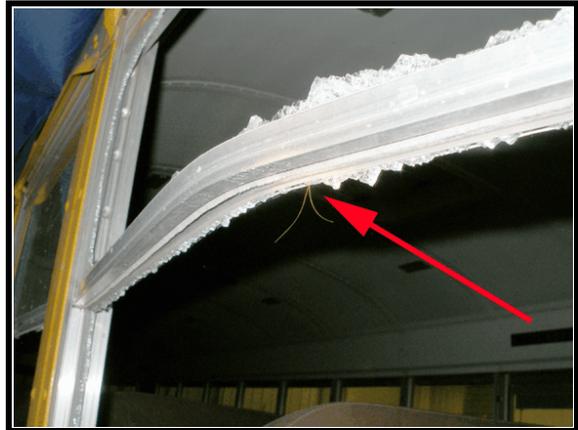
The bus was configured with 15 split sash windows on each side of the bus. The glazing for the second right side window was disintegrated for both the lower and upper portions of the window. The center frame of the window was bowed outward due to occupant contact (Occupant 3). Hairs and fibers were located on the frame. The glazing for the lower portion of the third right side window was disintegrated. The glazing for the lower portion of the fourth right side (emergency exit) window was cracked due to occupant contact (Occupant 5). The base of the window was open approximately 7-10 (2.8-3.9 in). A blood deposit was located at the bottom frame of the window. The glazing for the eighth right side window was disintegrated. The center frame was deformed inward and there were indications that the glass may have been broken by flying gravel.

**Figure 10.** Area of ejection, contact evidence on sash

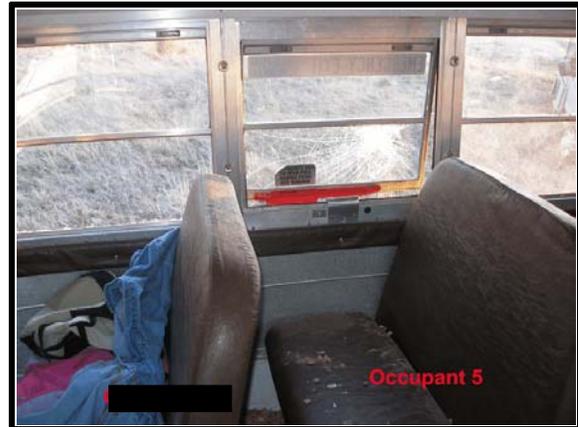
The 6-year-old female fourth row right occupant. She was 122 cm (48 in) in height and weighed 32 kg (71 lbs). At impact, she initiated a right lateral and slightly rearward trajectory. She contacted the emergency side window (**Figure 11**). The window was fractured in a star pattern. She sustained a contusion to the right arm from the contact with the window and a contusion to the right leg from contact with the lower side panel. She was transported from the scene to a local hospital where she was treated and released.

**Figure 11.** Occupant 5 seating position
