## ON-SITE SIDE IMPACT INFLATABLE OCCUPANT PROTECTION INVESTIGATION

CASE NUMBER - IN08013  
LOCATION - TEXAS  
VEHICLE - 2007 TOYOTA CAMRY LE  
CRASH DATE - January 2008

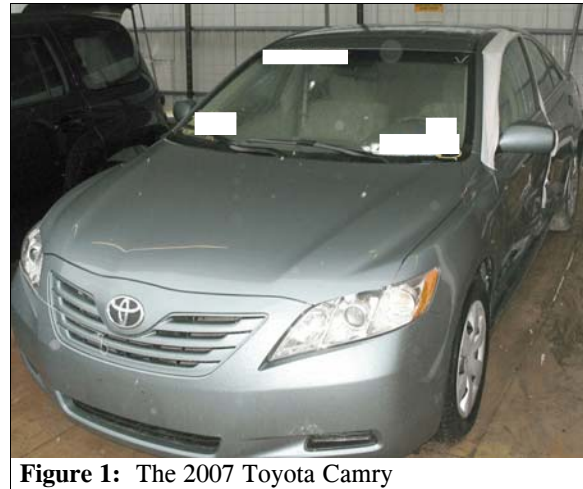
**Figure 1:** The 2007 Toyota Camry

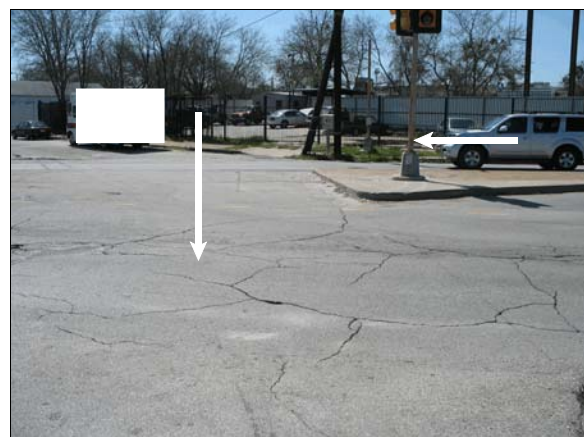
**Pre-Crash:** The Toyota was traveling southwest in the inside through lane approaching the left turn channel at the intersection (**Figure 2**). The Toyota's driver intended to turn left and travel southeast. The Mitsubishi was traveling west in the inside through lane (**Figure 3**), and the driver intended to continue straight through the intersection. It was not known if the Toyota's driver took any actions to avoid the crash. The crash occurred in the intersection (**Figure 4**).

**Figure 4:** Left arrow shows impact area in intersection (view from Toyota's path of travel); right arrow shows impacted traffic signal pole

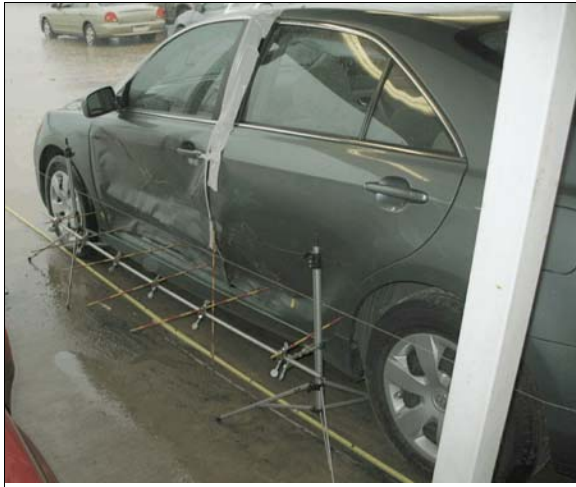
**Figure 5:** Damage to left side of Toyota from impact with front of Mitsubishi

**Exterior Damage:** The Toyota's impact with the Mitsubishi involved the left side of the vehicle. The left front door, left rear door and a small area of the left fender adjacent to the front door were directly contacted. The direct damage began 47 centimeters (18.5 inches) rear of the left front axle and extended 159 centimeters (62.5 inches) rearward across both doors. The crush measurements were taken at the lower door level and the residual maximum crush was measured as 13 centimeters (5.2 inches) occurring at both C<sub>4</sub> and C<sub>5</sub>. The table below shows the vehicle's left side crush profile.

The induced damage from the left side impact involved the left fender and the upper portions of the left front and left rear doors. The induced damage from the right side impact involved the right quarter panel, right C-pillar, and right rear door. The Toyota's right and left side wheelbases were extended 8 centimeters (3.1 inches).

**Damage Classification:** The Collision Deformation Classifications for the Toyota were **10-LPEW-1 (290 degrees)** for the impact with the front of the Mitsubishi (event 1), **03-RBWN-1 (90 degrees)** for the curb impact (event 2), and **03-RPEN-2 (90 degrees)** for the impact with the traffic signal pole (event 3). The WinSMASH reconstruction program, Missing Vehicle Algorithm was used to reconstruct the vehicle's Delta V for the left side impact with the Mitsubishi. The Total Delta V was 25 km/h (15.5 mph), and the Longitudinal and Lateral components were -8.6 km/h (-5.3 mph) and 23.5 km/h (14.6 mph). The WinSMASH reconstruction program, Barrier Algorithm was used to reconstruct the Delta V for the right side impact to the traffic signal pole. The Total Delta V was 14.0 km/h (8.7 mph), and the Longitudinal and Lateral components were 0.0 km/h and -14.0 km.p.h. (-8.7 m.p.h.).

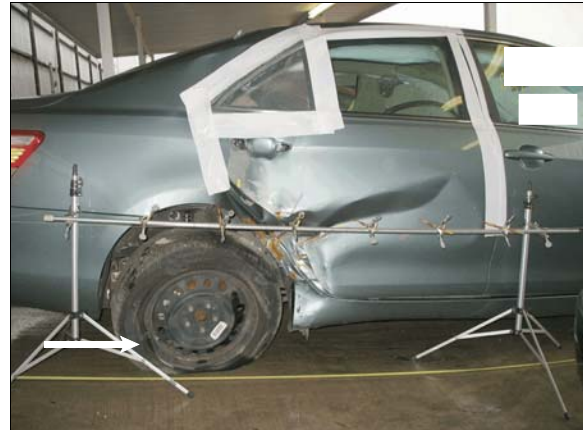
**Figure 6:** Arrow shows damage to right rear wheel from curb impact; damage to right rear door from impact with the traffic signal pole

The impact with the curb involved the right rear wheel. The rim was dented and the tire's side wall was punctured. No crush measurements were taken for this impact because tire impacts are out of scope of the measurement protocol.

The impact with the traffic signal pole involved the right side of the vehicle. The right rear door, right rear wheel and a small portion of the right quarter panel were directly contacted. The direct damage began 228 centimeters (89.8 inches) rear of the right front axle and extended 38 centimeters (15 inches) rearward. The crush measurements were taken at the mid-door level and the residual maximum crush was 20 centimeters (7.9 inches) occurring at C<sub>3</sub>. The table below shows the vehicle's right side crush profile.

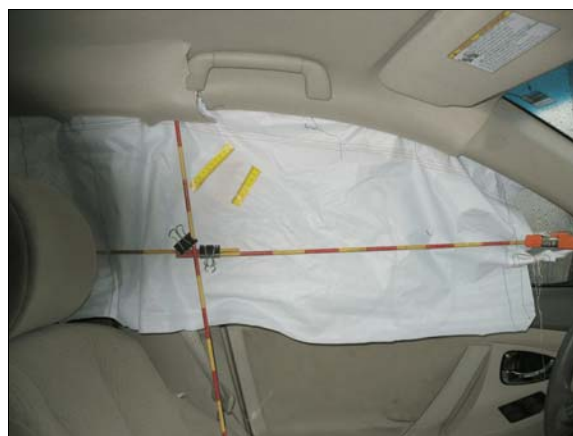
**Vehicle Interior:** A smear of makeup was found on the left side curtain air bag (**Figure 7**), which indicated the left side of the driver's face contacted the deployed air bag during the initial impact. The driver's seat belt webbing was slightly stretched (i.e., stiff and wavy), which indicated it was probably loaded by the driver during the crash. The right rear door intruded laterally 5 centimeters (2 inches) as a result of the traffic signal pole impact. There was no intrusion of the left side doors or B-pillar due to the impact with the Mitsubishi. There was also no deformation of the steering wheel or compression of the energy absorbing steering column.

**Figure 7:** Yellow tape shows makeup smear from driver contact on left side curtain air bag

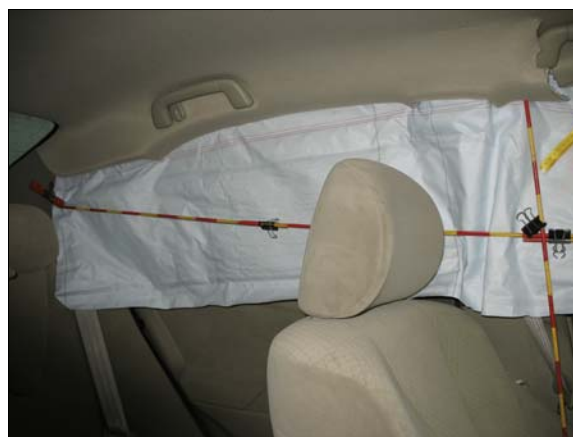
**Figure 8:** Back portion of left side curtain air bag

The Toyota's left side curtain air bag (**Figures 7 and 8**) and right side curtain air bag were located along the roof side rails, inside the head liner and extended the A-pillar to the C-pillar.

The side curtain air bags were 170 centimeters (66.9 inches) in length and 37 centimeters (14.6 inches) in height. They were designed with inflation chambers adjacent to the front and back outboard seat positions and the B-pillars, and there no external vent ports. The front of each air bag was anchored to the A-pillar via a fabric cord. The evidence of occupant contact involved the smear of makeup (Figure 6) mentioned above to left side curtain air bag. There was no evidence of occupant contact to the right side curtain air bag. There were no right side occupants within the vehicle at the time of the crash. There was also no indication of damage due to deployment to either side curtain air bag.

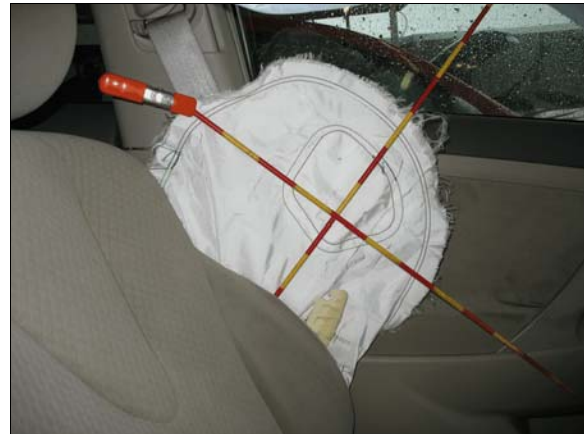
**Figure 9:** Toyota driver's seat back-mounted side impact air bag

The Toyota driver's seat back-mounted side impact air bag was located in the left side of the driver's seat back. The air bag deployed through a tear-seam in the side of the seat back. The deployed air bag (**Figure 9**) was 32 centimeters (12.6 inches) in height and 28 centimeters (11 inches) in width. Both sides of the air bag were stitched together in a trapezoid-shaped area near the top and there were no external vent ports. Inspection of the air bag revealed no evidence of occupant contact or damage during the deployment.
