**CALSPAN ON-SITE SIDE IMPACT INFLATABLE OCCUPANT PROTECTION  
CRASH INVESTIGATION**

**SCI CASE NO: – CA08013**

**VEHICLE – 2007 NISSAN SENTRA**

**CRASH DATE – FEBRUARY 2008**

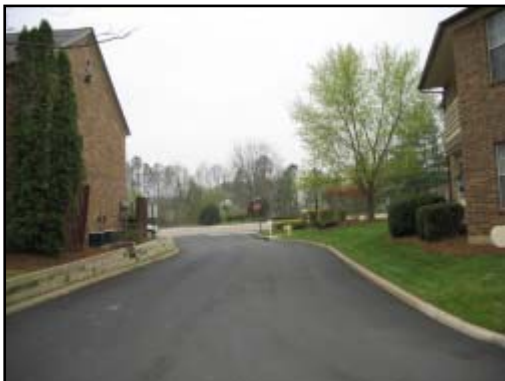
The unrestrained 26-year-old female driver of the Nissan Sentra was traveling east on the two-lane road as she was departing a residential complex (**Figure 2**). She was decelerating for a regulatory stop sign and stopped at the mouth of the four-leg intersection. The driver did not detect the southbound Ford Taurus and entered the intersection directly in the path of the Taurus.

**Figure 2. Nissan's approach to the intersection.**

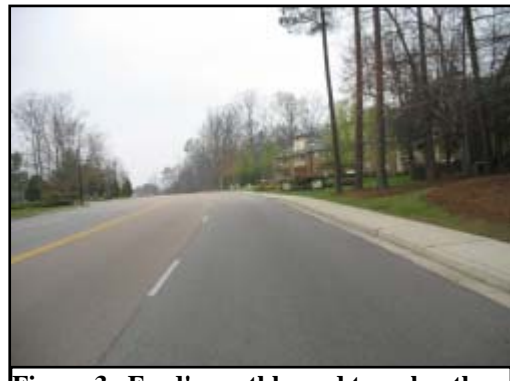
The southbound Ford Taurus was driven by a 26-year-old female driver in the outboard travel lane on an approach to the intersection. It was her intention to travel straight through the intersection (**Figure 3**). There were no traffic controls for the north and southbound traffic flow. As the driver of the Taurus detected the Nissan accelerate into her path of travel, she applied the brakes in an attempt to avoid the crash. The investigating officer noted in his report that there was tire/skid marks associated with the braking; however, these marks were not documented by the officer. These skid marks had eroded prior to the scene inspection by the SCI investigator.

**Figure 3. Ford's northbound travel path.**

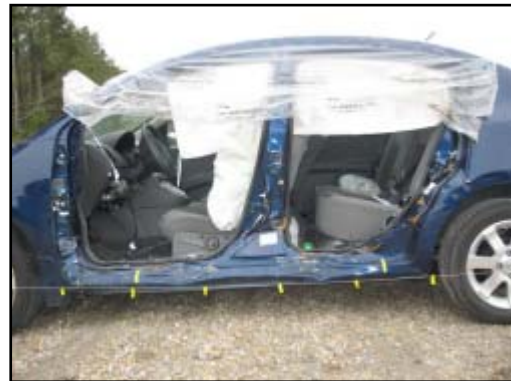
The exterior of the Nissan Sentra sustained moderate severity damage as a result of the intersection crash (**Figure 4**). The vehicle was towed to an auto body repair shop for a damage appraisal. At the body shop, the left side doors were removed for assessment of the damage to the left side structure. The front door hinges and the left rear lower door hinge were unbolted from the respective pillars. The upper rear door hinge was cut on the pillar side to remove the door. Both doors were discarded by the body shop prior to the assignment of this SCI investigation.

**Figure 4. Residual damage to the Nissan Sentra.**

The Nissan was subsequently deemed a total loss and was transferred to a regional salvage facility where it was inspected. The residual damage was measured at the sill level. The maximum crush measured 8 cm (3.1") and was located 107 cm (42.1") rear of the left front axle. The direct contact damage measured 124 cm (48.8") and began 83 cm (32.7") rear of the left front axle which extended 181 cm (71.3") rear of the reference point. The crush profile at this level and was as follows: C1 = 3 cm (1.2"), C2 = 6 cm (2.4"), C3 = 7 cm (2.8"), C4 = 8 cm (3.1"), C5 = 6 cm (2.4"), C6 = 0 cm. The Collision Deformation Classification (CDC) assigned for this crash was 10-LPEW-1.

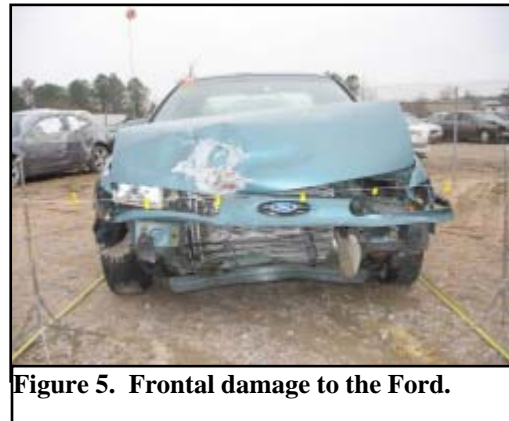
The frontal area of the Taurus sustained moderate severity damage (**Figure 5**). The bumper fascia and bumper beam separated from the vehicle during the crash. The direct contact damage extended across the full width of the Taurus and measured 142 cm (56"). Residual crush was documented at the frame rails and upper radiator support. The crush at the left and right frame rails measured 12 cm (4.7") and 10 cm (3.9"), respectively. At the upper radiator support, the residual crush was as follows: C1 = 11 cm (4.3"), C2 = 13 cm (5.1"), C3 = 12 cm (4.7"), C4 = 15 cm (5.9"), C5 = 14 cm (5.5"), C6 = 13 cm (5.1"). The CDC for this damage was 01-FDEW-1.

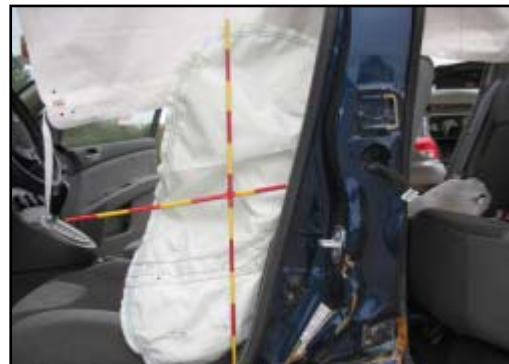
The left seat back mounted air bag was concealed within outboard aspect of the seat back. The air bag deployed through a 49 cm (19.3") tear at the forward seam of the seat back. The air bag membrane measured 43 cm (16.9") in height and 27 cm (10.6") in width and consisted of two panels sewn together at the forward edge. The height of the membrane resulted in overlapping height coverage with the curtain air bag. Three stitch patterns were sewn to the air bag membrane. These stitches were full width and were located 16 cm (6.3"), 18 cm (7.1"), and 20 cm (7.9"), receptively from the bottom of the air bag. These were probably designed to control the deployment path and inflation of the membrane. A single vent port was present at the forward edge, 4 cm (1.6") below the top of the air bag. The vent was port was located on the outboard aspect and measured 4 cm (1.6"). **Figure 6** is an overall view of the deployed left seat back mounted air bag.

**Figure 6. Deployed left seatback mounted side impact air bag.**

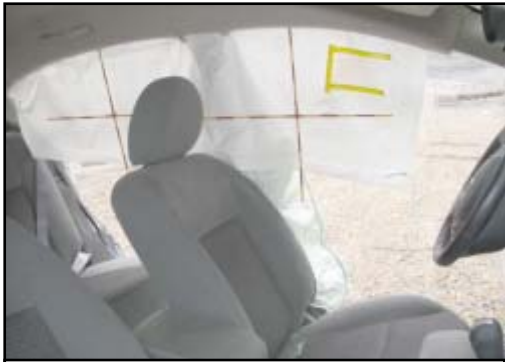
The left curtain air bag deployed from the roof side rail. The air bag membrane measured 146 cm (57.5”) in length. At the front left seating position, the membrane measured 43 cm (16.9”) in height and 42 cm (16.5”) in height at the left rear position. The air bag membrane covered the full height of the side glazing. The air bag was tethered at the A and C-pillars. The A-pillar tether was cut post-crash. It was unknown if the tether was cut by EMS or the repair facility. The tether measured 57 cm (22.4”) in length. The C-pillar tether was 8 cm (3.1”) in length. Longitudinally, the coverage area of this curtain air bag did not span across the left side glazing. A triangular shaped gap was present which began at the A-pillar and extended 46 cm (18.1”) rearward. A probable occupant contact point was present on the curtain air bag which consisted of a reddish colored make-up transfer. This contact was located on the inboard aspect of the membrane 12-27 cm (4.7-10.6”) rear of the forward edge and 6-15 cm (2.4-5.9”) below the roof rail. **Figures 7 and 8** are images of the deployed curtain air bag and the occupant contact point.

**Figure 7. Deployed left side curtain air bag.**

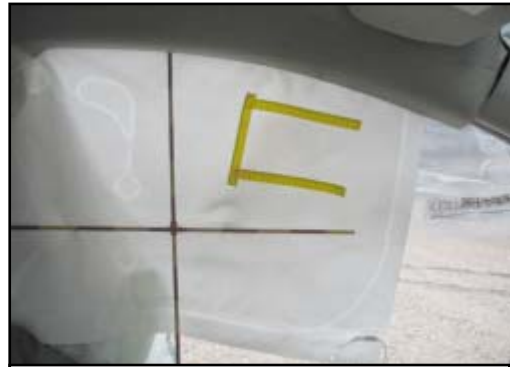
**Figure 8. Occupant contact on the left side curtain air bag.**

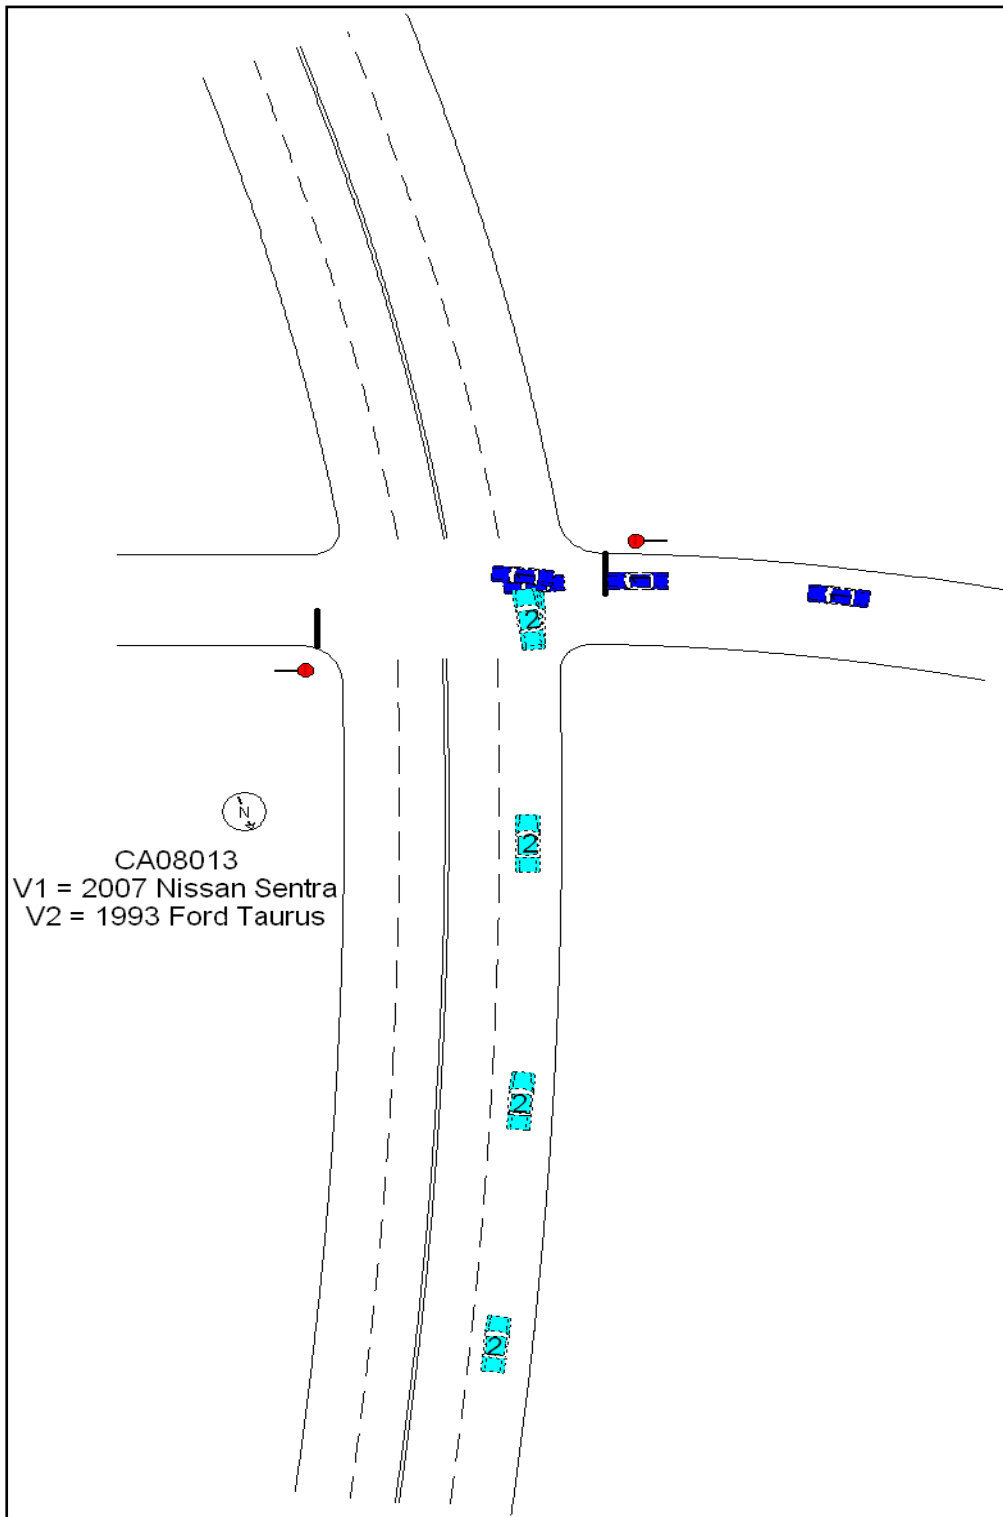
**Figure 9: Scene Schematic**

entrance/exit to a business park. The width of the east leg was 7.7 meters (25.2 feet). The west leg was configured with one travel lane in each direction. The west leg measured 7.7 meters (25.2 feet) in width and was an entrance/exit to an apartment complex. A left curve was present for eastbound travel. The intersection was controlled by stop signs for the east/west traffic. The posted speed limit for both roadways was 56 km/h (35 mph). The scene schematic is included as **Figure 9** of this report.
