**CALSPAN ON-SITE CHILD SAFETY SEAT CRASH INVESTIGATION
COSCO COMMUTER VENTURA CHILD SAFETY SEAT**

SCI CASE NO: CA08016

**VEHICLE: 2005 HONDA ODYSSEY
LOCATION: NORTH CAROLINA
CRASH DATE: APRIL, 2008**

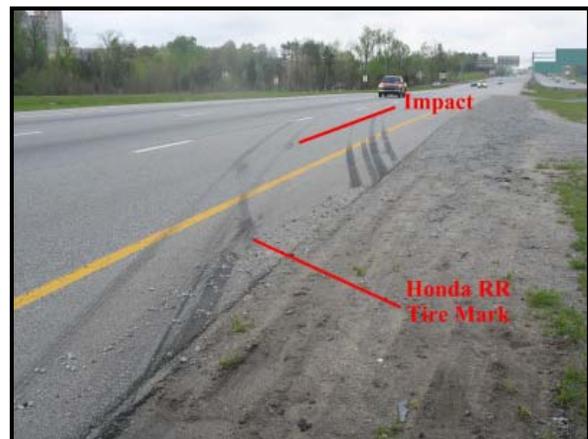
Figure 6: View of the POI and skid marks at the crash site.

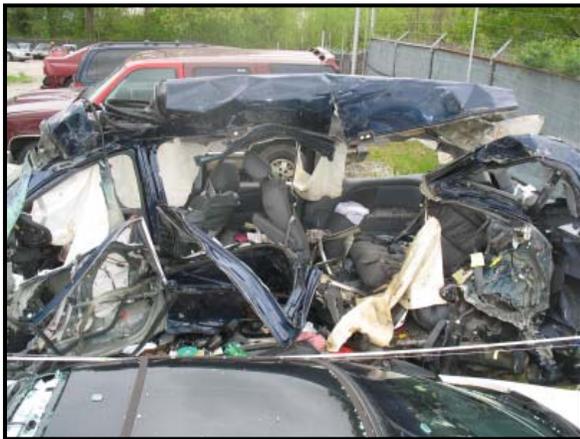
The left side plane, right side plane and top plane of the Honda Odyssey were damaged in the multiple event crash sequence. The left side sustained severe damage as a result of the impact with the front of the Freightliner. Refer to **Figures 8 and 9**. The direct contact damage began on the left fender 5 cm (2 in) forward of the front axle and extended 391 cm (154 in) to the D-pillar area. The Field L measured 432 cm (170 in) and began 46 cm forward of the axle. The left doors and B-pillar were crushed inboard to the approximate centerline of the vehicle resulting in extensive damage. The front door hinges were intact and still attached to the left A-pillar. The

front door striker remained engaged at the B-pillar. The forward aspect of the left rear door remained engaged with the B-pillar. The left side structure separated from the rear aspect of the door at the C-pillar area. This section of the left side peeled rearward and overlapped the D-pillar area. The left rear wheel and suspension separated during the impact. The residual crush profile of the left side measured at the mid door elevation was as follows: C1 = 3 cm (1.3 in), C2 = 50 cm (19.7 in), C3 = 87 cm (34.3 in), C4 = 87 cm (34.3 in), C5 = 18 cm (7.0 in), C6 = 5 cm (2.0 in). The maximum crush was located at the left B-pillar (between C3 and C4) and measured 106 cm (41.7 in). The Door Sill Differential (DSD) was 86 cm (34 in). The elevation of the maximum crush was approximately 102 cm (40 in). This elevation was consistent with the bumper height of the Freightliner. The left roof rail deformed laterally and buckled the roof into an inverted U-pattern along its entire length. The Collision Deformation Classification (CDC) of this impact was 09-LDAW5.

Figure 8: Overall left side view.

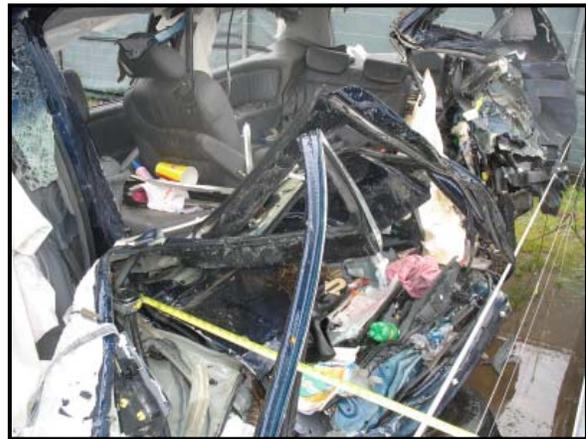
Figure 9: Left oblique view of the maximum crush at the B-pillar.

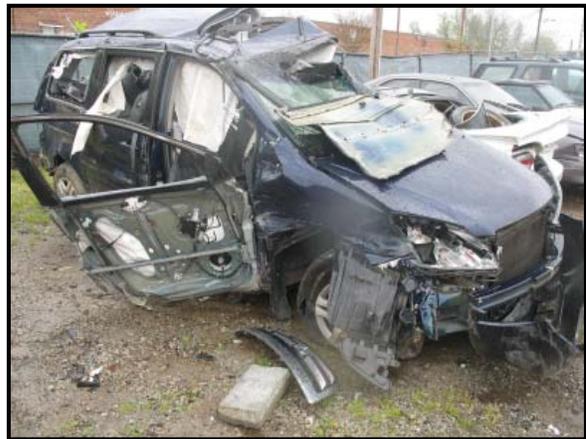
The entire right side of the Honda sustained direct contact damage attributed to the impact with the W-beam guardrail. The direct damage began at the right front corner in the area of the headlamp and extended to the D-pillar. The elevation of the damage was approximately 81 to 91 cm (32 to 36 in) above the ground consistent with the height of the guardrail. The maximum crush within the direct damage was an estimated 5 cm (2 in). The right front door was open at the time of the SCI inspection and could not be latched closed due to body deformation. There was no measurable change in the right wheelbase. The CDC of the guardrail impact was 03-RDEW1.

Figure 10: Front right oblique view of the Honda.

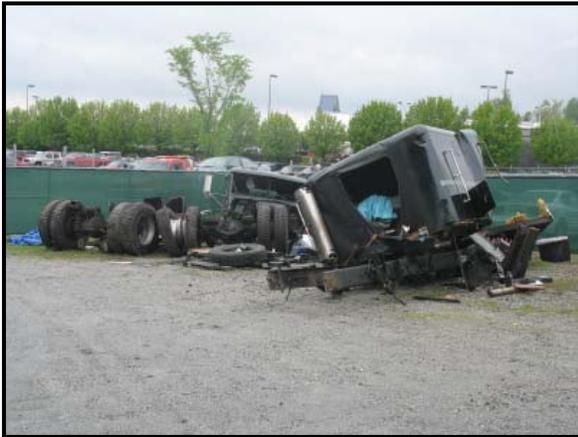
The Freightliner tractor sustained catastrophic damage as a result of the impact with the center barrier (**Figures 11 and 12**). The loaded trailer remained engaged with the tractor's fifth wheel through the crash sequence. The trailer had to be cut open and separated from the fifth wheel post-crash. Its contents were manually unloaded.

The components of the tractor were spread out over a 56 square meter (600 ft²) area. Only the sleeper compartment was still attached to the frame. The aluminum cab of the tractor was intact but had separated. All the tractor's axles had separated from the frame at their respective mounting points.

Figure 11: View of the damaged Freightliner.

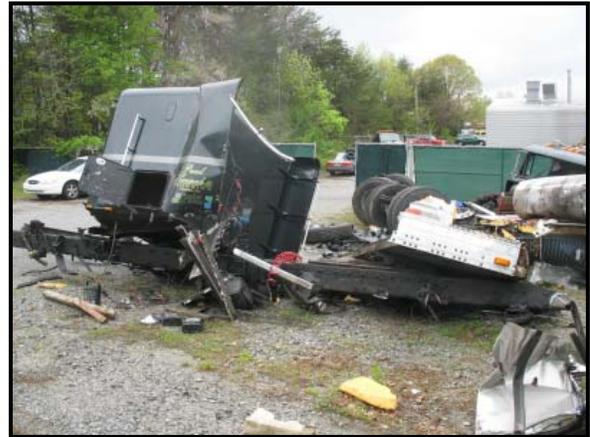
Figure 12: Left side view of the sleeper and 5th wheel.

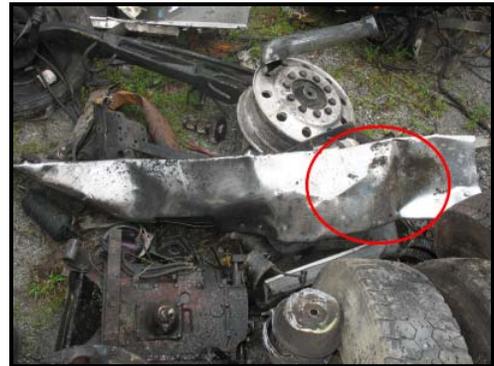
The left aspect of the Freightliner's front bumper exhibited a blue paint transfer indicative of the impact with the Honda. The transfer measured 25 cm (10 in) in width and began 70 cm (27.5 in) left of center. Refer to **Figure 13**. The bumper measured 244 cm (96 in) in width and had sustained overlapping damage during its impact with the center barrier. The Truck Deformation Classification (TDC) was 12-FDEWA.

Figure 13: Paint transfer to the Freightliner's front bumper.

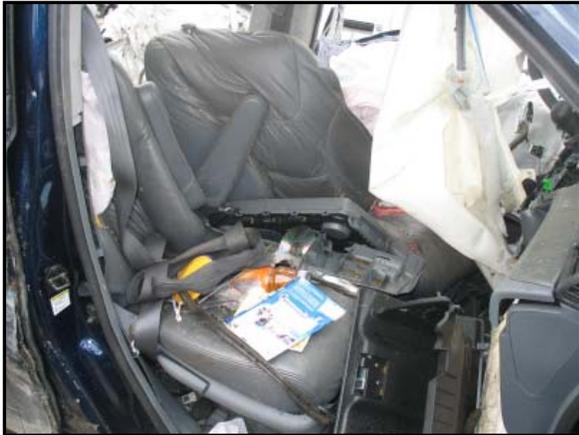
The Honda Odyssey sustained severe left side intrusion in rows one and two as a result of the impact. The driver seat was laterally compressed, forced over the center console and into the front right position. The front right seat was also laterally compressed 20 cm (8 in) and deformed. The outboard aspect of the front right seat was in contact with the right B-pillar and front door panel. The lower rear aspect front right door panel was fractured from contact with the front right seat. The center aspect of the door panel was scuffed at the arm rest elevation and immediately below the window sill as a result of contact with the right flank of the passenger. An 18 cm x 13 cm (7 in x 5 in) area of body fluid was

noted on the back side of the front right head restraint. This transfer resulted due to a probable contact from the second row left passenger. **Figure 14** is a right view of the front interior.

Figure 14: Interior view of front row.

and jammed in the D-ring from occupant loading. The latch plate was still buckled in the receiver that was attached to the inboard aspect of the seat. Refer to **Figure 14** above. At the latch plate, the webbing was shredded and frayed due to occupant loading. The second row left passenger was restrained at the time of the crash based on the observations of the SCI inspection.

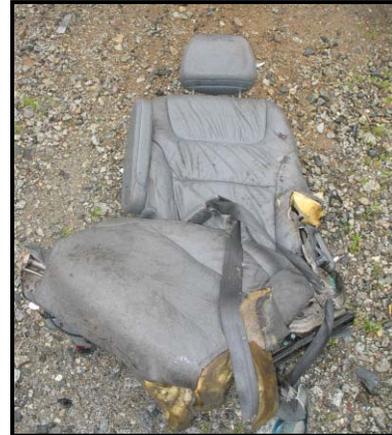
The second row left seat position was eliminated by the force of the impact and had disengaged from the floor. The seat was found loose within the interior, **Figure 15**. The safety belt was still latched to the receiver; the sheet metal surrounding the safety belt's outboard floor anchor had torn away from the floor pan. The second row right seat was not damaged.

Figure 15: Second row left seat.

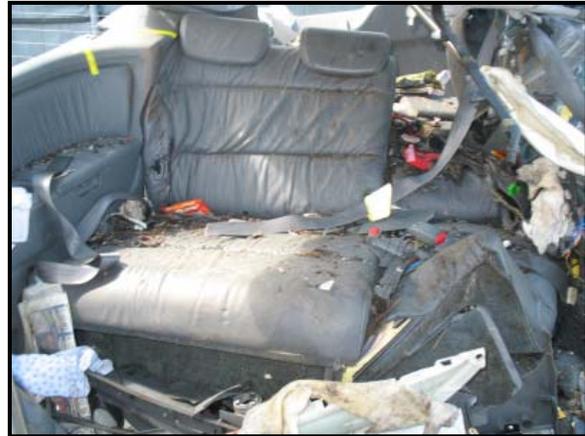
The third row of the Honda is depicted in **Figure 16**. The center and right aspects of the 60/40 split bench seat were (relatively) undamaged. The seat back angle measured 30 degrees rearward of vertical. The right aspect of the right side panel exhibited evidence of contact from the child safety seat. A beige colored transfer was noted at the junction of the seat back and the side panel.

Figure 16: Third row seat.

The forward 15 cm (6 in) portion of the left seat cushion was deformed vertically 13 to 15 cm (5 to 6 in). The seat back was forced rearward and measured 80 degrees. The seat back was jammed in this position due to the deformation and intrusion of the left side panel.

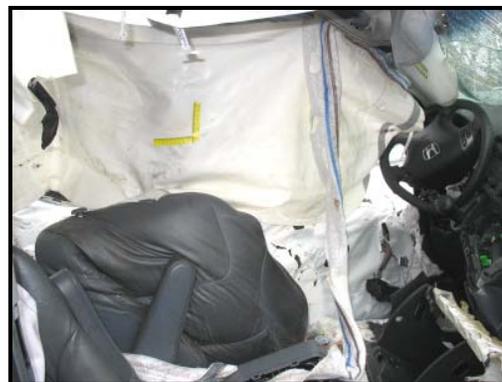
The inflatable side curtains deployed vertically downward during the crash and provided coverage across the side windows from the roof rail to the beltline. In overall dimensions, the curtain measured approximately 282 cm x 51 cm (111 in x 20 in). The left curtain was torn in two pieces at its mid-aspect due to intrusion. A possible contact from the driver's head was identified on the curtain in the area of the deformed left B-pillar. The contact measured 9 cm x 9 cm (3.5 in x 3.5 in) and was located 81 cm (32 in) aft of the curtain's forward edge and 23 cm (9 in) below the roof rail (**Figure 17**). An 18 cm x 15 cm (7 in x 6 in) beige colored area on the extreme lower rear aspect of the curtain was identified as a possible

Figure 17: Possible driver contact to the left curtain.

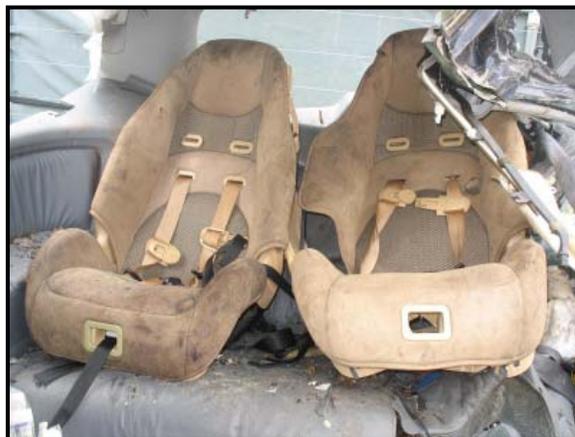
The two year old fraternal twins were restrained in the third row of the Honda within identical Cosco Commuter Ventura Child Safety Seats (CSS), Model No: 22-209-RDO (**Figure 18**). The left seat was manufactured in 12/29/05 and identified by Serial No: B258886. The right seat was manufactured in 12/20/05 with Serial No: B232893. The seats were designed to be used either as a forward facing seat utilizing the five-point harness or as a belt positioning booster seat with the harness removed. In the forward facing mode, the seats were rated for use by children that weighed between 10 to 18 kg (22 to 40 lb) with a height of 86 to 110 cm (34 to 43 in). As a booster seat, the CSS was rated for children that weighed 18 to 36 kg (40 to 80 lb) with a height of 110 cm to 132 cm (43 to 52 in). At the time of the crash, the CSS were secured within the Honda by the use of the vehicle's three-point lap and shoulder belt that was routed through the forward facing belt path. The children were restrained by the seat's five-point harness system. The CSS's were equipped with a lower anchor strap and a tether compatible with the Lower Anchors and Tethers for Children (LATCH) system. Both seats were found lying randomly within the vehicle at the time of the SCI inspection.

Figure 18: View of the third row child safety seats.

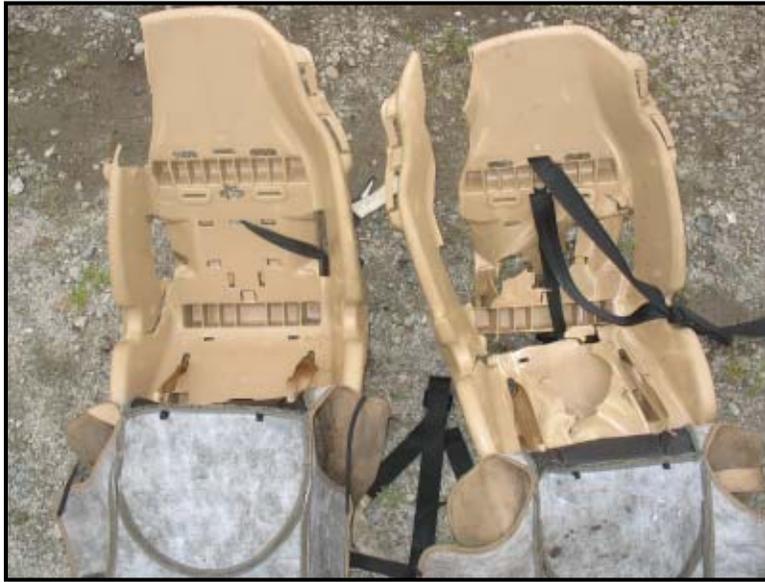
The harness straps of left CSS were routed through the lowest slots. Both straps were twisted. The chest retainer clip was present and operational. Inspection of the CSS revealed that the shell completely fractured due to its interaction with the intruding left side panel. Refer to **Figures 19 and 20** below. The shell was highly stressed and fractured along the right side, through the back, and across the base. The shell surrounding the harness strap adjuster, at the forward aspect of the base, fractured and adjuster was free. The tether strap and lower anchor strap were attached to the seat. Neither strap appeared to have been in use at the time of the crash.

The harness straps of the right seat were routed through the lowest slots. The left strap was twisted a single run. The strap had roped and was jammed in the left crotch clip. The right crotch clip was free. The chest retainer clip was in place and operational. The right side of the shell was fractured along the length of the back rest. Refer to **Figure 21**. The fracture resulted from its contact with the vehicle's right side panel. The lower anchors strap was attached to the seat. The tether strap had been removed from the seat for unknown reasons. It was found within the area of the third row.

Figure 19: View of the fractured child safety seats.

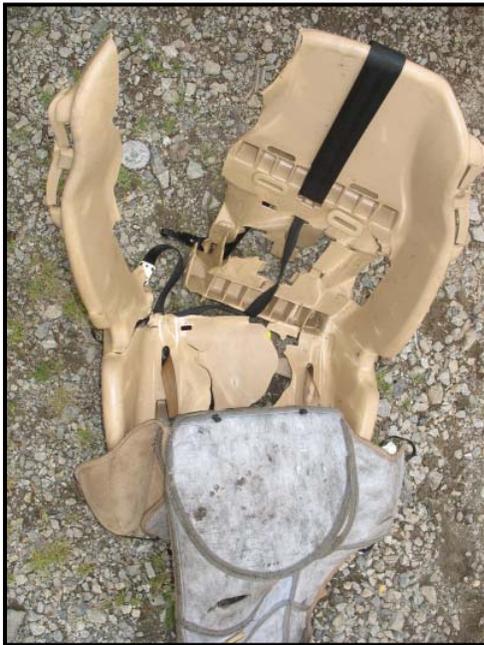
Figure 20: View of the complete fracturing of the right CSS.

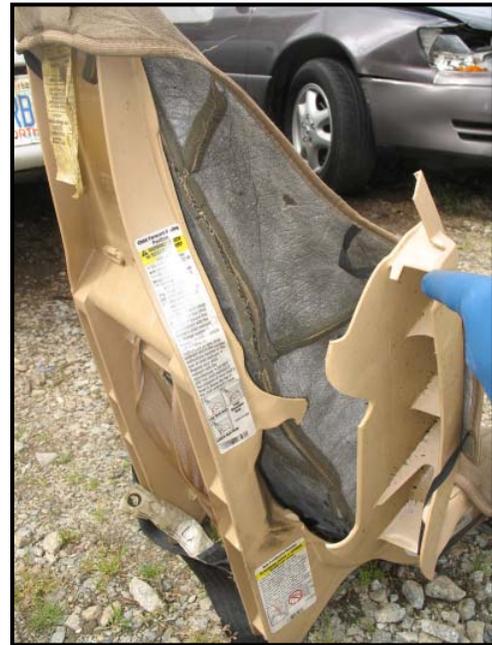
Figure 21: View of the right outboard fracture of the left CSS.
