## **ON-SITE CERTIFIED ADVANCED 208-COMPLIANT VEHICLE INVESTIGATION**

CASE NUMBER - IN08016  
LOCATION - NEBRASKA  
VEHICLE - 2004 MAZDA 6  
CRASH DATE - February 2008

1. <i>Report No.</i> IN08016		2. <i>Government Accession No.</i>		3. <i>Recipient's Catalog No.</i>	
4. <i>Title and Subtitle</i> On-Site Certified 208-Compliant Vehicle Investigation Vehicle - 2004 Mazda 3 Location - Nebraska			5. <i>Report Date:</i> February 5, 2009

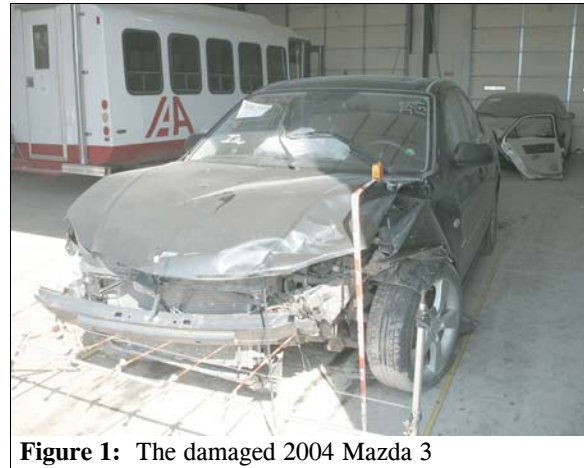
This crash was brought to the National Highway Traffic Safety Administration's attention on April 4, 2008 by the sampling activities of the National Automotive Sampling System-General Estimates System. This on-site investigation was assigned on April 10, 2008. The crash involved a 2004 Mazda 3 (**Figure 1**) and a 1991 Dodge Daytona, and occurred in February, 2008 at 1249 hours in Nebraska and was investigated by the applicable city police department. The focus of this on-site investigation was on the Mazda, which was certified by the manufacturer to be compliant to the Advanced Air Bag portion of the Federal Motor Vehicle Safety Standard (FMVSS) No. 208. This contractor inspected the crash scene and the Mazda on April 15-16, 2008. No interview was conducted with the Mazda's driver because she could not be contacted. The Dodge was sold at auction and was not available for inspection. This report is based on the police crash report, crash scene and vehicle inspections, occupant kinematic principles, and this contractor's evaluation of the evidence.

**Figure 1:** The damaged 2004 Mazda 3

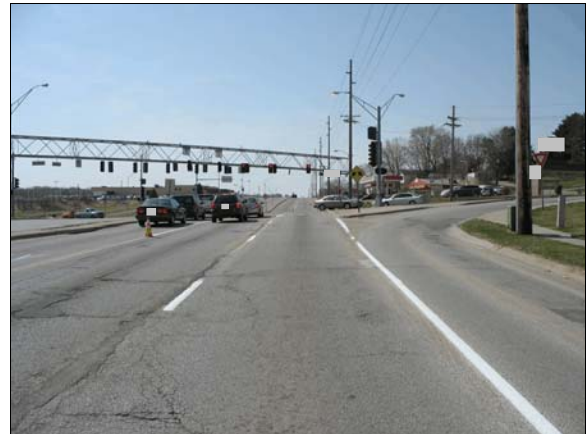
**Pre-Crash:** The Mazda was occupied by a restrained 28-year-old female driver, an unrestrained (unknown age and sex) front right passenger, and a restrained (unknown age and sex) second row left passenger. The driver was traveling south in the right through lane (**Figure 2**) approaching the intersection and intended to continue south. The Dodge was being driven by a restrained 20-year-old male driver. The driver was traveling north in the left turn/through lane and intended to turn left and proceed west. It is not known if the Mazda's driver made any avoidance maneuvers prior to the crash, which occurred within the intersection.

**Figure 2:** Approach of Mazda southbound to intersection in right through lane

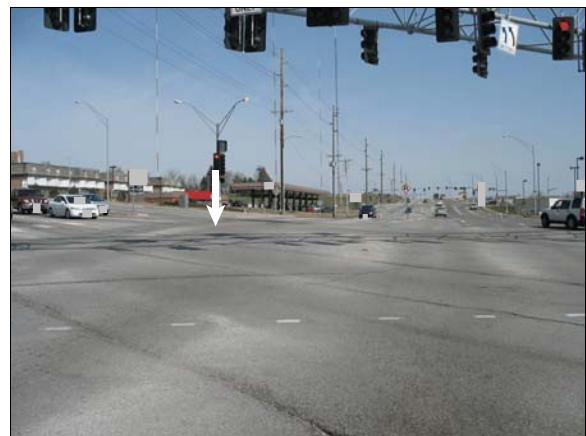
**Crash:** As the Dodge's driver was proceeding with the left turn (**Figure 3**), the front left of the Mazda (**Figure 4**) impacted the front of the Dodge. The Mazda's direction of principal force was within the 11 o'clock sector and the impact force was sufficient to trigger a deployment of the Mazda's driver and front right passenger air bags. The police crash report indicated that the Dodge's driver air bag also deployed. Both vehicles came to final rest within the intersection with the Mazda heading southwest and the Dodge heading northwest.

**Figure 3:** Dodge in left turn approaching area of impact (arrow)

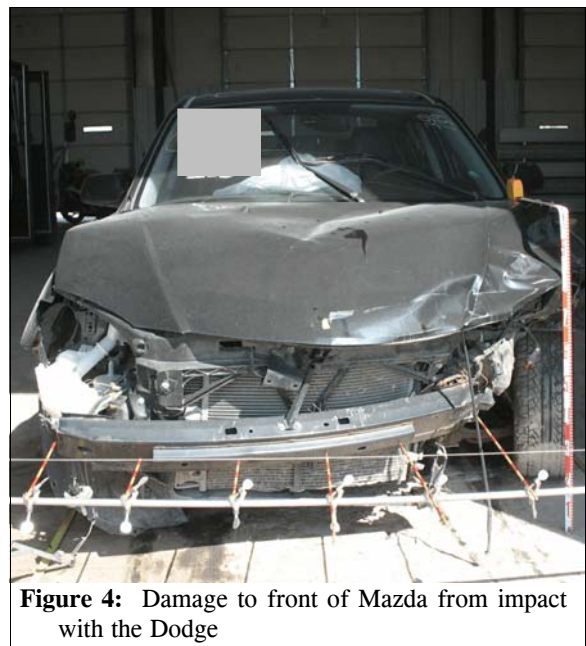
**Figure 4:** Damage to front of Mazda from impact with the Dodge

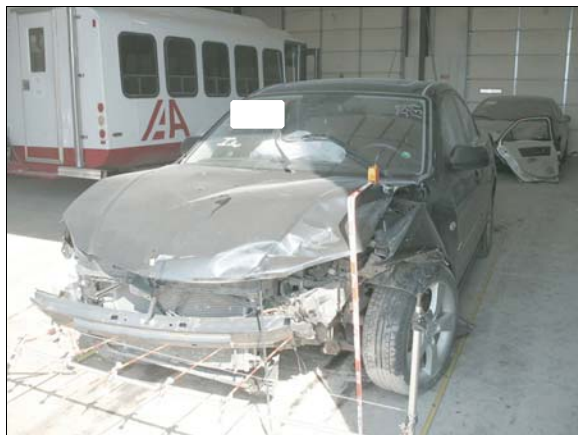
**Exterior Damage:** The Mazda’s impact with the Dodge involved the front plane. The front bumper, bumper fascia, grille, hood, left headlamp/turn lamp assembly, and the left fender were directly damaged (**Figure 5**). The direct damage began at the front left bumper corner and extended 56 cm (22.0 in) across the front bumper. The maximum residual crush was 26 cm (10.2 in) and occurred at C<sub>1</sub> (**Figure 6**). The table below shows the vehicle’s front crush profile.

The Mazda’s left side wheelbase was reduced 9 cm (3.5 in) while the right side wheelbase was extended 1 cm (0.4 in). Induced damage involved the hood, both fenders, and the right headlamp/turn lamp assembly.

**Figure 5:** The damage to the front of the Mazda

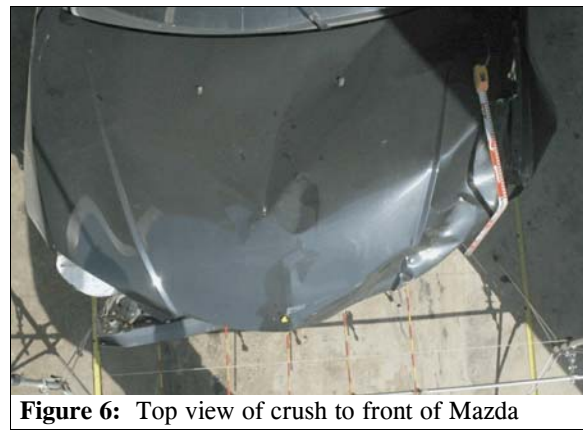
**Figure 6:** Top view of crush to front of Mazda

**Damage Classification** The Mazda’s Collision Deformation Classification was **11-FYEW-2 (340 degrees)**. The Missing Vehicle algorithm of the WinSMASH program calculated the vehicle’s total Delta V for the front impact as 41 km/h (25.5 mph). The longitudinal and lateral velocity changes were -38.5 km/h (-23.9 mph), and 14.0 km/h (8.7 mph). The results are considered borderline because they are based only on the Mazda’s crush profile.

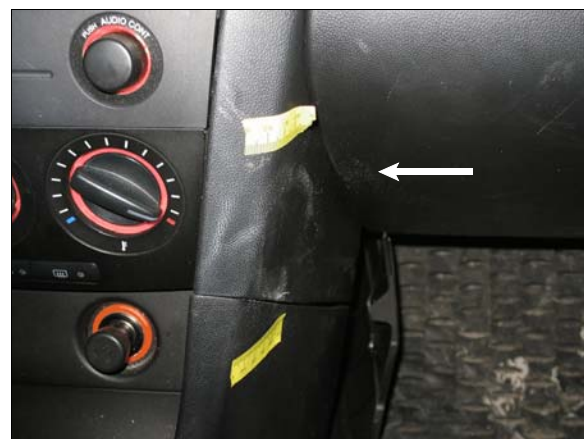
**Vehicle Interior:** The inspection of the Mazda's interior revealed occupant contact evidence on the right side of the center console and adjacent glove box door (**Figure 7**) due to contact by the front right passengers left knee. A scuff mark was also located on the left roof side rail. There was no deformation of the steering wheel rim or compression of the energy absorbing steering column, and all the doors remained closed and operational. All the window glazing was either fixed or closed and there was no glazing damage due to impact forces or occupant contact. No passenger compartment intrusions were observed.

**Figure 7:** Front right passenger contact to center console and edge of glove box door (arrow)

The Mazda's impact with the Dodge deployed the front right air bag and displaced the front right passenger forward and to the left opposite the 11 o'clock direction of principal force. The passenger's left knee loaded the left edge of the glove box door and the center console. There was no discernable occupant contact on the front right passenger air bag, but the passenger's face and chest probably loaded the air bag.

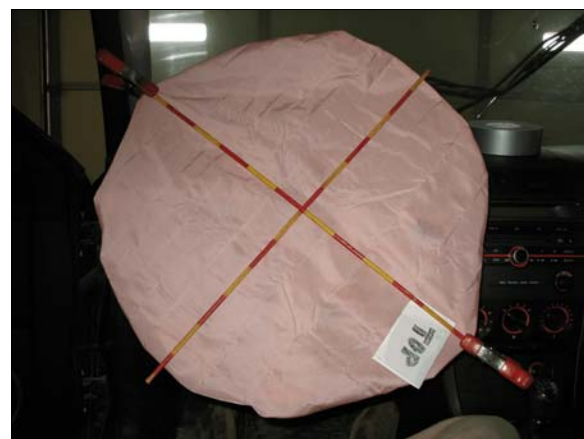
**Figure 8:** Mazda's deployed driver air bag

The driver's air bag was located within the steering wheel hub and the air bag module cover was a 2-flap configuration. The cover flaps were constructed of pliable vinyl and had a horizontal tear seam. The cover flaps opened at the designated tear points and there was no damage to the flaps or the air bag. The deployed driver's air bag (**Figure 8**) was round with a diameter of 59

cm (23 in) and had two vent ports located on the back on the air bag at the 11 and 1 clock positions. There was no discernable evidence of occupant contact on the air bag.

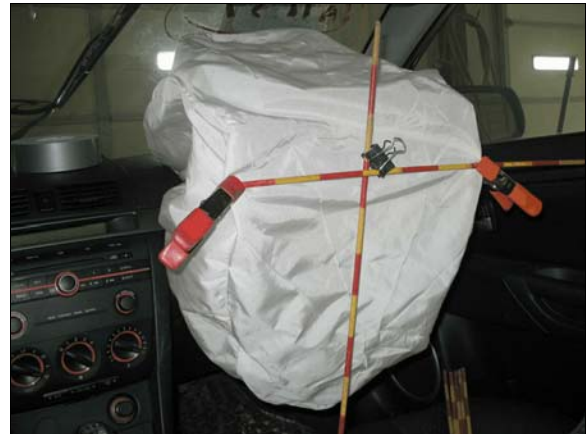
The front right passenger air bag was located within the top of the instrument panel. The air bag module cover consisted of a single cover flap that was 25 cm (9.8 in) in width and 13 cm (5.1 in) in height. The cover flap opened at the designated tear points and there was no damage to the cover flap or the air bag. The deployed front right passenger's air bag (**Figure 9**) was rectangular with a width of 33 cm (13 in) and a height of 48 cm (19 in). It had one vent port located on each side of the air bag. There was no discernable evidence of occupant contact on the air bag.

**Figure 9:** Mazda's deployed front right passenger air bag

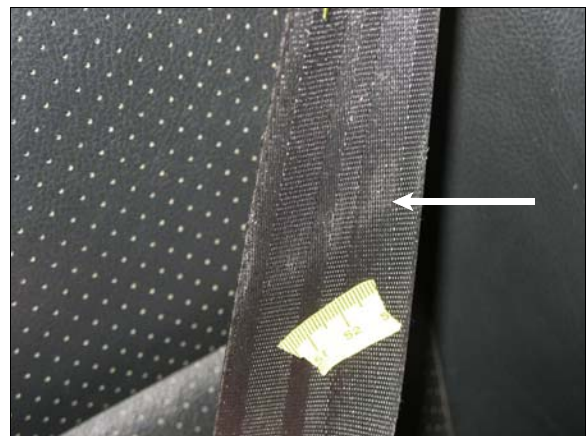
**Figure 10:** Arrow shows load mark abrasion on the Mazda driver's seat belt

The inspection of the driver's seat belt assembly revealed load abrasions on the belt webbing from the D-ring (**Figure 10**), and that the pretensioner actuated during the crash (**Figure 11**). The pretensioner distance had been reduced 7 cm as a result of the actuation. The evidence indicated that the driver was restrained in this crash.

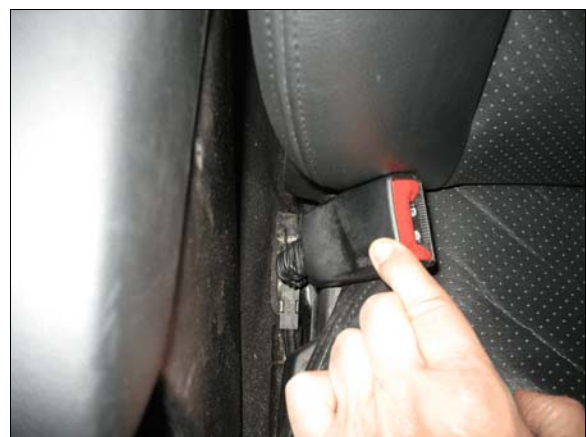
**Figure 11** Mazda driver's buckle mounted pretensioner actuated in the crash

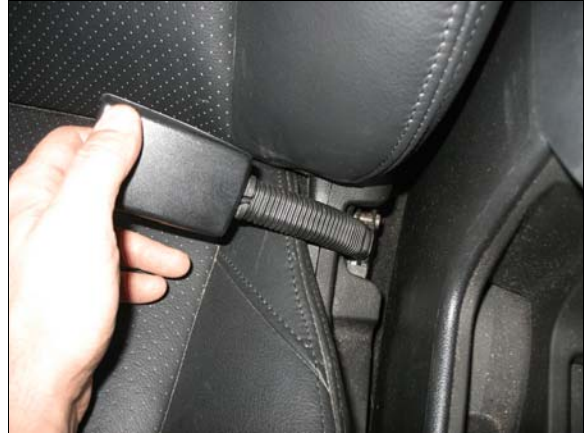
**Figure 12:** Mazda's front right passenger buckle-mounted pretensioner did not actuate in the crash

Inspection of the front right seat belt assembly revealed no evidence of loading and the pretensioner did not actuate (**Figure 12**). The evidence indicated that the front right passenger was not restrained in this crash.
