**CALSPAN ON-SITE CHILD RESTRAINT SYSTEM CRASH INVESTIGATION**

**SCI CASE NO.: CA08017**

**VEHICLE: 1995 SATURN SL1**

**CRASH DATE: APRIL 2008**

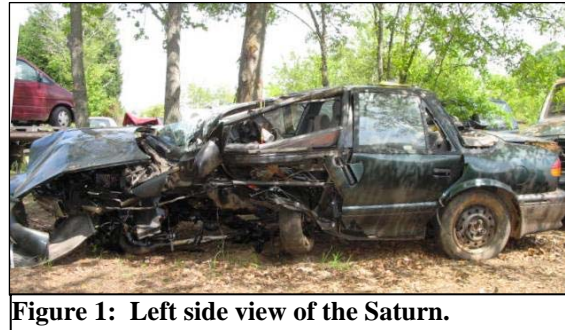
**Figure 1: Left side view of the Saturn.**

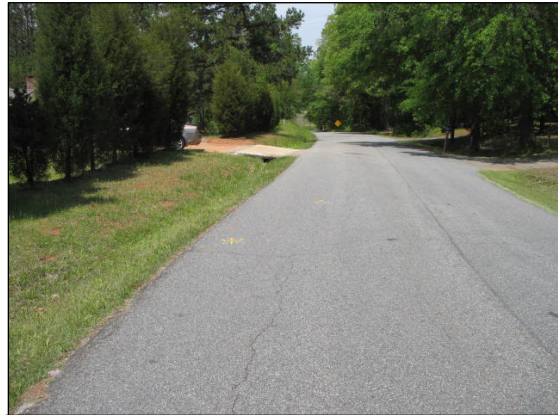
**Figure 2** is a northbound trajectory view of the Saturn. The road was not painted with lane lines or edge markings. In the vicinity of the crash site, the road curved right and then left forming a lazy S-curve for northbound traffic. The road grade was negative for northbound travel with a slope of -3.5 percent for the initial approach, -2.5 percent at the point of impact, and -3 percent at the location of final rest. The posted speed limit was 56 km/h (35 mph).

**Figure 2: Northbound trajectory view of the Saturn.**

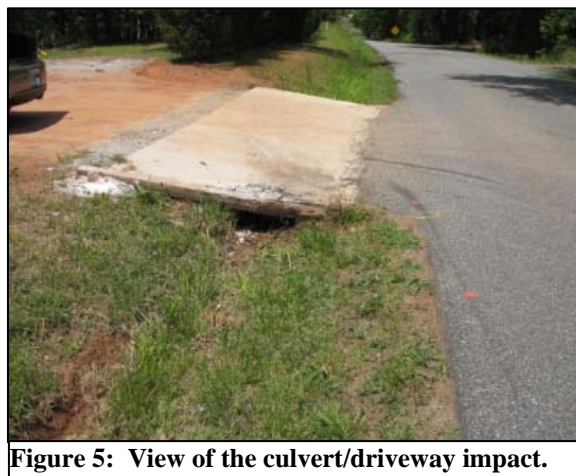
The front left area of the Saturn impacted the concrete slab and the culvert of the private driveway (**Figure 5**). As the front corner area crushed rearward, the left front tire and wheel engaged the culvert, displacing the left front axle position rearward. This initial impact resulted in a 12 o'clock direction of force. The offset engagement, coupled with the vehicle's forward momentum, reversed the vehicle's rotation from CW to counterclockwise (CCW). During the rapid rotation, the Saturn initiated a right side leading rollover sequence.

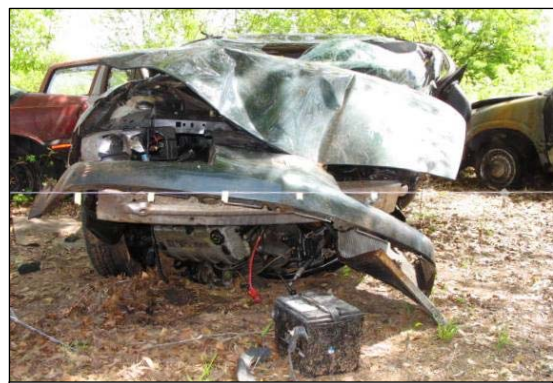
The Saturn sustained severe frontal damage from the initial culvert impact, undercarriage damage from engagement with the culvert, and moderate damage to the remaining planes from the rollover sequence. **Figure 6** is a frontal view of the damage to the Saturn. The bumper fascia was separated from the vehicle and was missing at the time of the inspection. The direct contact damage was estimated at 25 cm (10 in) in width originating at

**Figure 6: Frontal damage to the Saturn.**

the left bumper corner and extending inboard. The initial culvert impact deformed the full-width of the bumper beam, resulting in damage length of 102 cm (40 in). The maximum crush at mid-bumper level was 53 cm (21 in). A crush profile documented at the bumper beam produced the following measurements: C1 = 53 cm (20.9 in), C2 = 35 cm (13.8 in), C3 = 27 cm (10.6 in), C4 = 18 cm (7.1 in), C5 = 13 cm (5.1 in), C6 = 12 cm (4.7 in). The Collision Deformation Classification (CDC) was 12FLLE8.

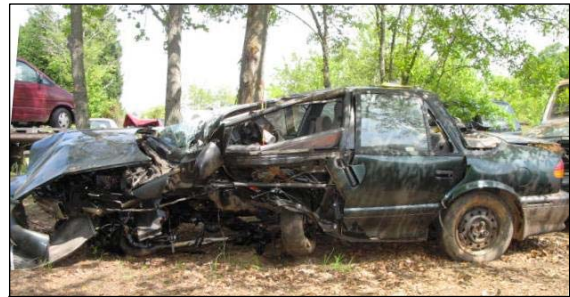
Damage from the engagement with the culvert extended through the front undercarriage of the vehicle. There was severe deformation to the structure of the engine compartment, which resulted in the separation of the engine and transmission from the vehicle. The left front axle position was displaced rearward, resulting in separation of the drive axle, suspension, and steering systems. The left front tire and wheel were displaced rearward to the location of the left B-pillar, as seen in **Figure 7**. This resulted in the corresponding longitudinal and vertical displacement of the left toe and floor pans, causing interior intrusions.

**Figure 7: Left side view of the Saturn.**

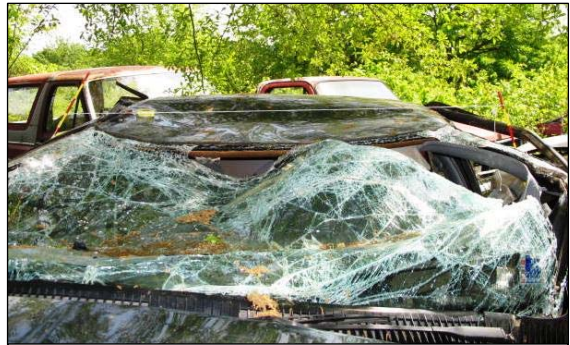
The most severe damage associated with the rollover was identified to the top plane of the vehicle as seen in **Figure 8**. The direct contact damage was 114 cm (45 in) and extended across the full-width of the windshield header. The maximum roof crush was crush 10 cm (3.9 in), located at the right A-pillar. The maximum lateral crush to the greenhouse area was located at the right A-pillar and measured 4 cm (1.5 in). The associated CDC was 00TDDO3.

**Figure 8: Top plane damage from rollover event.**

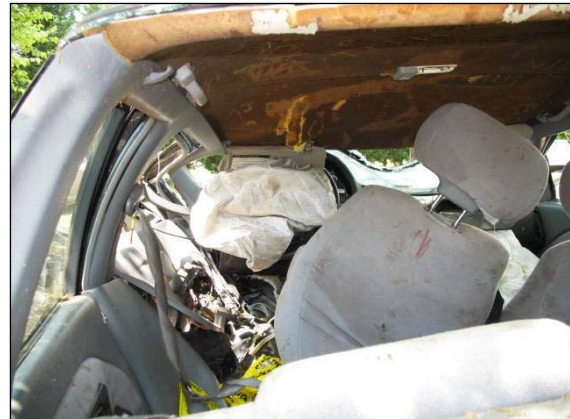
The Saturn sustained moderate severity interior damage that was attributed to passenger compartment intrusion, integrity loss, air bag deployment and occupant contacts. Longitudinal, lateral, and vertical intrusions within the front left seating position’s front, left side, and floor areas occurred during the engagement with the driveway culvert. Vertical intrusion of the top plane occurred during the subsequent rollover sequence. Combined, these intrusions displaced the driver seat at an upward diagonal angle from the area of impact, rotating the seat rearward and right laterally as seen in **Figure 9**.

**Figure 9: Interior view of the Saturn.**

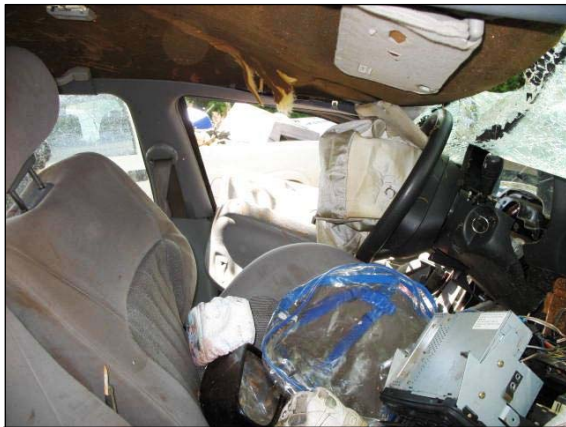
The driver's air bag module consisted of I-configuration cover flaps that were 8 cm (3 in) in width and 14 cm (5.5 in) in height. The internally tethered air bag had a diameter of 61 cm (24 in) in its deflated state. Two 3 cm (1 in) diameter vent ports were located on the back side of the air bag at the 11 and 1 o'clock sectors. Although the undamaged air bag was soiled, the SCI team was unable to identify any direct evidence of contact attributable to the driver. The driver air bag is depicted in **Figure 10**.

**Figure 10: Front left occupant position and deployed driver air bag.**

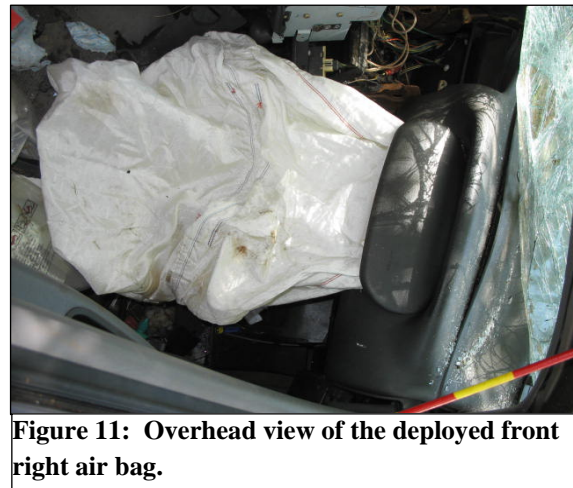
The front right air bag module was concealed by a single top-hinged cover that measured 30 cm (12 in) in width and 11 cm (4.5 in) in height. A mid-mount cover flap was positioned under an integrated brow in the upper instrument panel that limited the upward rotation of the flap. The front right air bag was not tethered or directly vented into the passenger compartment. There was no occupant contact evidence or damage to the front right air bag. The deployed front right air bag is depicted in **Figure 11**.

**Figure 11: Overhead view of the deployed front right air bag.**

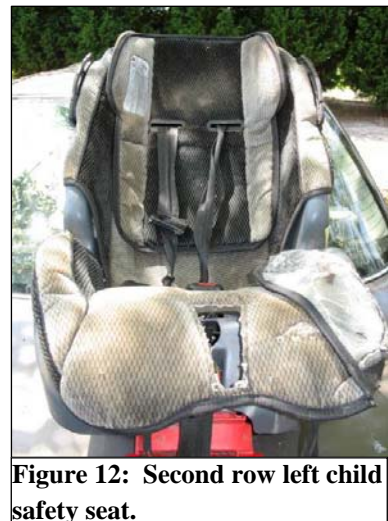
**Figure 12: Second row left child safety seat.**

common center buckle and a chest retainer clip. At the time of SCI inspection, the straps were twisted and creased. Due to the expulsion of body fluid by the child following the crash, the harness straps were stiff. The left half of the chest clip was missing. The harness straps were routed through the second slot from the top of five positioning slots.

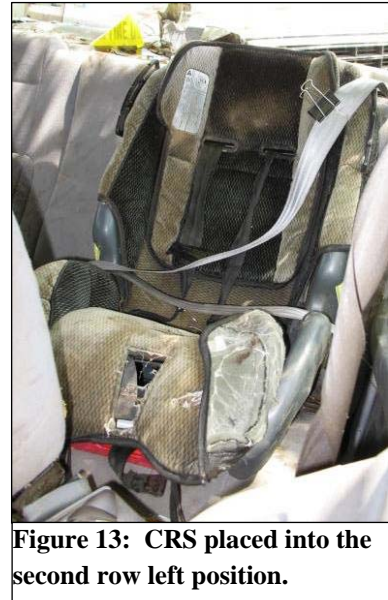
At the time of the crash, the CRS was used in a forward-facing mode with the child restrained by the internal harness. The CRS was secured to the second row left position by the vehicle's lap and shoulder belt. The lap belt was routed through the rear-facing belt path at the forward aspect of the CRS. The rear facing belt path should not be used when the CRS is in a forward facing position. **Figure 13** is a view of the CRS placed into the second row left position of the Saturn.

**Figure 13: CRS placed into the second row left position.**

Damage to the CRS consisted of abrasions to the lateral surfaces of the rear-facing belt path from frictional engagement with the vehicle's lap belt webbing. The lower left corner of the CRS shell was scuffed and deformed from possible contact with the driver seat back. This damage was primarily attributed to ground contact outside the vehicle during the handling of the CRS.

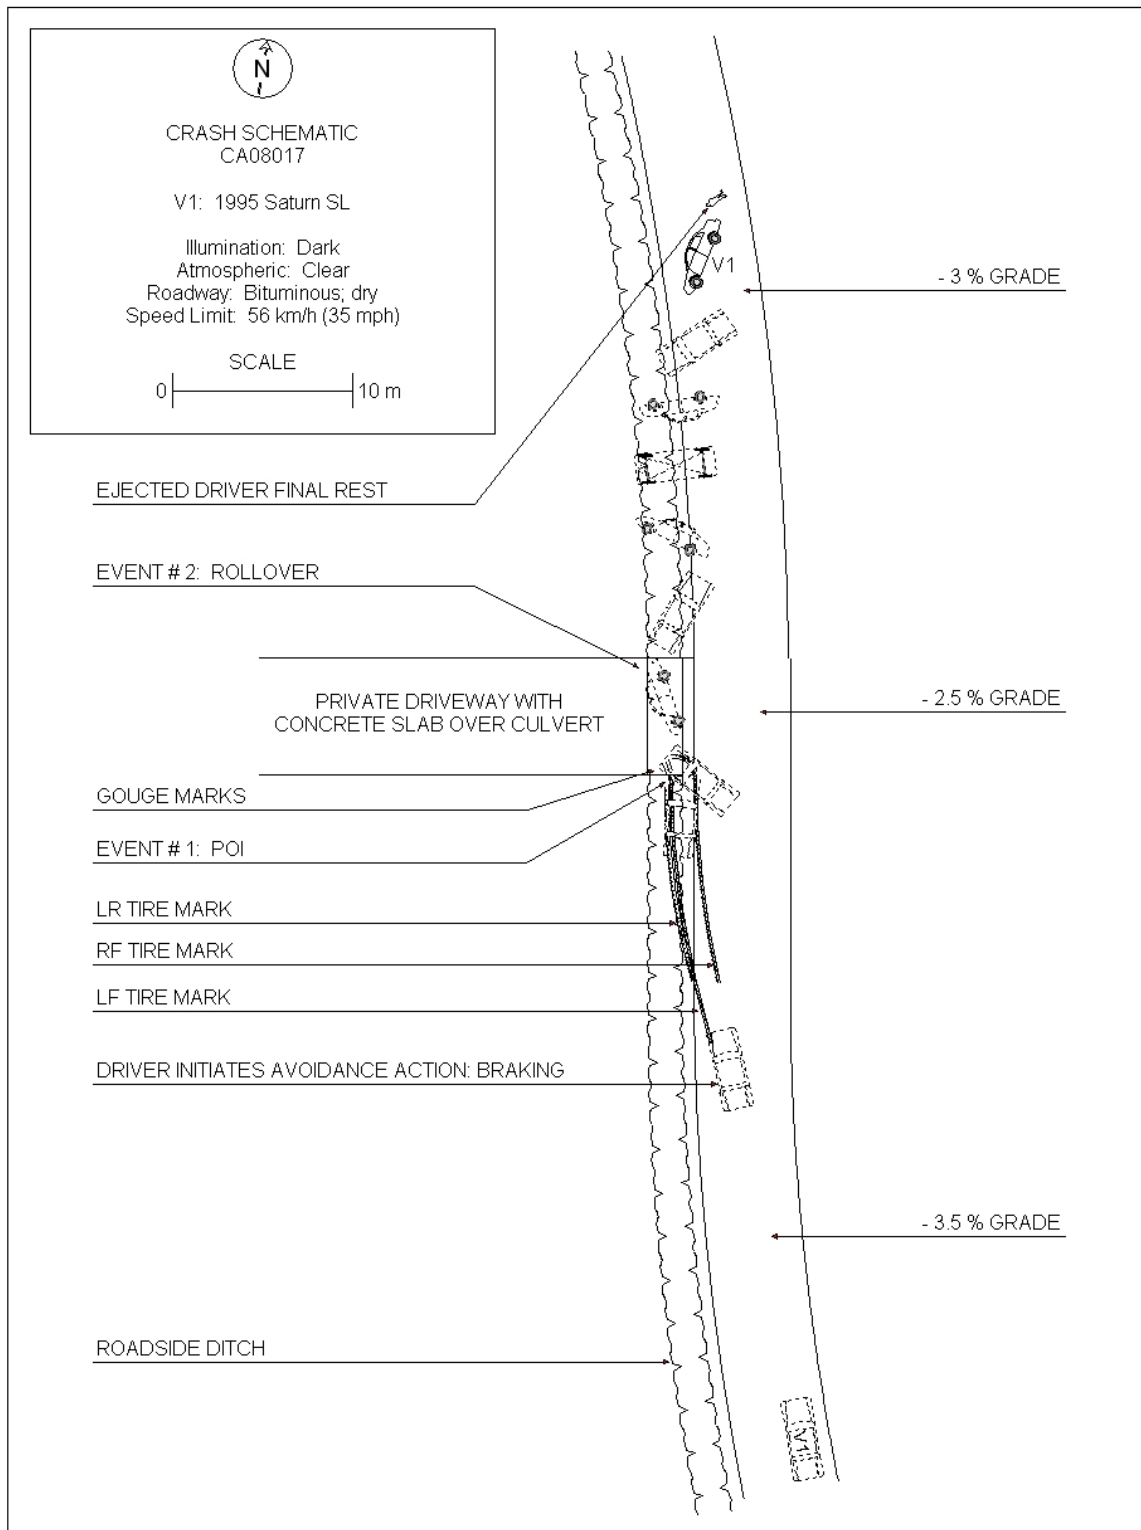
**Figure 14:** Crash schematic.

The road sides consisted of residential driveways with lawns extending to the road edges; there were no shoulders. A shallow drainage ditch paralleled the west (left) roadside with the centerline of the ditch located 1.3 m (4 ft) outboard of the pavement edge. Culverts extended under the driveways. The struck driveway culvert consisted of a 30 cm (12 in) diameter steel corrugated pipe with a 15x15 cm (6x6 in) timber positioned on the top of the culvert. A concrete driveway apron that was 2 m (6.5 ft) in width and 6.5 m (21 ft) in length transitioned the roadway to the residential driveway. Located north of the driveway, the ditch bank was approximately 1 m (3 ft) in height due to a change in the grade for the residence. The crash schematic is attached as **Figure 14**.
