ON-SITE ROLLOVER INVESTIGATION

CASE NUMBER - IN08018
LOCATION - MICHIGAN
VEHICLE - 2007 SUBARU FORESTER
CRASH DATE - January 2008

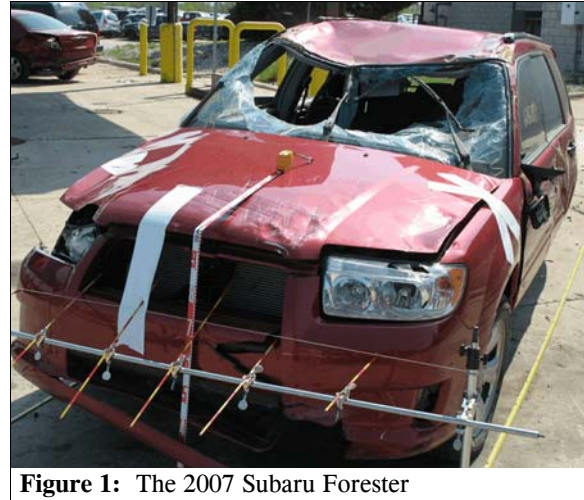
Figure 1: The 2007 Subaru Forester

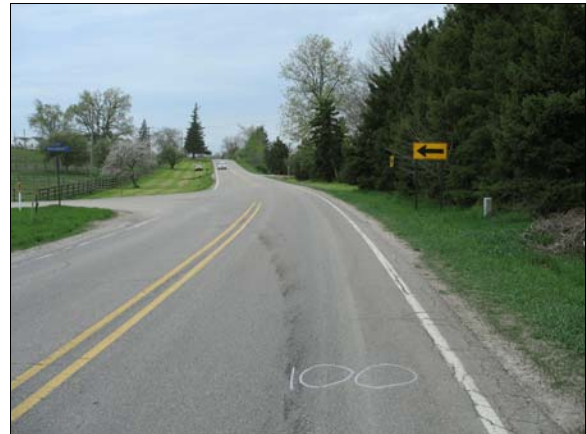
Pre-Crash: The Subaru was traveling west (Figure 2) at a driver estimated speed of 88 to 97 km/h (55 to 60 mph). The driver was intending to continue westbound and was negotiating a left curve. The driver stated during the interview that as the vehicle exited the curve, it contacted a patch of ice and began to rotate counterclockwise. The driver steered right and the vehicle began rotating clockwise and departed the north side of the road (Figure 3) where the crash occurred.

Figure 2: Subaru's approach to crash scene; number on roadway indicates meters to impact area

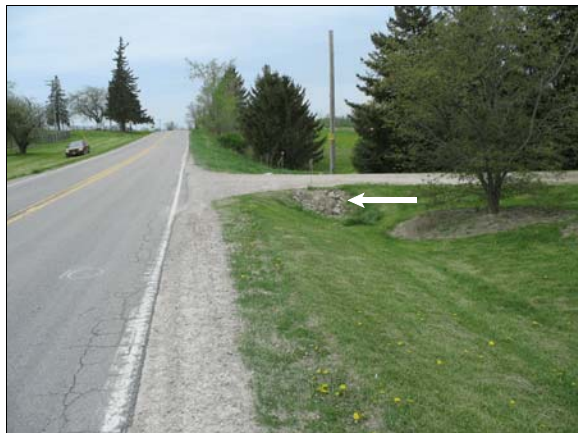
Crash: The Subaru entered a ditch and the front plane (Figure 4) impacted a culvert. The left front wheel loaded into the embankment and tripped the vehicle, and it rolled over six quarter turns with the left side leading. As the vehicle was on it's top, the back plane (Figure 5) impacted an evergreen tree and it came to final rest heading southeast with the back end against the evergreen tree (Figure 6). The vehicle traversed a distance of 11 meters (36.1 feet) from the area of rollover initiation to final rest.

Figure 3: Arrow shows location of initial impact with culvert and area of rollover initiation

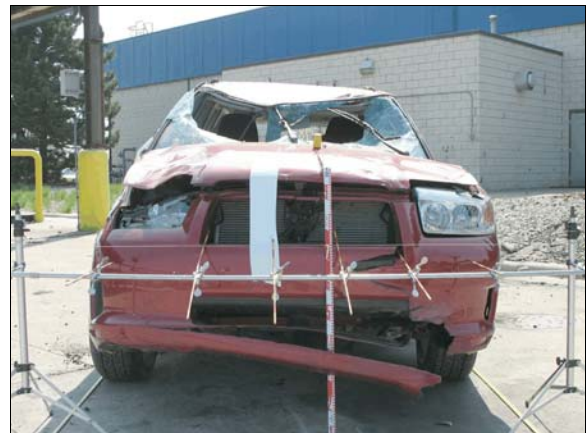
Figure 4: Damage to front of Subaru from impact with the culvert; scale numbers in tenths of meter

Exterior Damage: The Subaru’s impact with the culvert involved the front plane. The vehicle’s plastic bumper cover sustained the direct damage and the underlying bumper bar was crushed rearward. The direct damage began at the left corner of the bumper cover and extended 149 centimeters (58.7 inches) across the lower portion of the bumper cover. The crush measurements were taken on the bumper bar (this is the reason the field L is less than the damage width) and the residual maximum crush was 4 centimeters (1.8 inches) occurring at C₃. The table below presents the vehicle’s front crush profile.

Damage Classification: The Collision Deformation Classifications (CDCs) for the Subaru were **12-FDLW-1** (0 degrees) for the front impact with the culvert, **00-TDDO-3** for the rollover, and **00-BLAN-1** for the back end impact with the evergreen tree. The WinSMASH reconstruction program, Barrier Algorithm was used to reconstruct the Subaru's Delta V for the front impact. The total Delta V was 14.0 km/h (8.7 mph), and the longitudinal and lateral components were

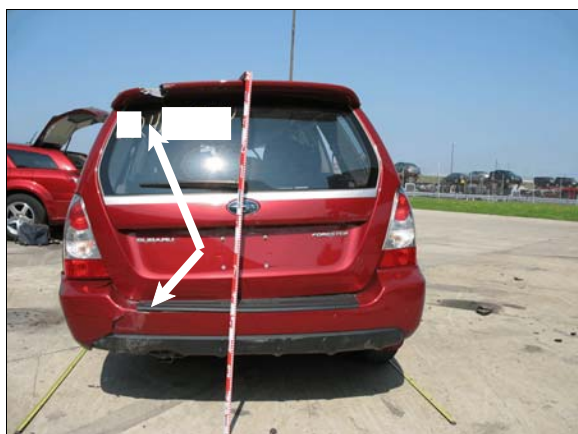
Figure 5: Back end damage from impact with tree (shown by arrows)

The Subaru's impact with the evergreen tree involved the back plane. The direct damage began 24 centimeters (9.4 inches) right of the left rear bumper corner and extended 21 centimeters (8.3 inches) across the back bumper. The maximum residual crush was 2 centimeters occurring at C₂. Only the bumper cover and upper spoiler (above the backlight) were directly damaged. The induced damage involved the back bumper and hatch. The table below presents the back crush profile.

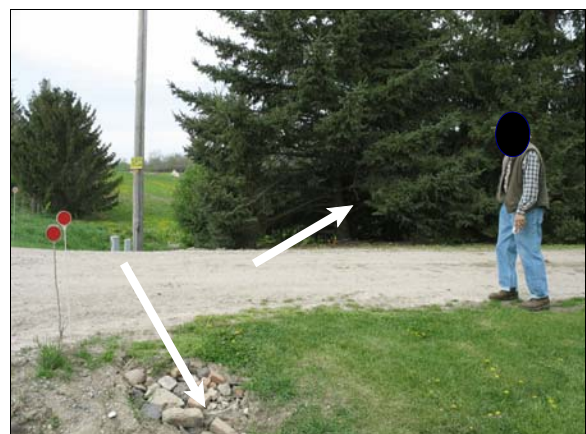
Figure 6: Area of initial impact (left arrow) and final rest (right arrow)

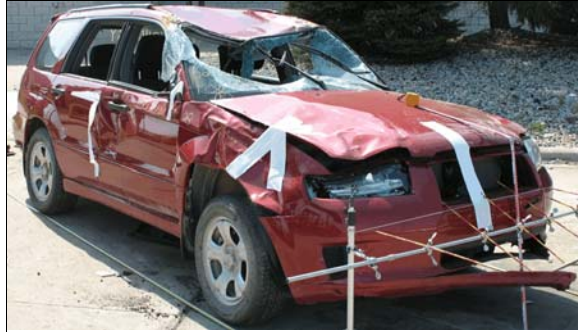
The damage from the rollover involved the top plane and both side planes of the Subaru (Figures 7 and 8). The direct damage on the left side included scratches on the A-pillar, front and back doors, quarter panel and deformation of the left rear wheel and suspension (Figure 9). The direct damage on the right side involved the right fender, A and B-pillars, and the front and back doors. Both left and right side view mirrors were broken off the vehicle and the roof, roof side rails, luggage rack, windshield header, and windshield were also directly damaged. The maximum vertical crush occurred at the right windshield header (Figures 10), and based on the vehicle inspection and measurements from an exemplar vehicle, the crush was 12 centimeters (4.7 inches, Figure 11). There was no measurable lateral crush to the roof side rails or A pillars. The vehicle’s left wheelbase was reduced 25 centimeters (9.8 inches) and the right wheelbase was extended 2 centimeters (0.79 inch).

Figure 7: Front right view of the front damage and damage from the rollover

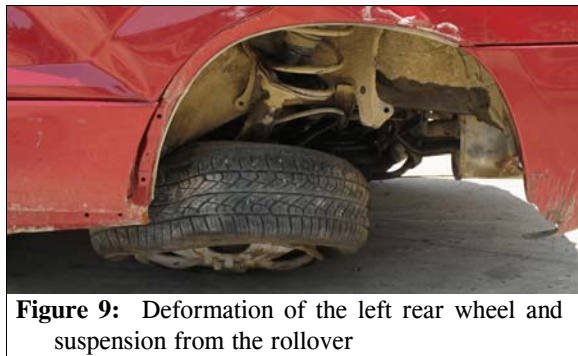
Figure 9: Deformation of the left rear wheel and suspension from the rollover

Tire	Measured Pressure		Vehicle Manufacturer’s Recommended Pressure		Tread Depth		Damage	Restricted	Deflated
	kPa	psi	kPa	psi	milli-meters	32 nd of an inch			
LF	221	32	200	29	6	8	None	No	No
LR	Flat	Flat	200	29	6	8	Bead separation	Yes	Yes
RR	228	33	193	28	6	8	None	No	No
RF	234	34	193	28	6	7	None	No	No

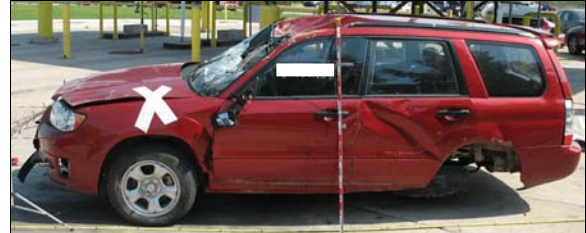
Figure 8: Damage to the left side from the rollover

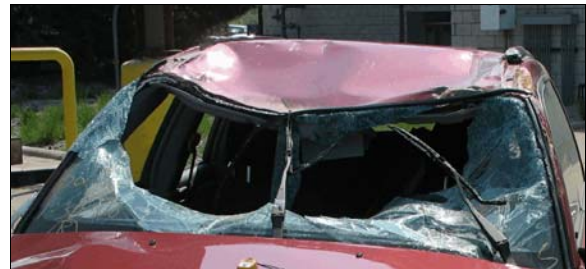
Figure 10: Crush to the windshield header and roof from the rollover

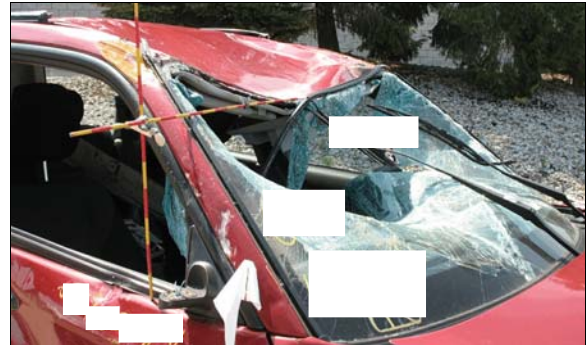
Figure 11: The maximum vertical crush to the windshield header; each increment on rods is 5 cm (2 in)

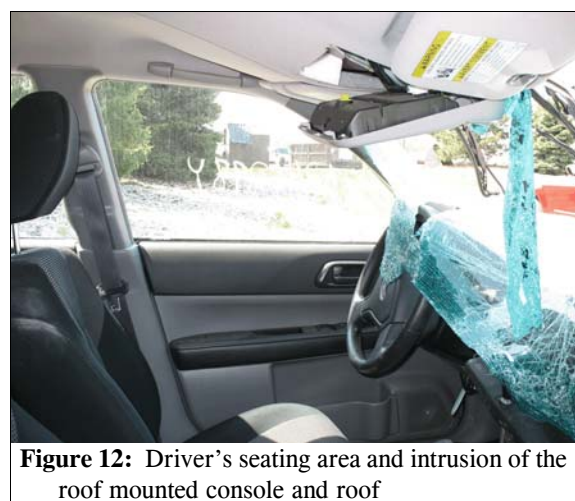
Vehicle Interior: Evidence of occupant contact was found on the wiper control lever, which was broken off the steering column, probably as a result of contact with the driver’s right hand. There were several intrusions of the passenger compartment. The most severe intrusion involved the roof mounted console, which intruded 26 centimeters (10.2 inches) vertically into the front center sector (**Figure 12**). The interior roof structure also intruded vertically 14 centimeters (5.5 inches) into the front left sector, 15 centimeters (5.9 inches) into the front center sector and 16 centimeters (6.3 inches) into the front right sector. There was no evidence of steering rim deformation or compression of the energy absorbing steering column.

Figure 12: Driver’s seating area and intrusion of the roof mounted console and roof
