**CALSPAN SUDDEN ACCELERATION INVESTIGATION**  
**SCI CASE NO: CA08020**

**VEHICLE: 2007 TOYOTA TACOMA**  
**LOCATION: FLORIDA**  
**CRASH DATE: DECEMBER 2007**

<p>16. Abstract</p> <p>This investigation focused on the alleged sudden acceleration and the crash dynamics surrounding the single vehicle rollover crash of a 2007 Toyota Tacoma pick-up truck. The 35 year old driver reportedly lost control of the vehicle due to the alleged sudden acceleration during a left turning maneuver. During the course of the acceleration, the vehicle lost traction and began yawing counterclockwise as it departed the eastbound lanes. The Toyota crossed the center median, entered the westbound lanes, and tripped into a right side leading five-quarter turn rollover. The vehicle tripped as a result of its transition from grass back to the road surface. The Toyota came to rest on its right side on the westbound traffic lanes. The driver reported that he sustained a forearm abrasion and he denied further medical attention. The vehicle sustained disabling damage and was towed. It was subsequently deemed a total loss by its insurance carrier.</p> <p>The National Highway Traffic Safety Administration's (NHT

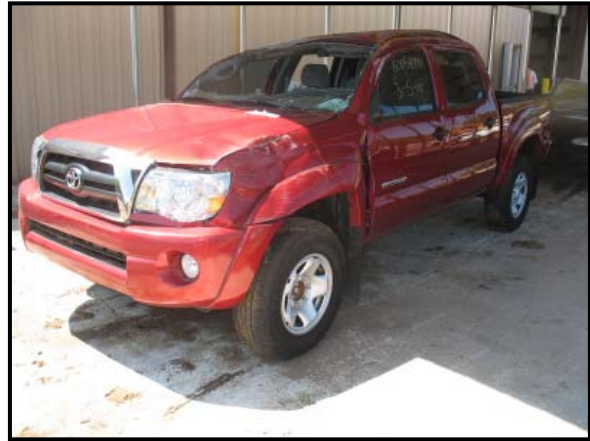
This investigation focused on the alleged sudden acceleration and the crash dynamics surrounding the single vehicle rollover crash of a 2007 Toyota Tacoma pick-up truck (**Figure 1**). The 35 year old driver reportedly lost control of the vehicle due to the alleged sudden acceleration during a left turning maneuver. During the course of the acceleration, the vehicle lost traction and began yawing counterclockwise as it departed the eastbound lanes. The Toyota crossed the center median, entered the westbound lanes, and tripped into a right side leading five-quarter turn rollover. The vehicle tripped as a result of its transition from grass back to the road surface. The Toyota came to rest on its right side on the westbound traffic lanes. The driver reported that he sustained a forearm abrasion and he denied further medical attention. The vehicle sustained disabling damage and was towed. It was subsequently deemed a total loss by its insurance carrier.

**Figure 1: Left front oblique view of the Toyota.**

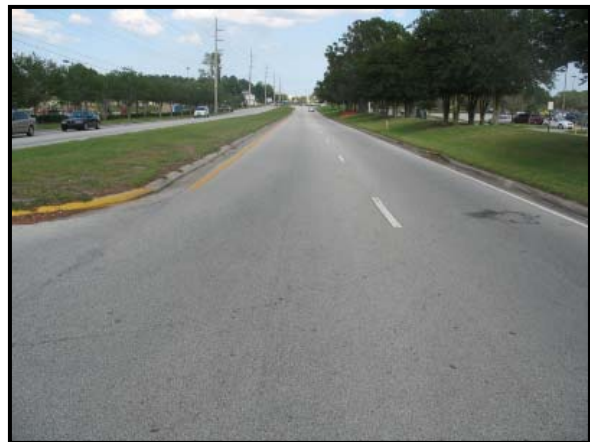
This single vehicle rollover crash occurred during the daylight hours in December 2007. At the time of the crash, the weather was clear. The asphalt road surface was dry. The crash occurred on a divided two-lane, straight, level, east/west roadway in a commercial setting. The east/west traffic flow was separated by a 6.6 m (21.7 ft) raised grass median. The median was bordered by a 0.5 m (1.7 ft) wide concrete gutter and 10 cm (4 in) curb. There was a three-leg intersection immediately west of the median that was controlled by overhead traffic signals. The intersection was the entrance/exit into/out of the parking lot of commercial businesses located on the north side of the roadway. **Figure 2** is an eastbound trajectory view of the Toyota at the intersection. Due to the passage of time between the December 2007 crash date and the SCI case assignment in June 2008, no physical evidence of the crash remained at the site.

**Figure 2: Eastbound trajectory view at the crash site.**

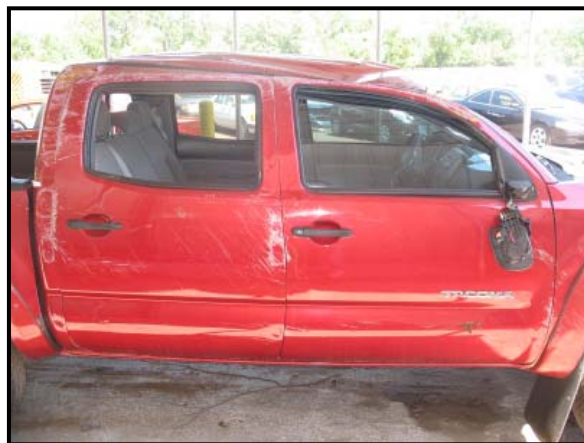
**Figures 3 through 5** are exterior views of the Toyota Tacoma. The Tacoma sustained damage to the right, top and left planes consistent with a right side leading five-quarter turn rollover event. The right side plane exhibited body panel abrasions that were oriented in two different directions indicative of ground contact at two different points in time. The top and left planes exhibited body panel abrasions that were oriented in a single direction. The exterior mirrors on both side planes fractured and separated from their respective doors. There was

**Figure 3: Right side view.**

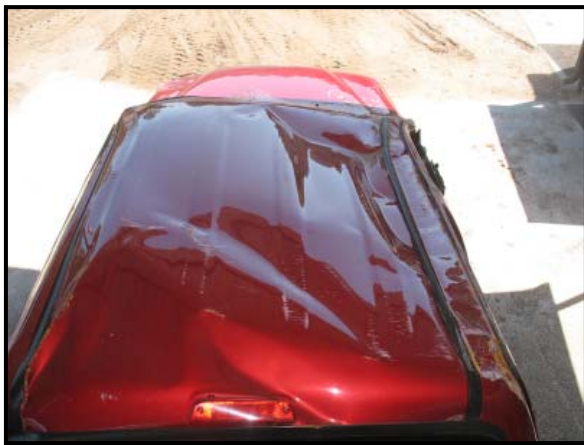
The maximum lateral deformation was located at the right A-pillar and measured 4 cm (1.5 in). The maximum vertical deformation was located within the right B-pillar roof area, 16 cm (6.2 in) inboard of the right roof rail and 24 cm (9.5 in) forward of the right B-pillar. The maximum deformation measured 11 cm (4.3 in). The Collision Deformation Classification (CDC) was 00-TPDO3

Figure 4: Top view of the Tacoma.

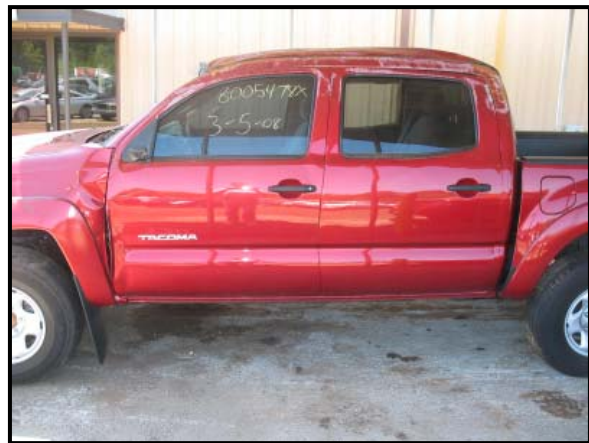
Figure 5: Left side view of the Toyota.

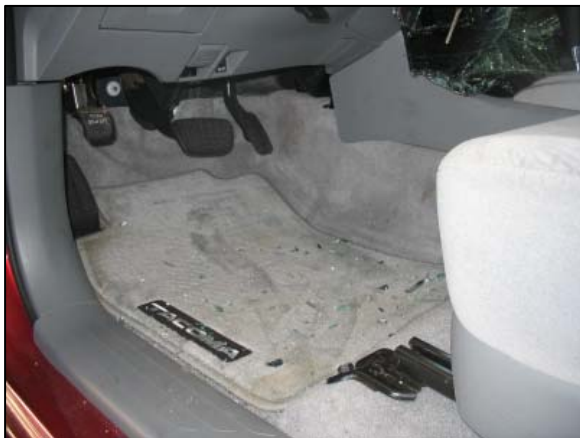
**Figure 6** is an interior view of the driver position as it was first observed. The foot controls were not damaged and operated properly. The accelerator did not bind; its return spring was strong. It was observed that the rubber pad covering the steel brake pedal was partially displaced. Refer to **Figure 7**. Normally, the pad was attached to the steel pedal by inserting the four edges of the pedal under molded flaps on the back side of the rubber pad. At the time of the SCI inspection, the pad was only attached to the pedal by the lower outboard corner. This implied to this investigator that the driver's foot may have been trapped and/or captured under the pedal and as the driver attempted to free his foot, the pad became dislodged. It was possible that his foot becoming trapped may have been associated with the loss of control. The brake pedal was firm when depressed and the system held pressure.

**Figure 6: Interior view with the OEM carpet mat.**

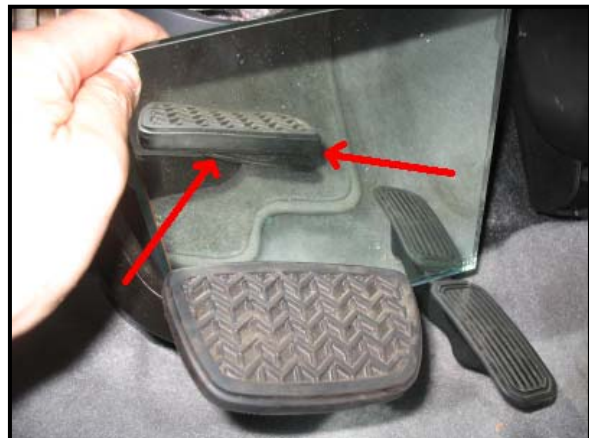
**Figure 7: Displaced brake pedal pad.**

Additionally during the exemplar testing, the SCI investigator was able to peel the brake pedal pad off the brake pedal quite easily with the sole of his right shoe. This created a condition similar to the brake pedal pad found during the Tacoma vehicle inspection. The possibility of the driver’s foot/shoe getting caught up between the pedals during the crash existed, as well. The pad could also have been displaced due to the occupant kinematics caused by the rollover.

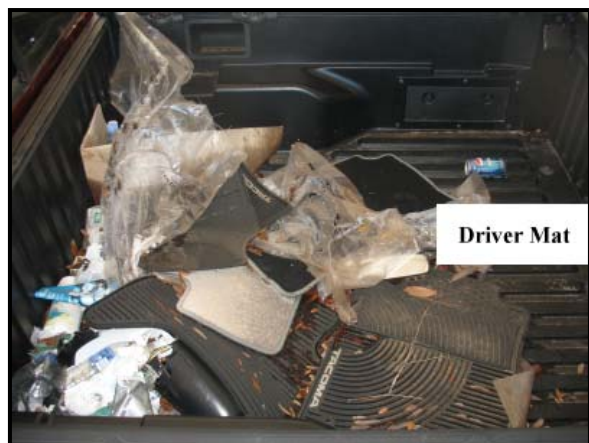
An OEM carpeted floor mat was installed in the left position and clipped into place. On top of the carpeted mat, an OEM rubber all-weather mat was also in use. It should be noted that this mat, an additional rubber mat for the front right position and a mat for the rear right position were found within the bed of the pickup. Refer to **Figure 8**. The OEM rubber mat was contoured to fit within the left floor pan (**Figure 9**) and was flexible. There were cut-outs on the forward left and forward right sides of the mat for the dead pedal and accelerator, respectively. There were no abrasions or damage to the floor mat. It was not possible to bunch-up the mat and cause it to interfere with the accelerator. **Figure 10** is a view of the rubber mat displaced to its most forward position. In this displaced position, the forward right corner of the mat remained

**Figure 8: Mats found in the open truck bed.**

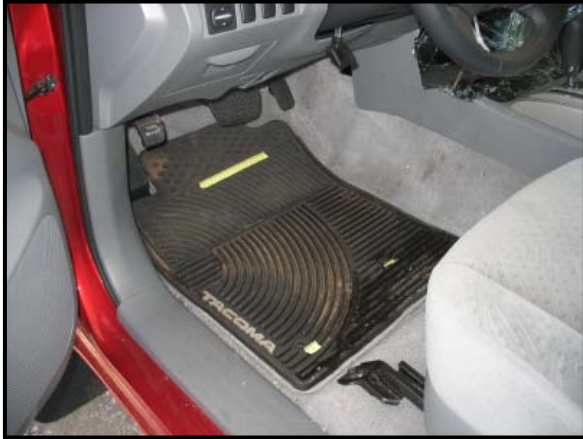
**Figure 9: Interior view with the OEM rubber floor mat in place.**

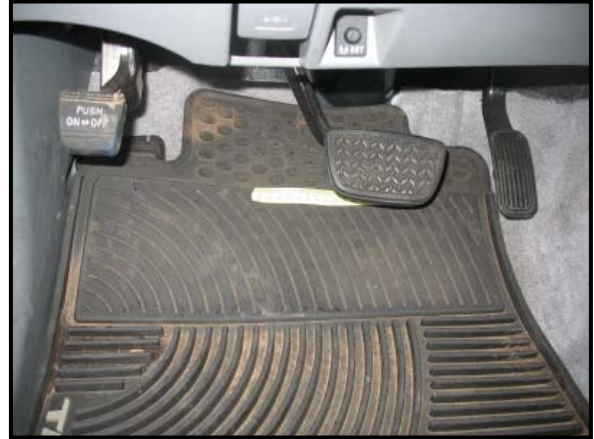
**Figure 10: Rubber Mat displaced to its most forward position.**

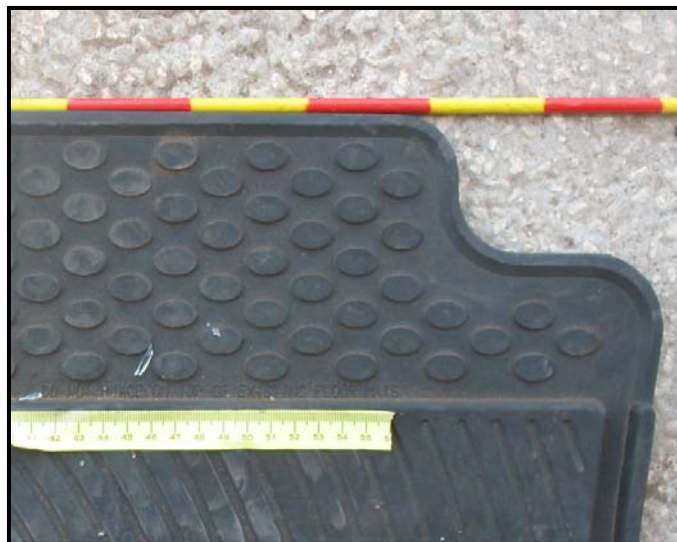
clear of the accelerator. The mat could not be shifted laterally due to the vertical side wall of the console. There was a warning molded into the mat stating: *“Do Not Place On Top Of Existing Floor Mats”*. **Figure 11** is a close-up view of the forward right corner of the mat and the molded warning.

**Figure 11: Forward aspect of the OEM rubber mat.**

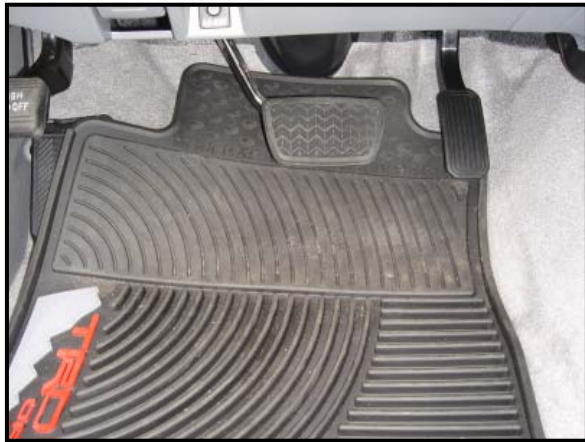
The Office of Defects Investigation (ODI) of the NHTSA has identified a condition where an unsecured OEM rubber all-weather floor mat may become displaced forward and entrap the accelerator in an open position. Although this condition could not be replicated during the SCI inspection of the Florida Toyota Tacoma, exemplar vehicle testing has shown the possibility does exist that the accelerator may become entrapped by the raised molding of the displaced mat. **Figures 12 and 13** are interior views of a Toyota Tacoma obtained from ODI that depict the displaced mat and accelerator pedal entrapment.

**Figure 12: View of the displaced floor mat obtained from ODI.**

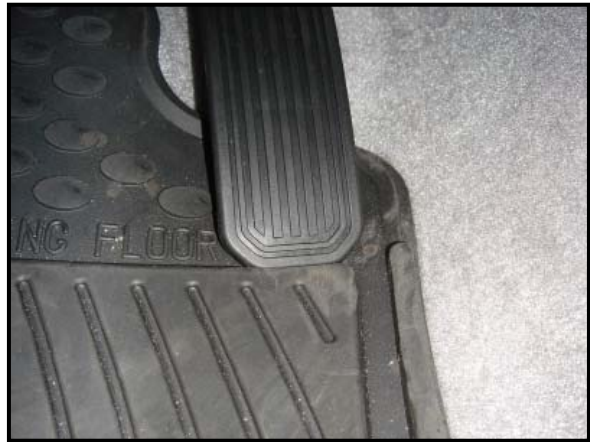
**Figure 13: Close-up view of the entrapped accelerator pedal in Figure 12.**

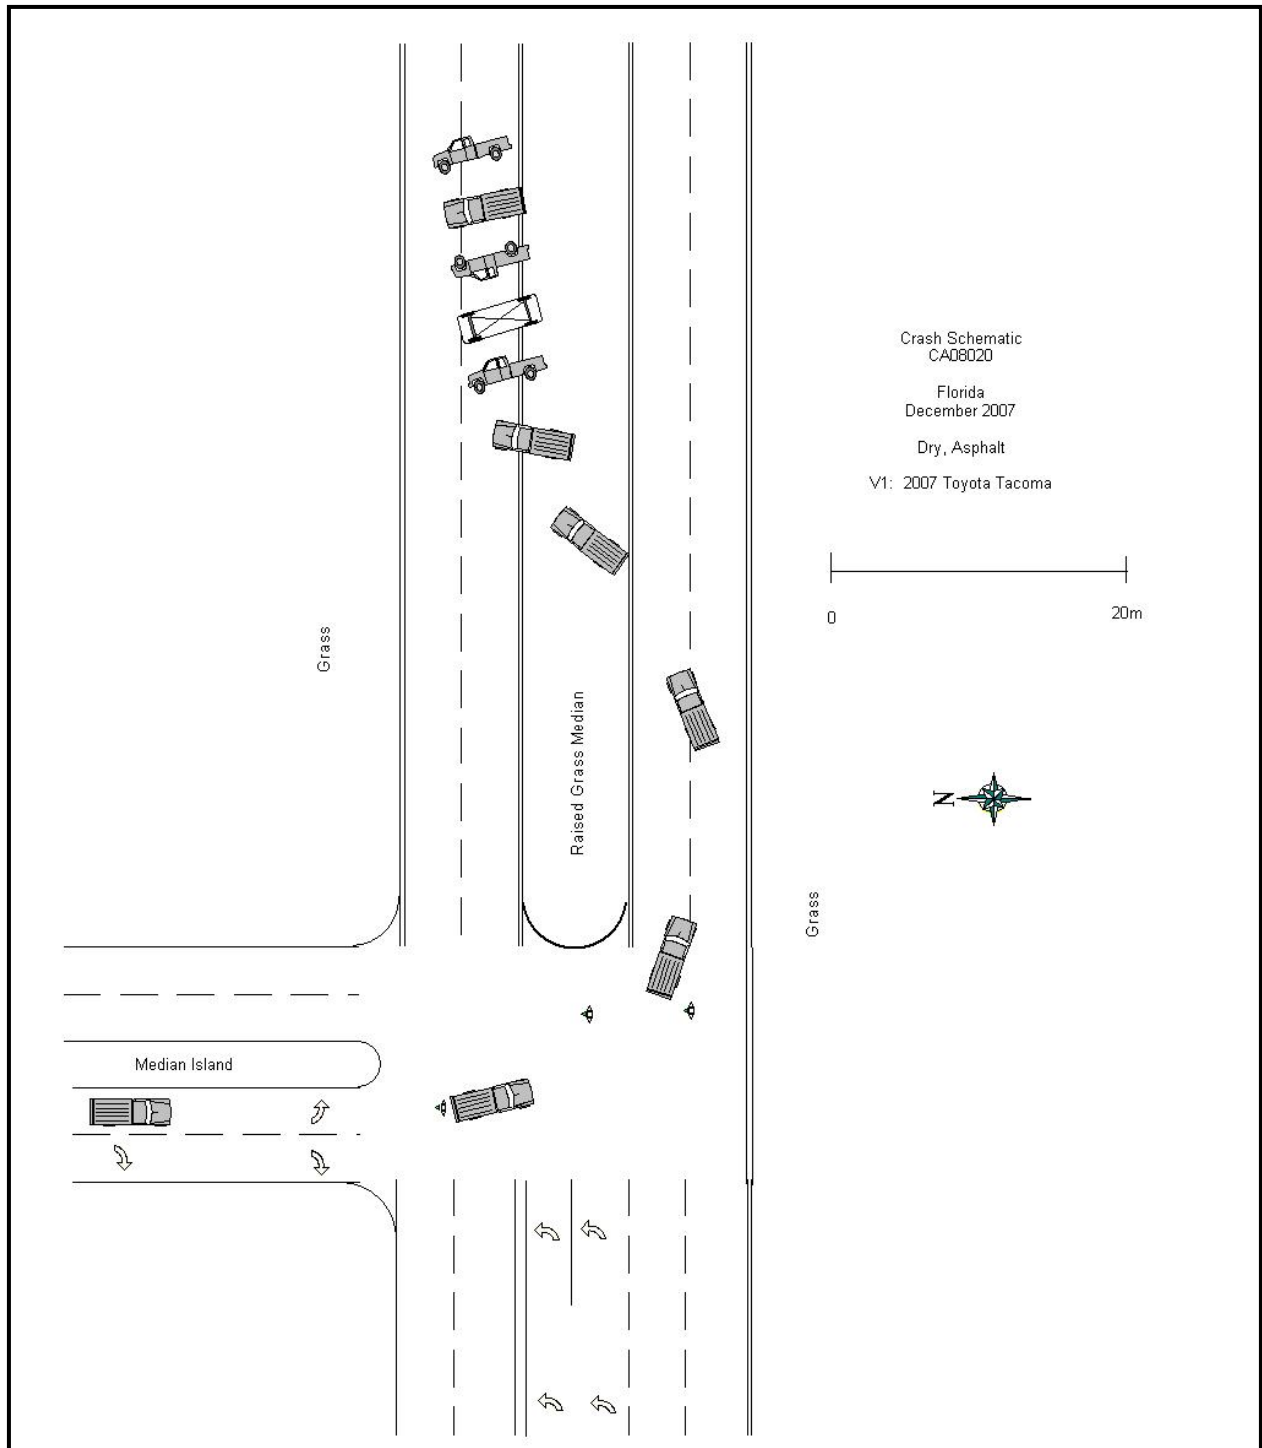
arrow and there was no other traffic in front of him. He estimated his speed was approximately 30 km/h (20 mph). As the driver initiated a left turn, he tapped the brakes and he felt the rear tires break traction. Allegedly, the Toyota then suddenly accelerated. The driver counter-steered to the right and then back to the left in an effort to regain control of the vehicle. He reported that he began to panic and the next thing he recalled was entering the center median. The engine was racing and he indicated that he attempted to apply the brake with his right foot. He stated that he braced himself by the steering wheel and elevated himself to fully apply the brake with his body weight; however, the brakes were not effective. The Toyota crossed the center median in a counterclockwise rotation. A schematic of the crash is included at the end of this report as **Figure 14**.

**Figure 14: Crash Schematic.**
