ON-SITE SIDE IMPACT INFLATABLE OCCUPANT PROTECTION INVESTIGATION

CASE NUMBER - IN08022

VEHICLE - 2007 HONDA ACCORD EX

CRASH DATE - March 2008

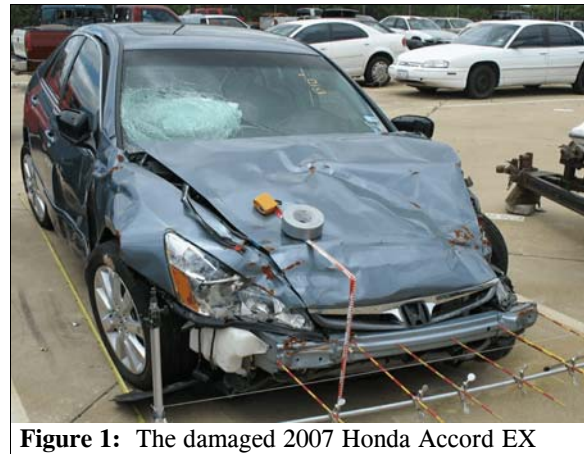
Figure 1: The damaged 2007 Honda Accord EX

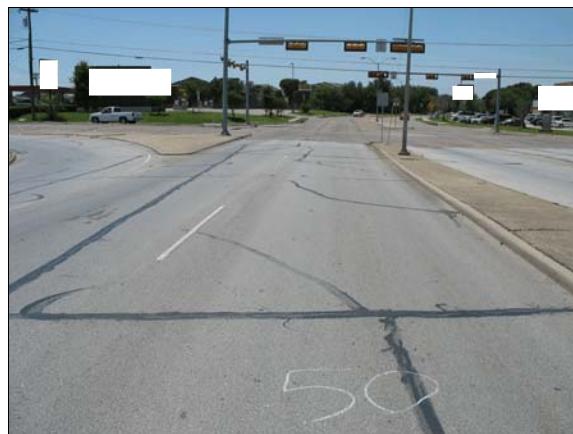
Figure 1: 2007 Honda southbound in the northbound lanes approaching the intersection; number on pavement indicates meters to impact

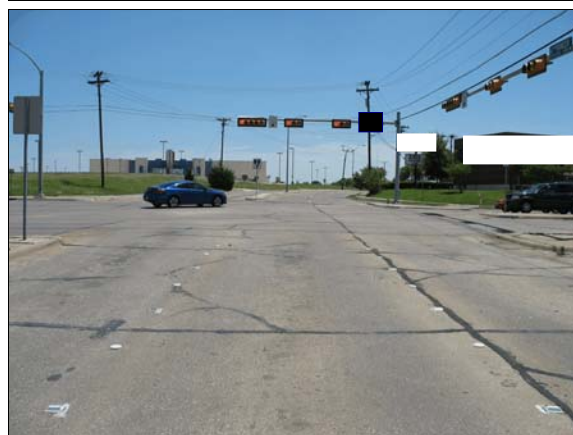
Figure 2: 1994 Honda's approach in the inside through lane to impact within the intersection

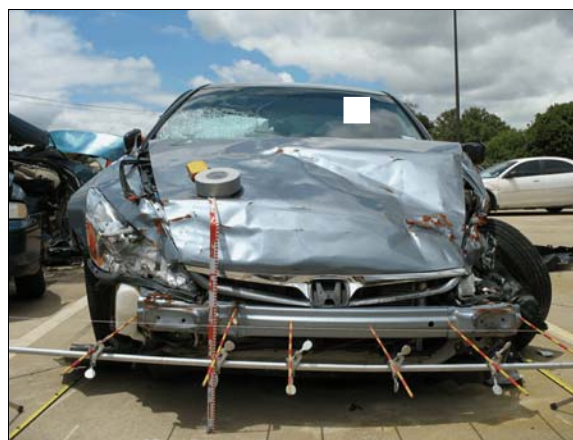
Figure 3: Damage to front of 2007 Honda from impact with left side of 1994 Honda

Exterior Damage: The 2007 Honda's initial impact with the 1994 Honda (event 1) involved the front plane. The front bumper, grille, hood, both headlamp/turn signal assemblies and both fenders were directly damaged. The direct damage began at the front right bumper corner and extended across the entire front bumper (**Figure 3**). The residual maximum crush was 21 cm (8.3 in) occurring at both C₄ and C₅ (**Figure 7**). The table below shows the vehicle's front crush profile.

Damage Classification: The 2007 Honda's Collision Deformation Classification (CDC) for the front impact (event 1) was **01-FDEW-1 (20 degrees)**. The CDC for the right side impact (event 2) was **03-RYAW-2 (90 degrees)**. The CDC for the bus sign impact (event 3) was **02-RPEN-2 (70 degrees)**. The Damage algorithm of the WinSMASH program calculated the vehicle's total Delta V for the front impact as 55 km/h (34 mph). The Longitudinal, and Lateral velocity changes were -52 km/h (-32 mph) and -19 km/h (-12 mph).

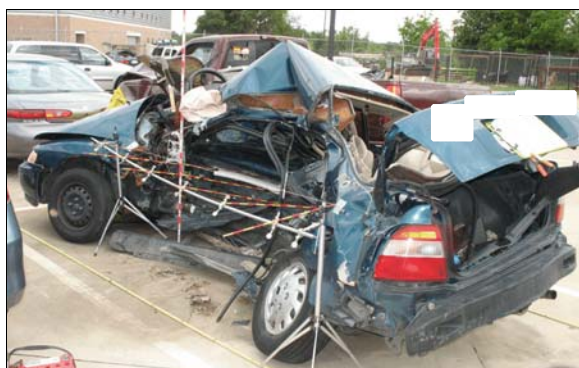
Figure 4: Damage to left side of 1994 Honda from impact with front of 2007 Honda

Exterior Damage: The 1994 Honda's initial impact with the 2007 Honda involved the left side (**Figure 14**). The left side doors, left fender, A, B and C-pillars, and the left quarter panel sustained direct damage. The direct damage began 20 cm (7.9 in) rear of the left front axle and extended 226 cm (89 in) rearward along the left side of the vehicle. Due to the separation of the left rear door latch, the crush measurements were taken at the mid door level as well as the sill. There was also separation of the sill that occurred below the left rear door. As a result, the crush at the two levels was equal at C₄-C₆, and the maximum residual crush was 140 cm (55.1 in) at the mid-door level occurring at C₄. The door sill differential, which was measured at the point of maximum crush was therefore 0 cm. The table below shows the left side crush profile, which reflects the average of the two levels of crush.

Damage Classification: The CDC for the 1994 Honda’s left side impact (event 1) was **10-LDAW-7 (290 degrees)**. The CDC for the impact to the left quarter panel (event 2) was **09-LBEW-2 (270 degrees)**. The CDC for the bus stop sign impact to the left quarter panel (event 4) was **09-LBEN-2 (270 degrees)**. The Damage algorithm of the WinSMASH program calculated the total Delta V for event 1 as 63 km/h (39 mph). The longitudinal and lateral velocity changes were -22 km/h (-14 mph), and 59 km/h (37 mph).

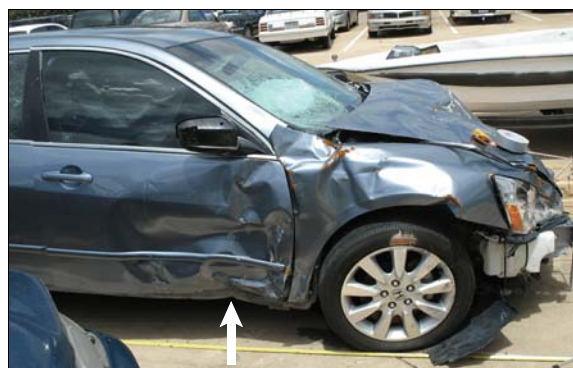
quarter panel impacted the 2007 Honda's right fender and right front door (event 2, **Figure 5**). The direction of principal force was within the 03 clock sector and the impact force was sufficient to trigger deployment of 2007 Honda's right side curtain air bag and front right seat back-mounted side impact air bag. The vehicles remained engaged and traversed 27 m (88.6 ft) southward into the southern leg of the intersection and departed the east roadside. As the vehicle's traveled southeast toward the final rest positions, the left side of the 2007 Honda impacted a bus stop sign (event 3). The impact broke the sign off at the base and it was dragged along with the vehicle and impacted the 1994 Honda's left quarter panel (event 4) as the vehicles came to final rest on the sidewalk heading southeast (**Figure 6**). The 2007 Honda traveled approximately 48 m (157.4 ft) from the impact area to final rest. The 1994 Honda traveled 49 m (160.7 ft) from the impact area to final rest.

Figure 5: Damage to right fender and right front door of the 2007 Honda from impact with 1994 Honda left quarter panel; arrow shows overlapping damage from bus stop sign impact

The second impact with the 1994 Honda (event 2) involved the right side. The right fender, right front door, right A-pillar, and side view mirror were directly damaged. The impact with the bus stop sign (event 3) also involved the right front door, mirror and sill. The damage from both impacts overlapped and extended to 89 cm (35 in) rear of the right front axle. The induced damage from the front impact (event 1) also overlapped the damage to the right fender and no crush profile was taken.

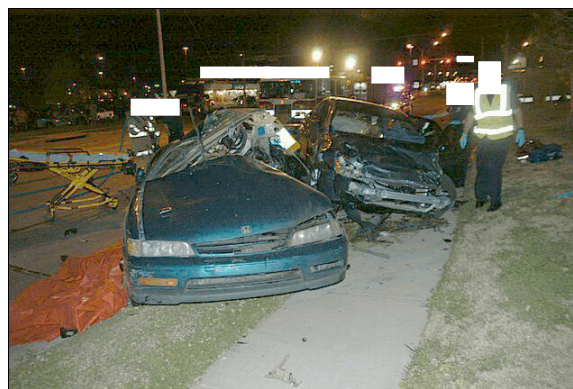
Figure 6: Police on-scene photo of final rest positions of both vehicles

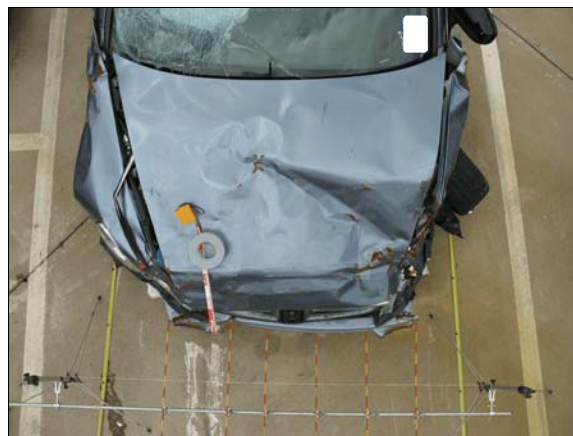
Figure 7: Top view of the front crush on the 2007 Honda

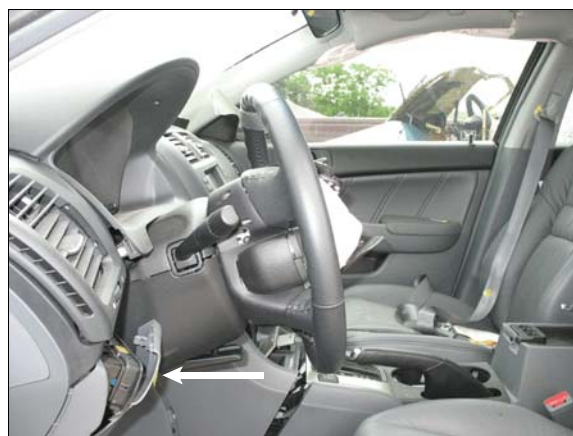
Vehicle Interior: Inspection of the vehicle’s interior revealed occupant contact evidence on the driver’s air bag, steering wheel rim (**Figure 8**), lower instrument panel on each side of the steering column (**Figures 8 and 9**), and right portion of the center console. The right half of the steering wheel was deformed forward 4 cm (1.6 in), probably as a result of the driver riding down the deployed air bag and loading the steering wheel. The lower instrument panel was deformed on each side of the steering column due to loading by the driver’s knees. The driver’s air bag had a few blood stains on it, but they appeared to related to blood spatter and not direct occupant contact. The right portion of the center lower instrument panel was discolored, probably due to loading by the front right passenger’s left knee.

Figure 8: Left side view of deformation on the steering wheel and left lower instrument panel (arrow) due to driver loading

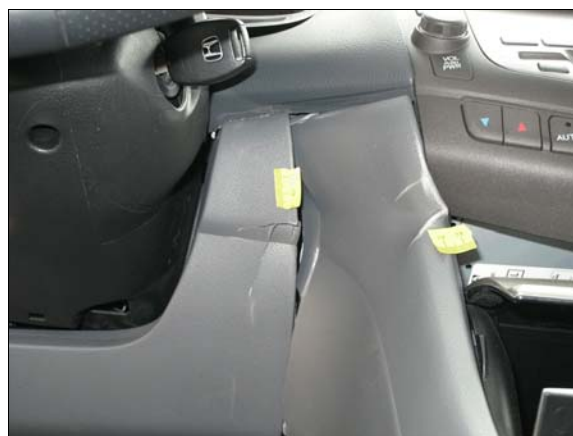
Figure 9: Deformation of the center lower instrument panel due to loading by the driver’s right knee

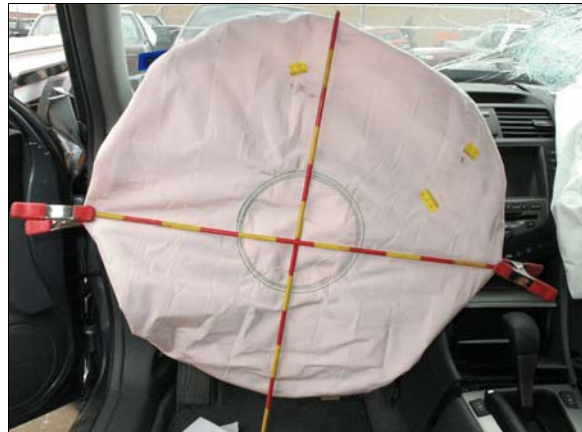
The driver's frontal air bag was located within the steering wheel hub. An inspection of the air bag module cover flaps and the air bag fabric revealed that the cover flaps opened at the designated tear points. There was no evidence of damage to the module cover flaps or air bag fabric. The blood stains mentioned in the vehicle interior section above were located on the upper center and upper right portions of the air bag (**Figure 10**). The deployed air bag was round with a diameter of 59 cm (23.2 in). The air bag was designed with four tethers and two vent ports.

Figure 10: Driver's deployed air bag; yellow tape highlights areas with blood stains

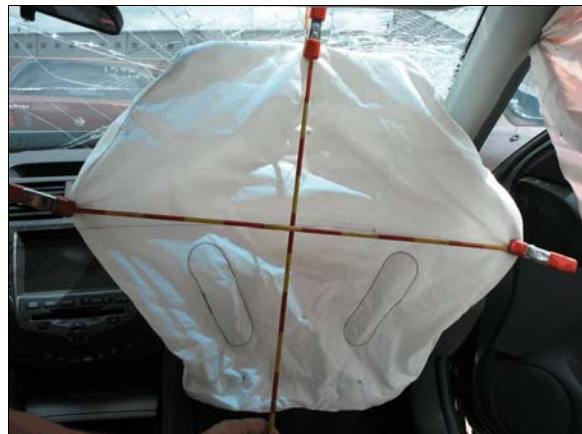
The front right passenger's frontal air bag was located within the top of the instrument panel. The inspection of the air bag module cover flaps and air bag fabric revealed that the cover flaps opened at the designated tear points. There was no evidence of damage to the air bag fabric or cover flaps. The deployed air bag (**Figure 11**) was hexagonal and was 62 cm (24.4 in) at its widest point and 54 cm (21.3 in) in height. The air bag was designed with two tethers and two vent ports. There was no evidence of occupant contact on the air bag.

Figure 11: Front right passenger's deployed air bag

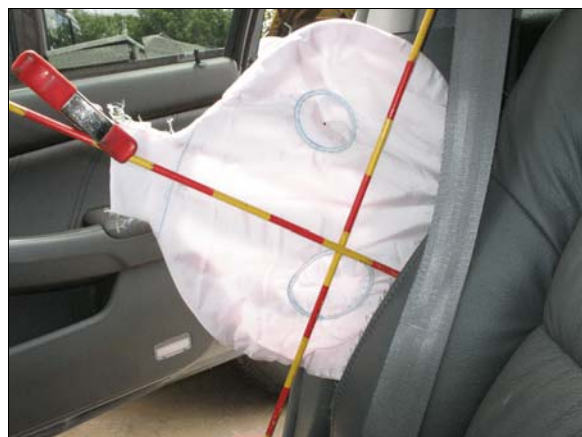
Figure 12: Front right passenger seat back-mounted side impact air bag

The front right seat back-mounted side impact air bag (**Figure 12**) was located within the outboard side of the seat back and deployed through a tear seam. The air bag was oval with a maximum width of 23 cm (9.1 in) and a height of 32 cm (12.6 in). The air bag was designed without vent ports. The inboard and outboard sides of the air bag were stitched together in a circular pattern near the top and bottom in order to shape the air bag during deployment. An inspection of the air bag and the seat back revealed that the tear seam opened at the designated tear points. There was no damage or discernable evidence of occupant contact on the air bag.

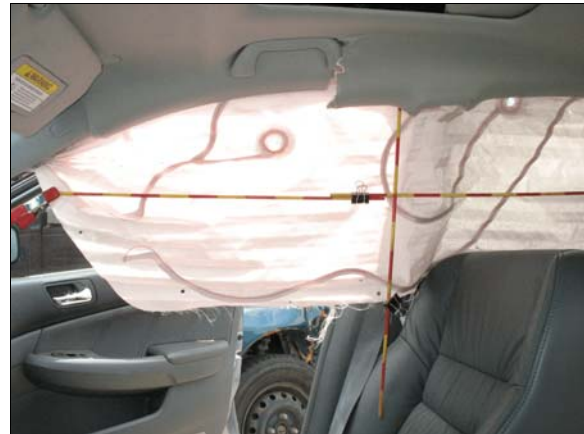
Figure 13: Right side curtain air bag (front portion)

The right side curtain air bag was located within the right roof side rail and extended from the A-pillar to the D-pillar. The curtain air bag (**Figures 13**) was 170 cm (66.9 in) in length and 37 cm (14.6 in) in height. The air bag was designed with two vent ports, one at the lower front corner and one at the back. The curtain air bag deployed uniformly from under the roof liner along the roof side rail. There was no damage or discernable evidence of occupant contact on the air bag.

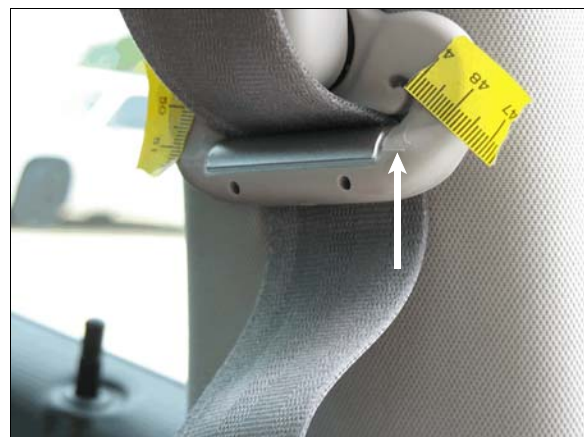
Figure 14: Arrow shows load abrasion on plastic of driver's D-ring

The inspection of the driver's seat belt assembly revealed load marks on the D-ring and belt webbing (**Figures 14** and **15**). The belt webbing would not retract due to actuation of the

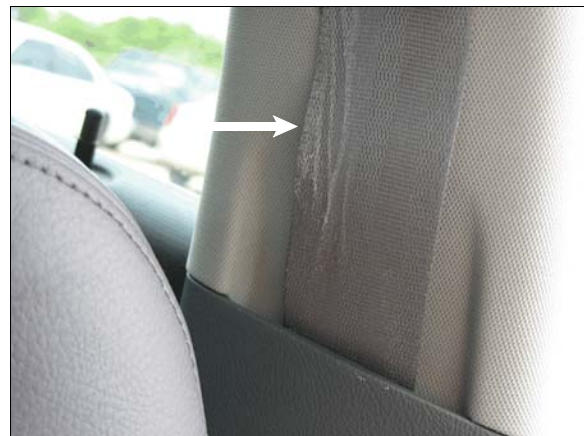
Figure 15: Load abrasions on driver's seat belt

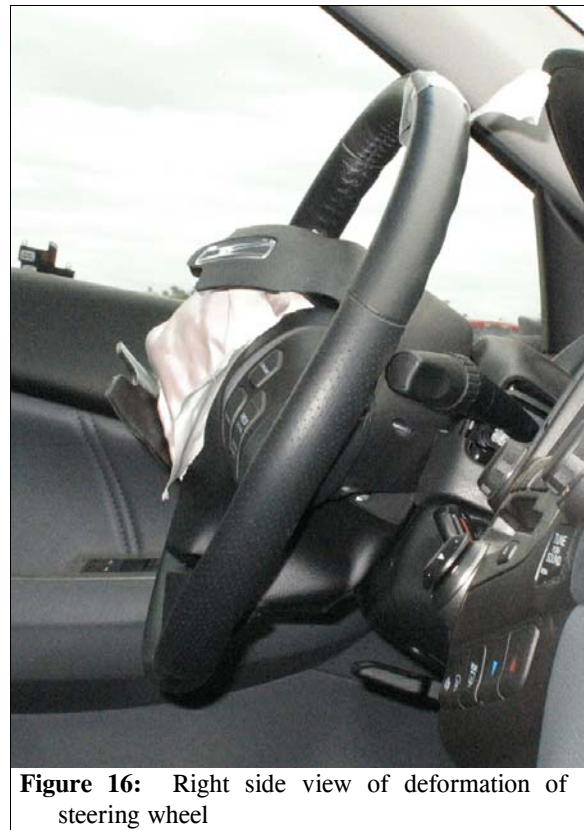
The 2007 Honda's front impact with the 1994 Honda displaced the driver forward and slightly to the right opposite the vehicle's 1 o'clock direction of force. He loaded the seat belt and his face and chest loaded the deployed air bag and his knees loaded the lower instrument panel (including the knee bolster). The driver rode down the air bag and loaded the steering wheel, which bent the right half section forward 4 cm (1.6 in, **Figure 16**). The driver sustained a through and through laceration on the middle lower lip due to loading the steering wheel rim and contusions on the chest from loading the air bag and the seat belt. He sustained contusions on the abdomen and right hip from loading the seat belt. Contact with the air bag also caused abrasions on the left elbow and both upper thighs. The driver's upper thighs were also contused from loading the steering wheel.

Figure 16: Right side view of deformation of steering wheel
