**CALSPAN ON-SITE OFFICE OF DEFECTS CRASH INVESTIGATION**

**SCI CASE NO.: CA08023**

**VEHICLE: 2007 DODGE CALIBER**

**CRASH DATE: MARCH 2008**

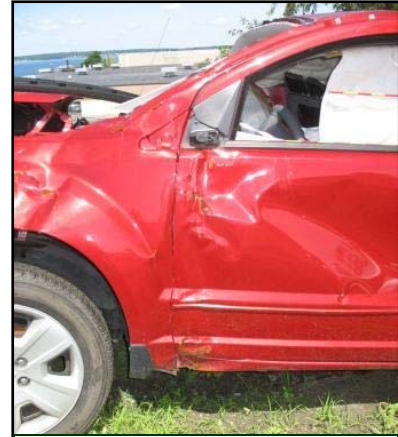
As the vehicle yawed CW off the left road edge, the forward aspect of the left front door impacted a delineator post located at the outboard edge of the paved shoulder. The direct contact damage began 53 cm (21 in) aft of the left front axle and extended 14 cm (5.5 in) rearward (**Figure 3**). The combined induced and direct contact damage length (Field L) was 30 cm (12 in), originating 47 cm (18.5 in) aft of the referenced axle, extending rearward. Maximum crush was 4 cm (1.75 in) on the sill and was located 58 cm (23 in) aft of the axle position. The direct contact damage extended vertically 75 cm (29.5 in) and included contact and separation of the rear view mirror. The Collision Deformation Classification (CDC) for this event was 09-LPAN-1.

**Figure 3. Delineator impact to the left front door.**

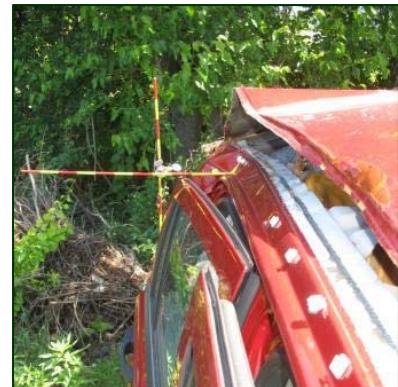
The Caliber sustained moderate severity damage from the rollover event that involved direct contact damage and deformation to all body panels. Maximum vertical roof crush was 4 cm (1.5 in), located on the side rail at the right C-pillar area. The maximum lateral crush at this same location was 6 cm (2.5 in). The crush values are depicted in **Figure 4**. The roof panel was bonded to the side rails with two continuous beads of adhesive. The full length of the right side bond separated from the A-pillar to a point immediately forward of the right D-pillar (**Figure 5**). It appeared that the inboard bead of adhesive had minimal contact with the roof panel (**Figure 6**). The outer bead was at the edge of the roof panel and was painted over during the assembly process. The CDC for the rollover event was 00-TDDO-2.

**Figure 4. Vertical and lateral crush to the right C-pillar area.**

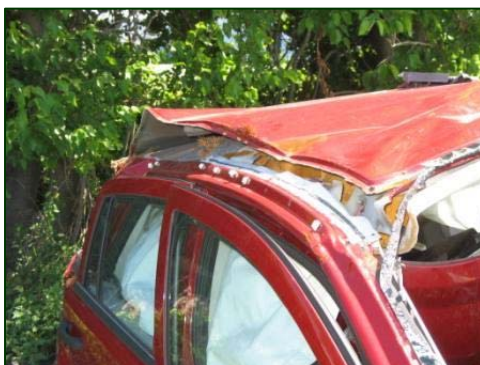
**Figure 5. Separated roof panel.**

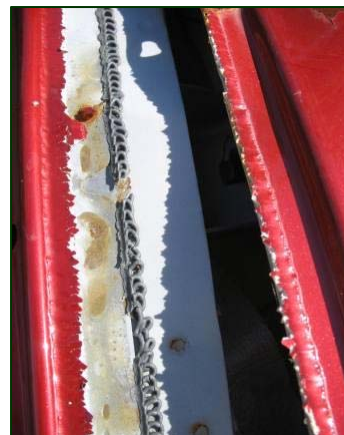
**Figure 6. Separated adhesive beads.**

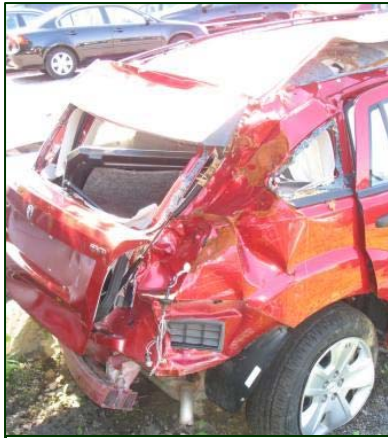
During the rollover, a tree(s) or tree branches (cedar) were impacted by the right D-pillar area and the base of the right upper A-pillar area. The D-pillar impact was lateral in direction and involved the pillar, lift gate window frame, and the quarter panel above the tail lamp lens (**Figure 7**). The damage involved a non-horizontal impact force that resulted in 32 cm (12.5 in) of direct contact damage. The maximum lateral crush was estimated at 17 cm (6.5 in). The CDC for this impact was 00-RBHN-3.

**Figure 7. Right D-pillar area damage.**

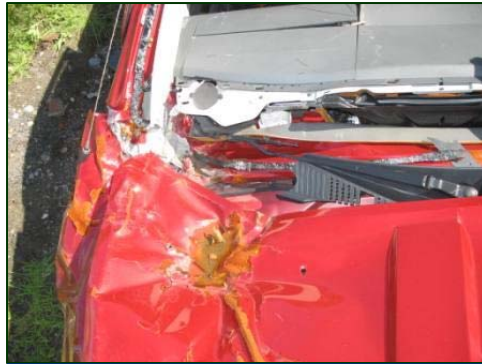
**Figure 8. Vertical impact to the right cowl / lower windshield area.**

The vertically oriented impact damage to the base of the upper right A-pillar area involved the pillar, windshield, wiper cowl area, hood and the right front fender (**Figure 8**). Tree bark was embedded into the upper A-pillar area. This non-horizontal impact crushed the hood and cowl area downward to a depth of 17 cm (6.5 in). The CDC for this impact was 00-TFRN-6.

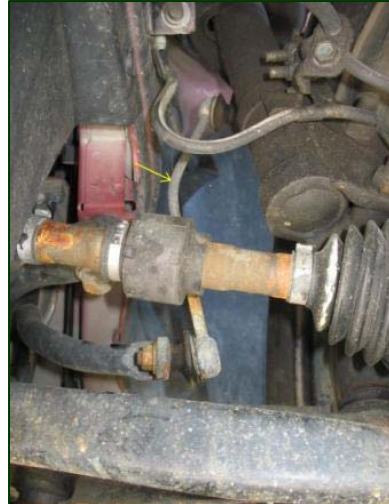
The vertical stabilizer links that connected the sway bar to the strut were deformed. These links consisted of a solid rod with a small tie-rod-type pivot at the top and bottom ends. The studs were fastened to the sway bar and the strut housing. Based on an exemplar vehicle, these stabilizer links were 27 cm (10.5 in) in length (centerline of bearing studs) and were 6 mm (0.25 in) in diameter. The left stabilizer link was bowed at the upper third in a lateral inboard direction. The upper third aspect of the right link was bowed in a forward direction. There was no evidence of contact from adjacent suspension/steering components. These links probably deformed during the rollover as the front suspension was fully compressed by tire contact to the ground. The pivots remained intact and tight on both links. **Figures 9 and 11** are of the front stabilizer links of an exemplar vehicle. **Figures 10 and 12** are the deformed links from the 2007 Dodge Caliber case vehicle.

**Figure 10. Deformed left front stabilizer link of the case vehicle.**

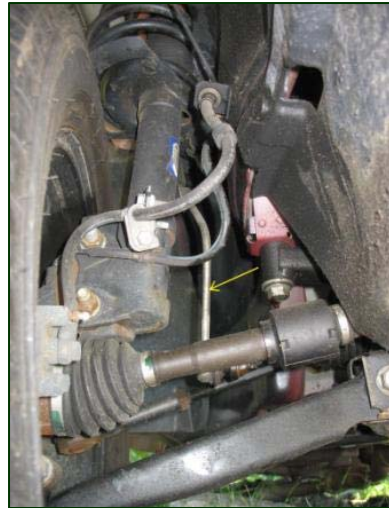
**Figure 12. Deformed right front stabilizer link of the case vehicle.**

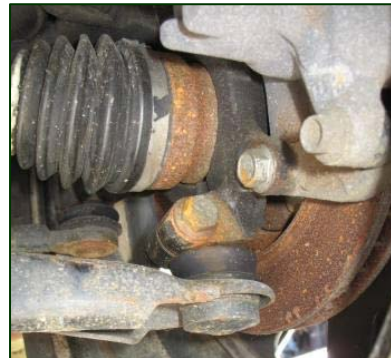
**Figure 13. Intact lower left ball joint and outer tie rod of the 2007 Dodge Caliber.**

boots were intact and the tie rods pivoted on the bearing stud/socket joint with no free-play or indication of binding. The tapered studs were fully engaged in the steering knuckles and the retaining nuts were fully engaged. Minimal surface rust was present on the outer surface of the tie rods and the steering knuckles. Based on the extent of rust on the brake rotors, the majority of the undercarriage rust was attributed to the vehicle sitting idle for the past three months. **Figure 13** is a view of the intact left tie rod and ball joint.

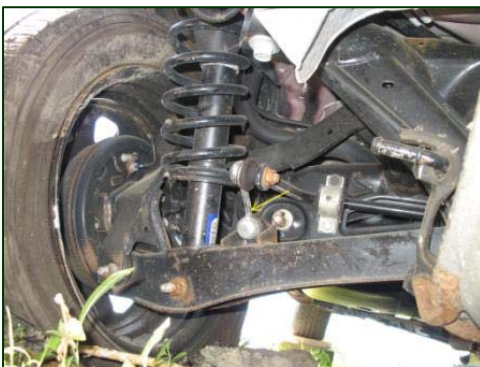
The rear stabilizer links were similar to the fronts with knuckles at the mounting points. Both rear stabilizers were intact and tight at the knuckle joints; however, both were deformed at the lower aspect due to the forward displacement of the rear axle. An inspection of an exemplar vehicle indicated that these stabilizer links were originally straight (**Figure 14**) with a length of 8 cm (3.1 in) at the mid points of the knuckles and a diameter of 6 mm (0.25 in). The deformed links from the 2007 Dodge Caliber are shown in **Figures 15 and 16**.

**Figure 15.** Deformed left rear stabilizer link of the 2007 Dodge Caliber.

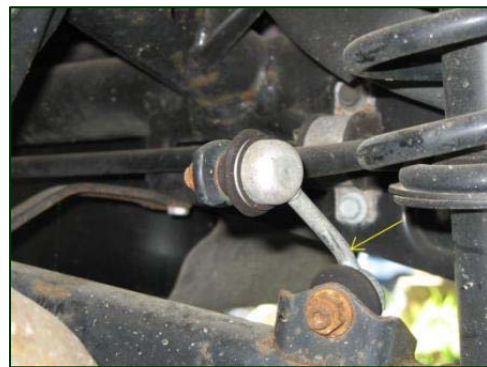
**Figure 16.** Deformed right rear stabilizer link of the 2007 Dodge Caliber.

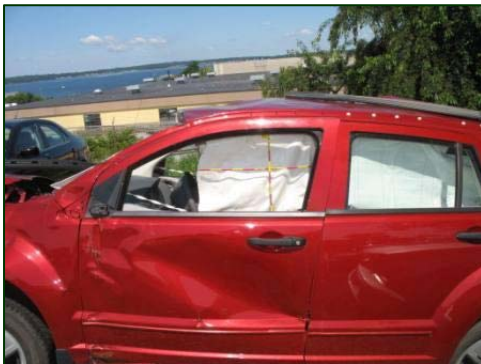
The IC air bags were 168 cm (66 in) in length and 46 cm (18 in) in height. The vertical dimension of the IC provided full coverage to the side glazing. A void in IC coverage was located at the A-pillar area (**Figure 17**). This area was 30 cm (12 in) in length at the top of the door, 18 cm (7.25 in) in height at the forward aspect adjacent to the A-pillar, 34 cm (13.5 in) from the pillar rearward at the side rail, and 46 cm (18 in) in height at the forward edge of the curtain. This void in coverage was located a 4 cm (1.5 in) aft of the mid point of the steering wheel rim, extending forward.

**Figure 17.** Exterior view of the deployed left IC air bag.

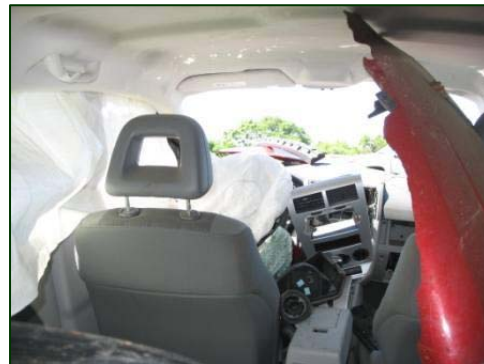
The ICs were tethered to the A- and C-pillars. The A-pillar tether was 48 cm (19 in) in length and the C-pillar tether was 46 cm (18 in) in length. The tethers on both ICs were intact. There was no evidence of occupant contact or crash related damage to the ICs. **Figure 18** is an interior view of the deployed air bags in the driver's position.

**Figure 18.** Interior view of the deployed air bags for the driver's position.
