## TRANSPORTATION RESEARCH CENTER

### ON-SITE NOT IN TRAFFIC SURVEILLANCE BACK OVER INVESTIGATION

CASE NUMBER - IN08023  
LOCATION - TEXAS  
VEHICLE - 1994 GMC SUBURBAN  
CRASH DATE - May 2008

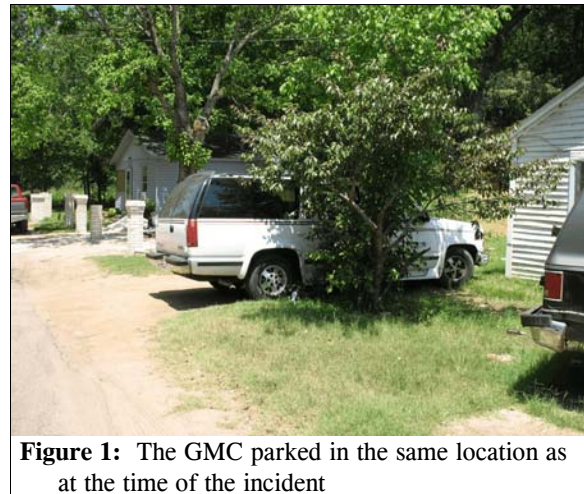
**Figure 1:** The GMC parked in the same location as at the time of the incident

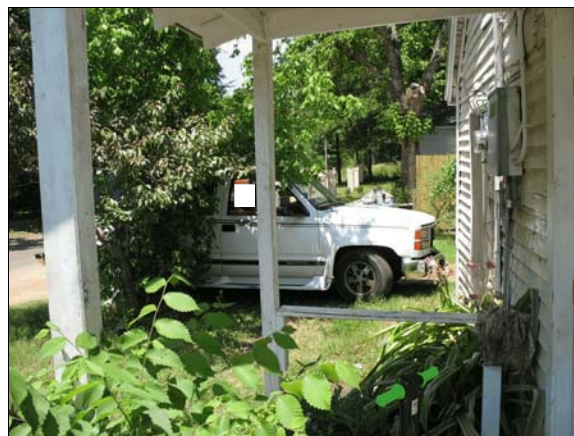
**Figure 2:** View of front porch and GMC

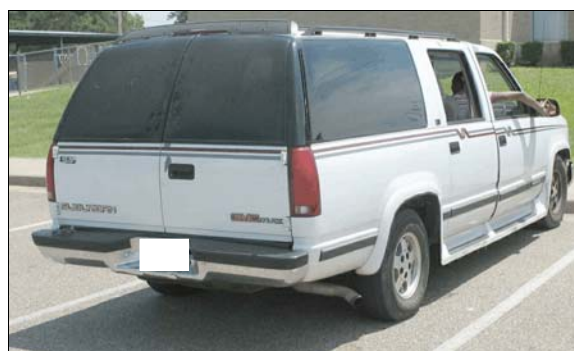
**Figure 3:** Back right view of the GMC

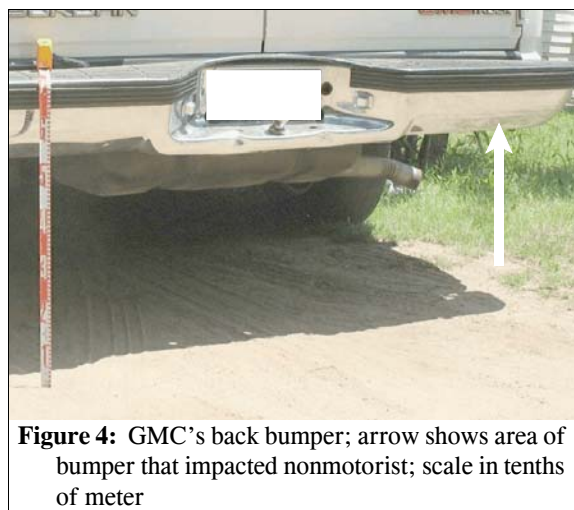
**Figure 4:** GMC's back bumper; arrow shows area of bumper that impacted nonmotorist; scale in tenths of meter

**Crash:** The driver stated that immediately after initiating the backing maneuver, the children began yelling at her to stop. The right portion of the back bumper (**Figures 3 and 4**) impacted the nonmotorist, knocked him to the ground, and the vehicle's right rear tire rolled onto his head. The driver said she felt something, but did not realize there had been an impact. She thought the back wheels had rolled over a depression in the driveway. When she stopped the vehicle, the right rear tire was on the nonmotorist's head. She estimated that she had backed up approximately 1 second before she heard the children yelling for her to stop. Based on the driver's description

There was no damage and no evidence of nonmotorist contact to the GMC's back bumper. Based on the driver's description of the incident and the Collision Deformation Classification (CDC) guidelines for pedestrian impacts, the CDC was estimated to be **06-BRLN-1 (180 degrees)**.

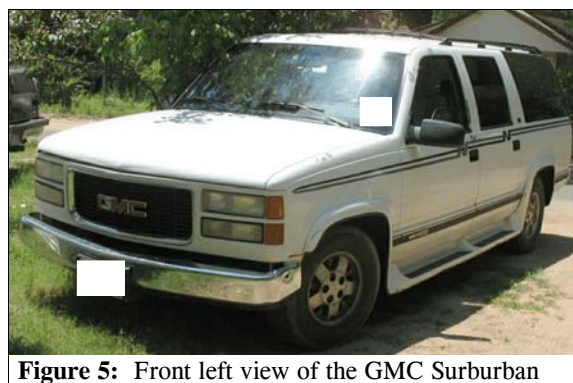
The 1994 GMC Suburban (**Figure 5**) was a rear wheel drive, four-door, large utility wagon (VIN: 1GDEC16K8RJ-----) equipped with a 5.7L, V-8 engine and automatic transmission. The GMC was not equipped with a back up/parking aid, and captains's chairs were installed in the second row. The windows in the second row, third row, and left and right backlights were equipped with AS-3 tinted glazing. The GMC's specified wheelbase was 334 centimeters (131.5 inches), the specified rear overhang was 134 centimeters (52.7 inches), and the specified overall length was 558 centimeters (219.5 inches). The vertical distance from the ground to the bottom of the back bumper was 44 centimeters (17.3 inches). The vertical distance from the ground to the beltline was 116 centimeters (45.6 inches).

**Figure 5:** Front left view of the GMC Suburban

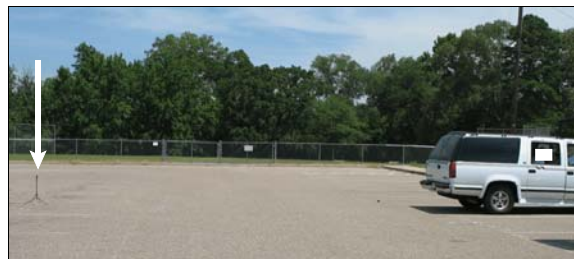
The initial set of observations was made with the driver looking over her right shoulder out of the backlight. Two surrogate passengers were seated in the second row left and right seats to determine if their presence constituted a vision obstruction to the driver. The passenger's heads did not extend above the head restraints of the captain's chairs and did not block the driver's view. The target was moved rearward from the back bumper along the vehicle's centerline until it came into the driver's view. The target had to be moved rearward from the back bumper 8.8 meters (28.9 feet) before the top of target became visible to the driver (**Figures 6 and 7**). The target was then moved to the right 1.1 meters (3.6 feet) where it became obstructed by the pillar that divided the center backlights. The target became visible on the right side of the center backlight pillar when moved 0.7 meter (2.3 feet) further to the right. When the target was moved 1.8 meters (5.9 feet) further to the right, it became obstructed by the right D-pillar. The target became visible again on the right side of the D-pillar when it was moved 1.9 meters (6.2 feet) further to the right. The target was moved another 0.8 meter (2.6 feet) to the right and it became obstructed by the second row right head restraint. The target was no longer visible when moved further to the right. The target was placed back at the centerline, and when moved 0.6 meter (2.0 feet) to the left, it became obstructed by the second row left head restraint. The target was no longer visible to the driver beyond this point because it was not natural for her to turn her head further to the right.

**Figure 6:** Arrow shows position of target where driver could first see it while looking over her right shoulder out of the backlight

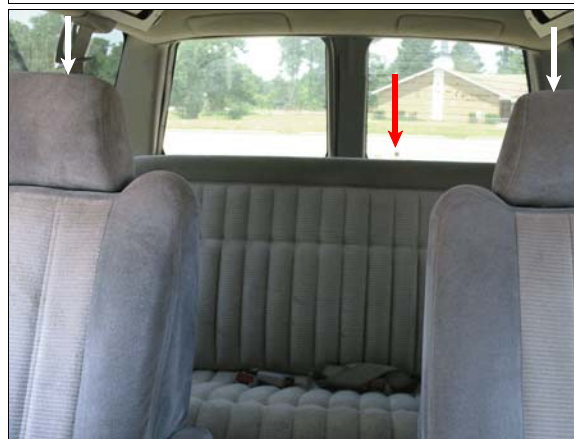
**Figure 7:** View out of backlight from driver's seat; arrows show target and second row captain's chairs

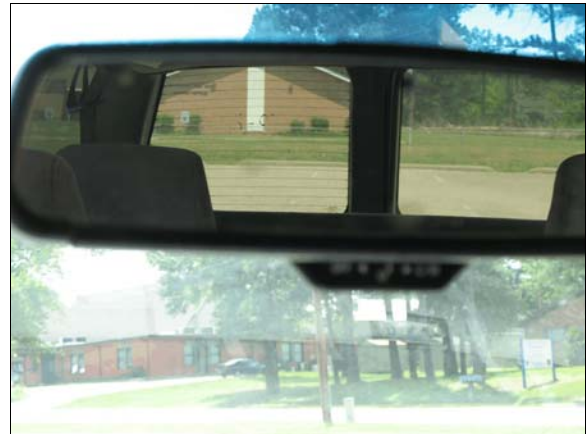
The target was moved rearward from the back bumper as the driver viewed through the rearview mirror (**Figure 8**). The driver could not see the target until it was moved rearward 6.0

meters (19.7 feet). The target became obstructed by the center pillar between the backlights when moved to the right 0.6 meter (2.0 feet), and it became visible again when moved 0.4 meter (1.3 feet) further to the right. When moved an additional 0.6 meter (1.8 feet) to the right, the target went out of the rearview mirror's field of view. The target was returned to the initial location at the centerline and when moved left 1.1 meters (3.6 feet), was obstructed by the second row left head restraint and was not visible again when moved further to the left.

**Figure 8:** Close-up view of the rearview mirror from the driver's seat

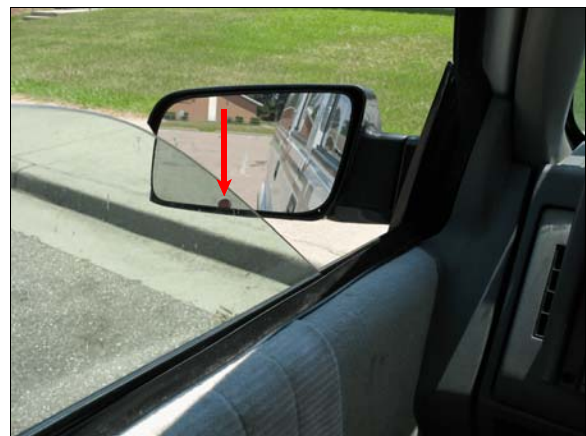
The target was placed at the back left bumper corner as the driver viewed through the left side view mirror and moved left 1.1 meters (3.6 feet) where the driver could no longer see it. The target was repositioned at the bumper corner and moved forward, toward the mirror 1.1 meters (3.6 feet) where it went out of the driver's view at the bottom of the mirror (**Figure 9**).

**Figure 9:** View through left side view mirror from driver's seat; arrow shows target where it begins to go out of the mirror's bottom field of view

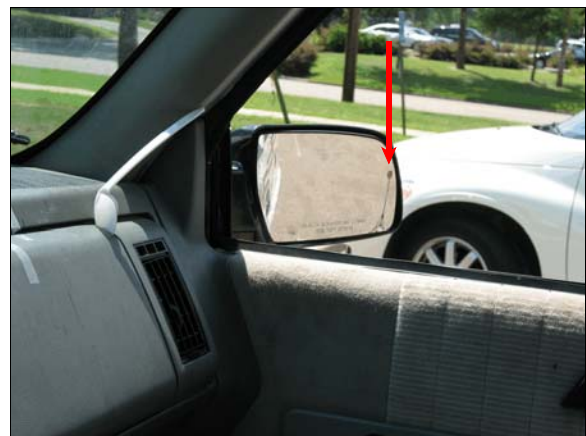
The right side view mirror was loose and did not retain its adjustment. The driver said it was necessary to adjust it each time she drove the vehicle. She adjusted it to her preference prior to the observations. The target was positioned at the back right bumper corner and was moved to the right 1.6 meters (5.3 feet) where the driver could not longer see it (**Figure 10**). When moved forward 1.7 meters (5.6 feet), the target went out of the driver's view at the bottom of the mirror.

**Figure 10:** View through right side view mirror from the driver's seat, arrow shows target where it begins to go out of the mirror's lateral field of view

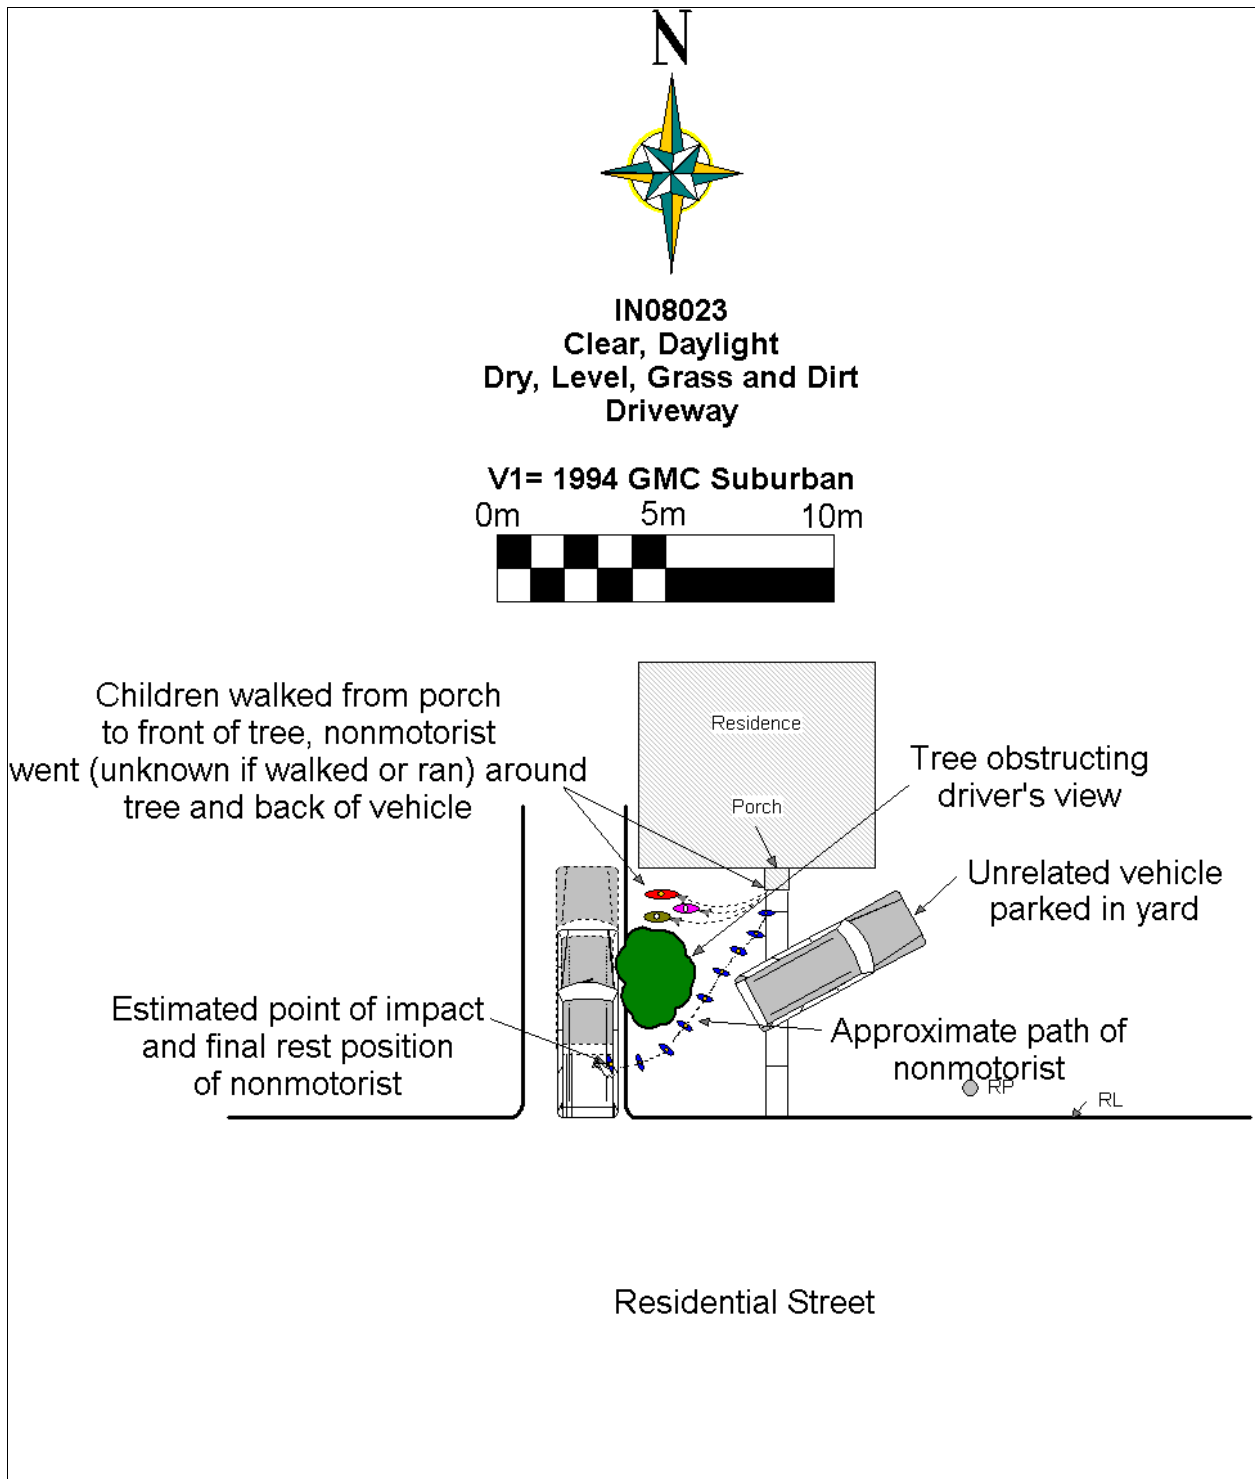
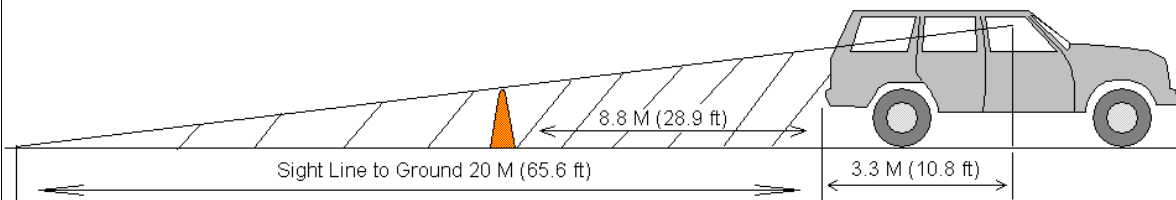
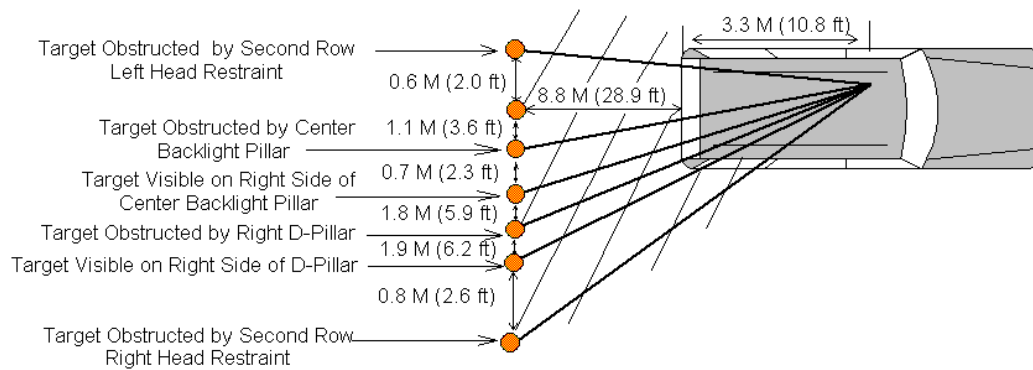
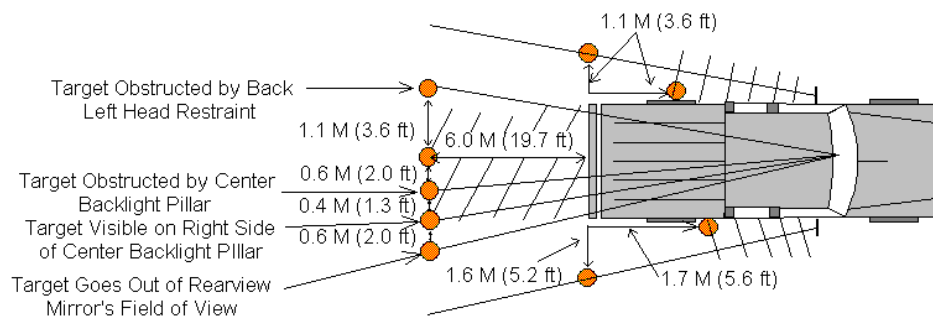
## Nominal Visibility Diagram 1994 GMC Suburban

1. Distance Back of GMC  
To Point a 71 cm (28 in) High Reference Target  
Comes Into Driver's View as She Looks Over Right Shoulder Out of Backlight

2. Rearview Mirror and Side View Mirrors Blind Zones
